# A Large Scale Landslide in a Coal Mine in Marly Formations: Evaluation, Analysis and Rehabilitation

**ABSTRACT:** This paper describes a large scale landslide in a coal mine in Servia area in Kozani, Greece, which occurred in February 2011. The landslide, of ~250m width and ~350m length, took place in marly lacustrine sediments. The main factors for the manifestation of the landslide were a temporary interruption of works, the existence of a specific weak surface, the clayey nature and the sensitivity of marl to environmental agents, the action of water and the large slope height. Due to the magnitude and the position of the failure, a geotechnical solution was proposed that involved rearrangement of ground masses. The proposed solution led to successful rehabilitation and unimpeded continuation of the exploitation process.

Reference: Prountzopoulos, G., Fortsakis, P., Marinos, V. and Marinos, P. (2016). *A Large Scale Landslide in a Coal Mine in Marly Formations: Evaluation, Analysis and Rehabilitation*. International Journal of Geoengineering Case Histories, Vol.4, Issue 1, p.29-45. doi: 10.4417/IJGCH-04-01-03

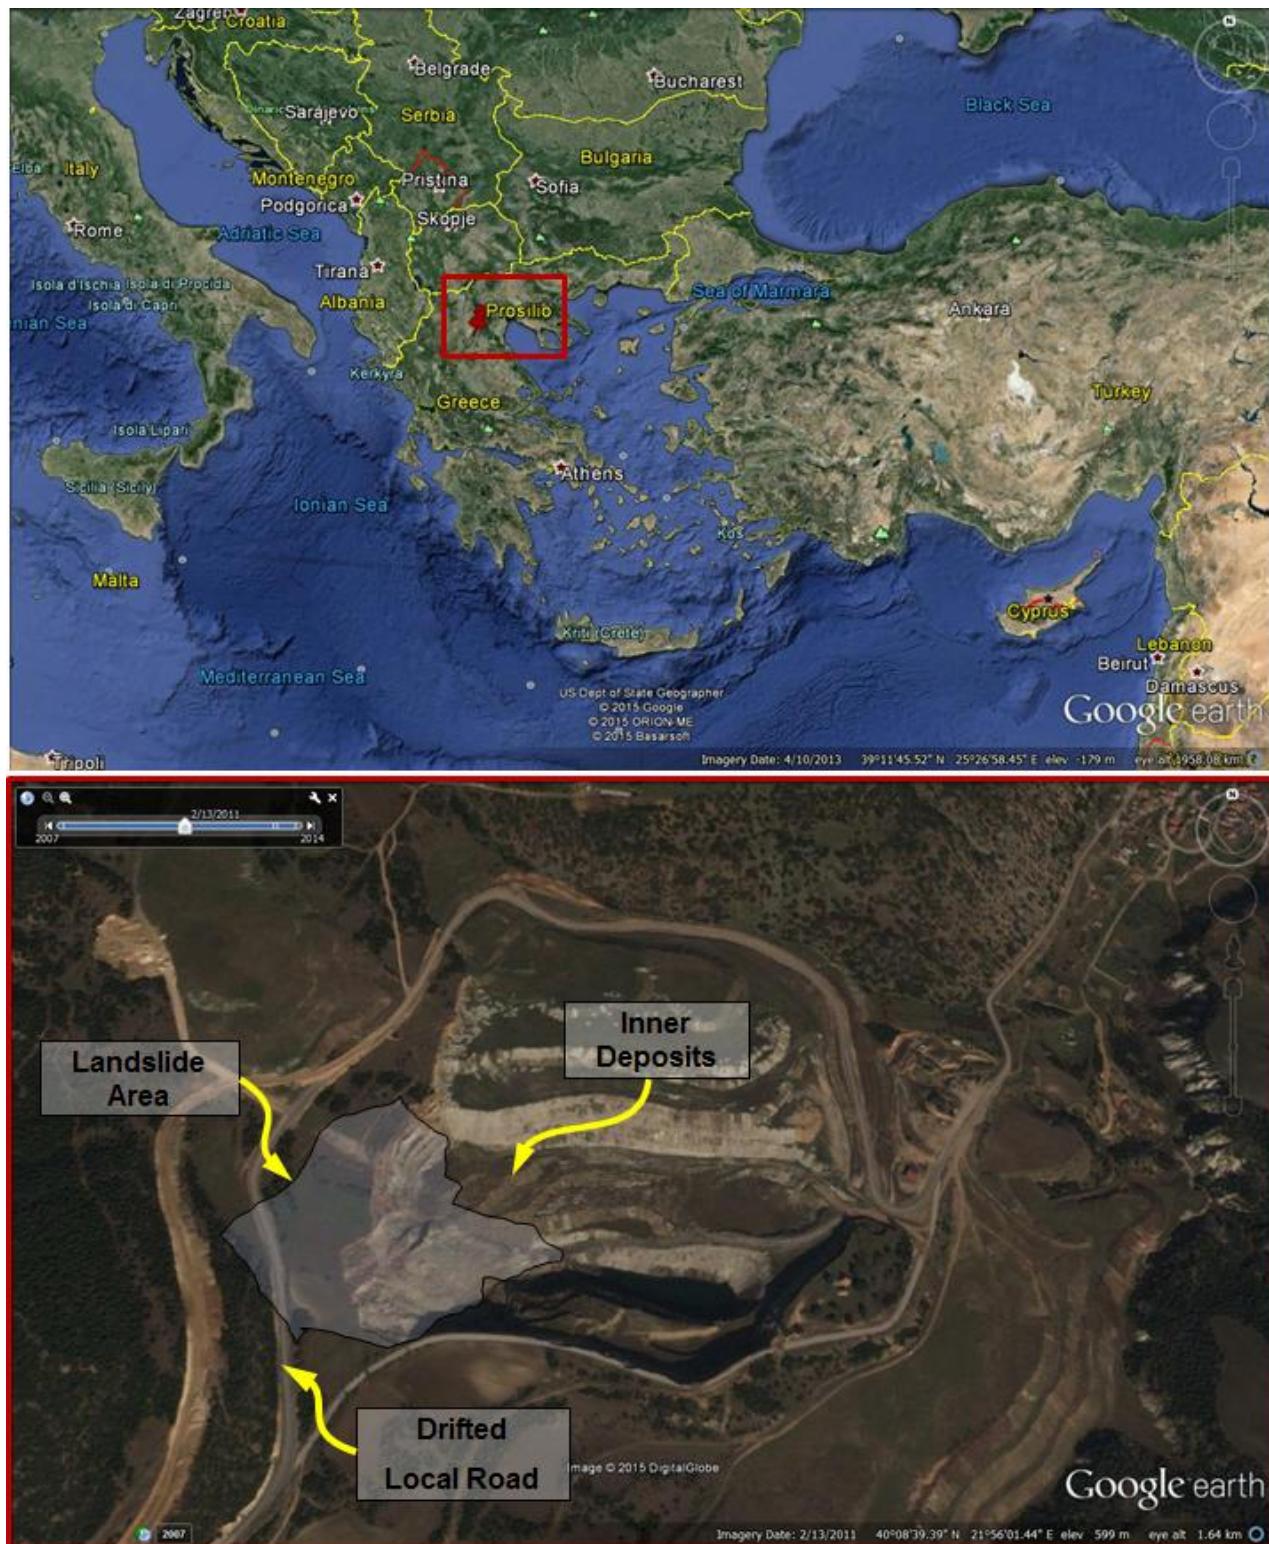
Figure 1 includes a demarcation of the position of the landslide, together with an aerial photo of the coal mine, only few days before the landslide. The landslide area, the local road affected by the landslide and the initially placed deposits for lateral retaining action to the mine slope are indicated on the satellite photo.

Figure 1. Position of landslide (up – red pin inside the red rectangle) and aerial photograph of the coal mine 2 weeks before the landslide (down). The area that was later occupied by the landslide is indicated with the transparent shape.

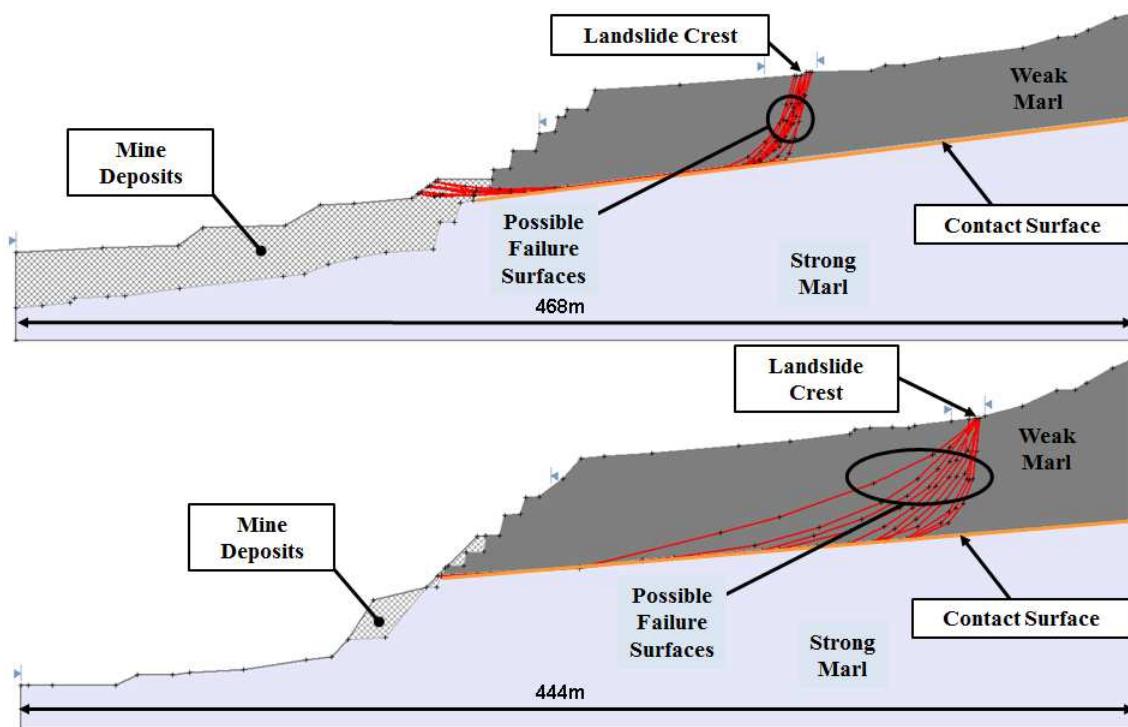
Given the three dimensional character of the landslide, as mentioned earlier, two analysis sections were systematically checked (Sections 2 and 3) so as to estimate some rational parameters for the assessment of rehabilitation proposals. Figure 5 illustrates the analysis sections along with their main features. The process that was adopted is summarized in the following steps:

Figure 5. Analysis Section 2 (up) and 3 (down). Slide software model.

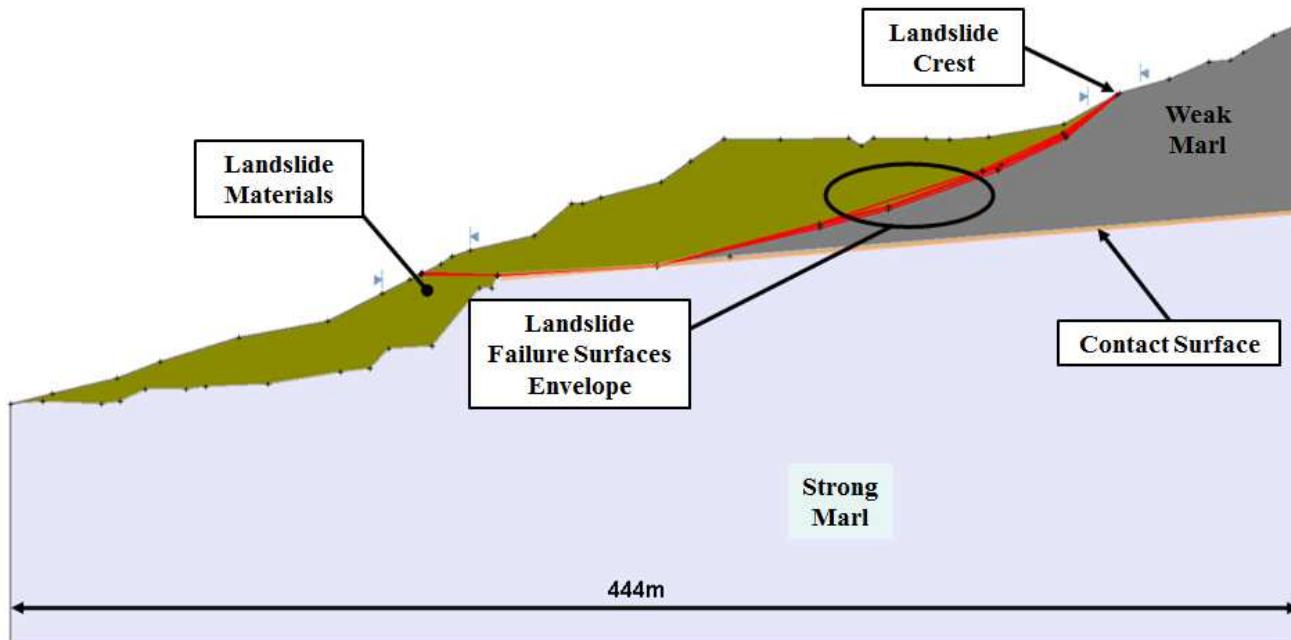
Figure 10. Analysis Section 3 after the landslide

To evaluate the stability conditions of the landslide before any intervention, it was assumed that the critical failure surfaces either pass through the total failure envelope of the event, or through zones where significant shearing and relative movements were observed between “intact” parts of the marl formation, such as the zone downslope of the large scale trench that is shown in Figure 4.
