Remediation of The Pissouri Landslide in Cyprus

Reference: Alexandris, A., Griva, I.K. and Abarioti, M. (2016). *Remediation of The Pissouri Landslide in Cyprus*. International Journal of Geoengineering Case Histories, Vol.4, Issue 1, p.14-28. doi: 10.4417/IJGCH-04-01-02

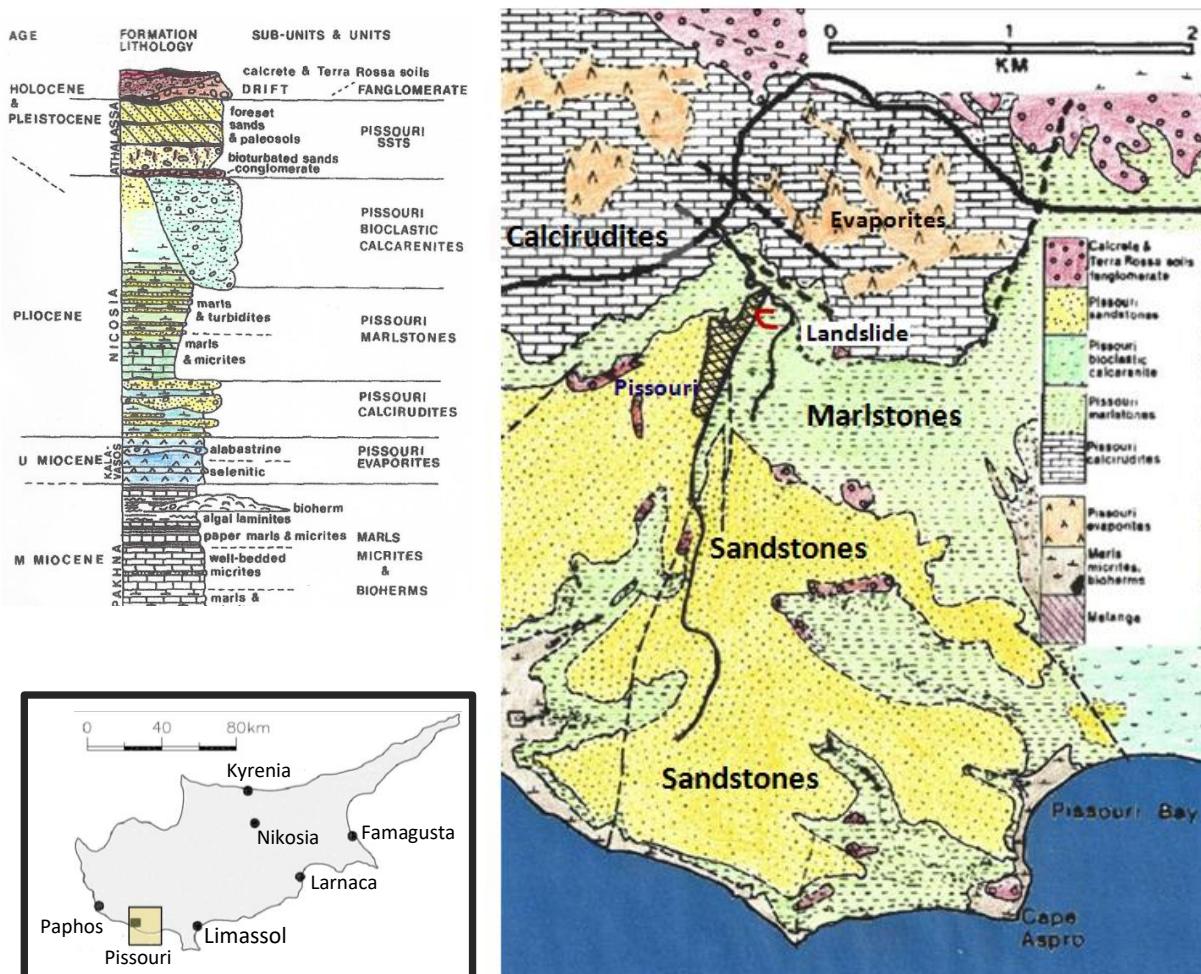
reddish-brown rock which in places disintegrates into a compound of marl blocks within a matrix of stiff fissured silty/clayey soil. The regional distribution of the aforementioned sedimentary units is depicted in Figure 3 (after Stow et al., 1995). The location of the landslide is also noted on the map.

Figure 3. Regional Geology of the Pissouri area. The village is developed on sandstones (yellow) underlain by the Pissouri marls (olive green). Geology after Stow et al., (1995)

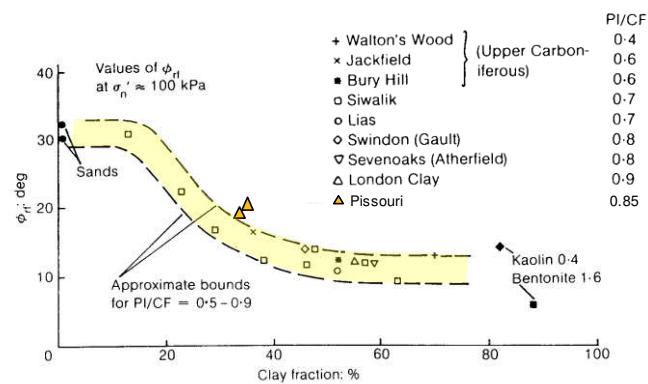
Figure 8. A comparison of the residual angle of shearing resistance of the weathered Pissouri marl with the dataset presented by Skempton (1985).

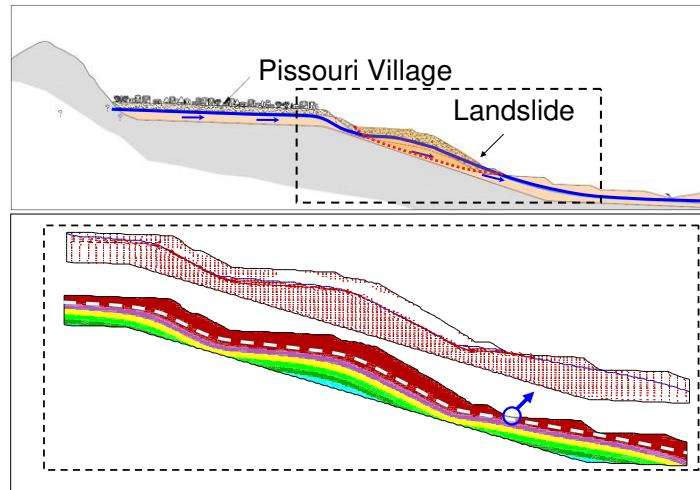
Figure 12. Typical results of the seepage analysis (flow vectors and pore water pressures).

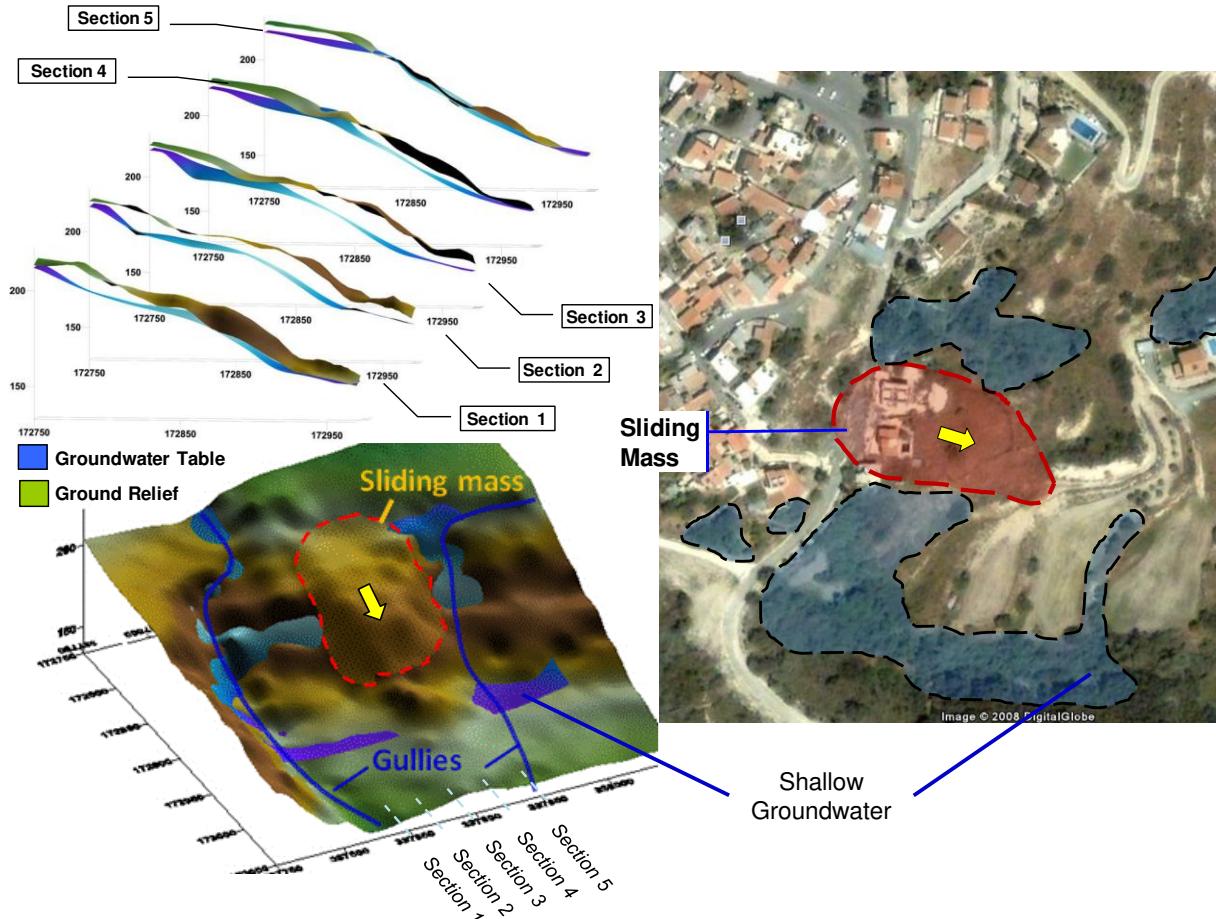
photographs, (Figure 12) and compares well with groundwater level measurements from piezometers installed in the vicinity of the landslide. The piezometric surface of Figure 13 represent the average dry season water table. During a wet season the water table within the landslide mass is expected to rise significantly and the development of a perched water table during thunderstorms should also be considered.

Figure 13. Left: A digital elevation model of the landslide area, overlain to the surface of the computed groundwater table. The groundwater table geometry is also presented as a series of sections in the upper figure.

Right: Blue areas in satellite image indicate areas where the ground water table is at shallow depth and coincide with the most densely vegetated areas.
