Geotechnical Damage Caused by the 2016 Kumamoto Earthquake, Japan

Reference: Kiyota, T., Ikeda, T., Konagai, K. and Shiga, M. (2017). *Geotechnical Damage Caused by the 2016 Kumamoto Earthquake, Japan*. International Journal of Geoengineering Case Histories, <http://casehistories.geoengineer.org>, Vol.4, Issue 2, p.78-95. doi: 10.4417/IJGCH-04-02-01

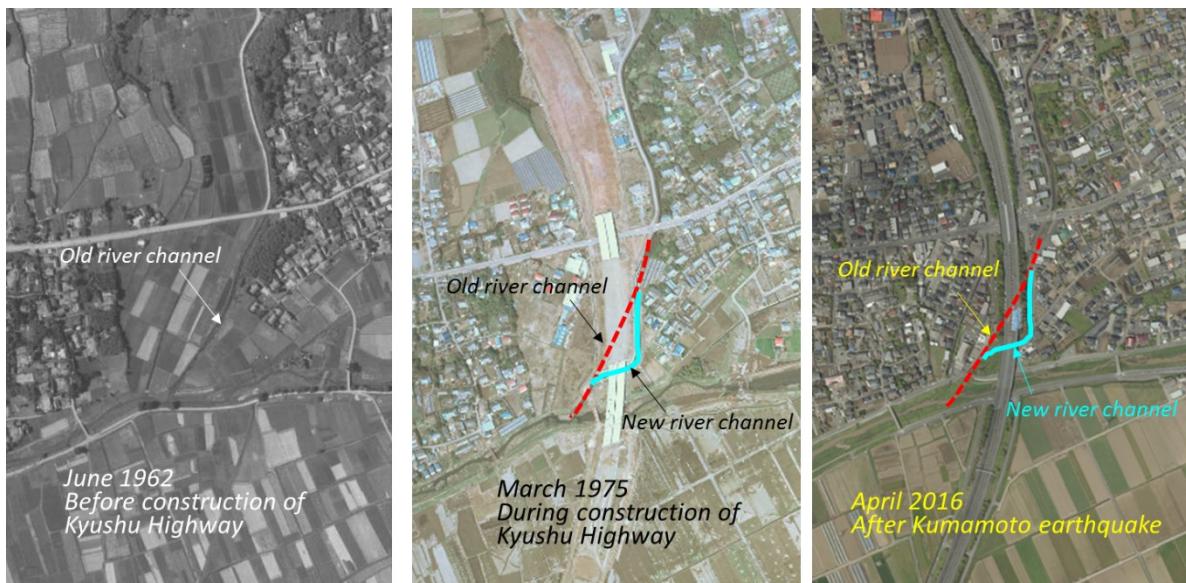
At site 6 in Fig. 3, a 50 m-long embankment on one side of Kyushu Highway, which connects Fukuoka to Kagoshima, suffered from significant damage (Fig. 10). The damage was caused by the earthquake on the 14th of April, in the form of subsidence and lateral flow. The highway was closed to traffic until the end of April, which disrupted emergency distributions in the affected areas. According to the land classification map (Fig. 7) and old aerial photos taken before the construction of the highway provided by GSI (2016) (Fig. 11), the exact location of the damaged embankment used to be a small river channel, which suggest that the process of liquefaction of saturated loose filled soil was the potential cause of damage to the embankment. In fact, the residential house near the damaged embankment suffered from large tilting as shown in Figure 10, indicating a bearing capacity lowering of foundation ground due to liquefaction.

Figure 11. Aerial photo of damaged highway embankment before and after the 2016 Kumamoto earthquake (Modified from GSI aerial photo).

Since the other side of the embankment survived the earthquake, as an emergency response, the number of driving lanes at the damaged embankment was temporarily reduced to one in each direction, and only the one-lane reopened from the 29th of April. Due to the critical importance of the Kyushu Highway, however, careful investigation shall be conducted to thoroughly understand the cause of the damage observed and to propose effective countermeasures for the conclusive restoration of the embankment.

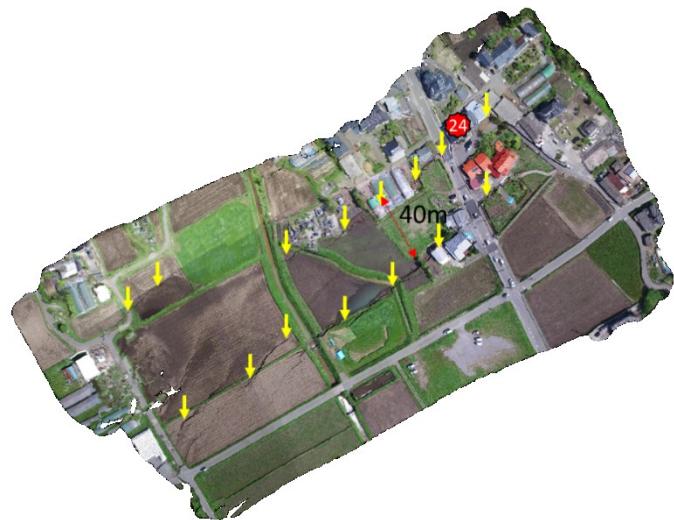
A trough-like depression was found at several locations in the basin of Aso Caldera. According to both the authors' site investigation and aerial photointerpretation of cracks on ground surface provided by the GSI (2016) and Kokusai Kogyo co. ltd (2016), the trough-like depression, with a maximum depth of about 1-1.5 m, was found to stretch several kilometers in length, the width of the depression was several tens of meters. At site 23, the ground depression caused damage to a residential house (Fig. 36). The damage due to the depression has also been harmful to agriculture in this area (Figure 37). The mechanism of the depression, however, is not yet identified. The residents in the affected area reported that the depression occurred immediately when the main shock occurred on the 16th of April. The fact indicates that the cause of the depression was probably not liquefaction. Refer to a separate report by Konagai et al. (2016) for further information about this feature.

Figure 37. Digital image obtained by UAV around the trough-like depression area (c.f. Fig. 26).
