# Uplift of an Underground Tank in Northern Malabar Region, India

**ABSTRACT:** An underground reinforced concrete tank was constructed for a project in the southwest region of India. The tank was 90 m x 35 m in plan and 7.3 m deep resting on partly filled-up and partly native soil. During the peak monsoon, a sudden uplifting of the base slab by about 300 mm and subsequent failure of the foundation raft and a partition wall was observed. Laboratory testing was executed and hydrogeological survey was carried out using ground penetrating radar, seismic refraction and infiltrometer testing, and an analytical study was carried out to identify the root cause of the tank uplifting. Based on this study, it was observed that the uplifting and structural failure was essentially due to the peculiar land terrain and soil properties and the development of excess hydraulic head below the bottom of the tank. After considering different options, the rectification measures were carried out by provision of dewatering wells along the tank periphery to release the excess hydrostatic pressure and stabilize the foundation raft. The structural repair of the top of the foundation raft and partition wall

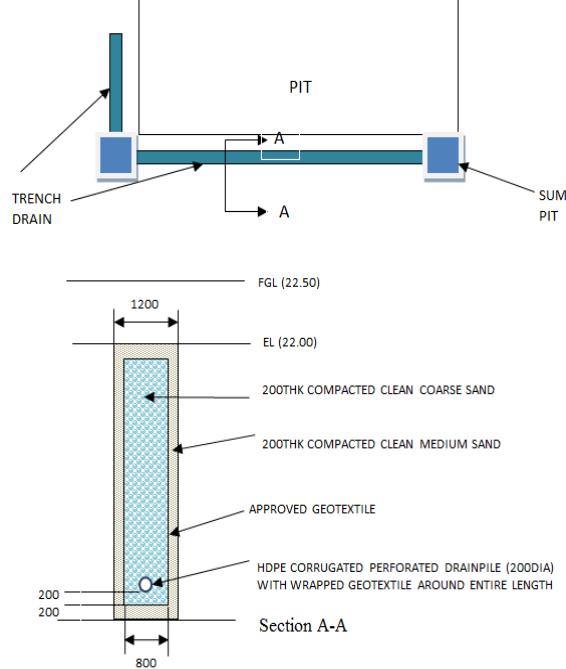
<p>Section A-A</p>	<p>The shallow depth of the trench may not work effectively to release the entire hydrostatic pressure from founding depth of the tank which was 7.3 m deep.</p>
Option 2	<p><b>DEWATERING WELLS:</b></p> <p>These wells are constructed by drilling a hole of sufficient diameter to accommodate a pipe column and filter and placing filter material in the annular space. The water will be directly pumped out from these wells to lower the groundwater table.</p>

Options	Description	Schematic Representation	Remarks
Option 1	<p><b>TRENCH DRAINS:</b></p> <p>Intercepting drains consist of shallow trenches with collector pipes surrounded by drainage material, placed to intercept seepage moving horizontally in an upper pervious stratum. The water is pumped out from the sump tank.</p>
