Lessons Learned from Dike Failures in Recent Decades

ABSTRACT: The paper describes five different dike failures that occurred in recent decades. The case histories were located on different rivers and involved different loading conditions. The observed failure mechanisms involved erosion and stability problems. The types of erosion observed were both internal erosion due to extreme groundwater flow and external erosion caused by the river flow and wave action. The case involving instability was caused by uplift, i.e., increased hydraulic head led to a sharp reduction in maximum shear strength between subsoil layers. Two cases demonstrate the importance of dike management and maintenance. Despite the variations in the loading conditions and failure mechanisms, all the cases show that the strength of a dike depends not only on the material used to build the dike but also on the strength of the subsoil.

Lessons Learned from Dike Failures in Recent Decades. International Journal of Geoengineering Case Histories, Vol.4, Issue 3, p.203-229. doi: 10.4417/IJGCH-04-03-04

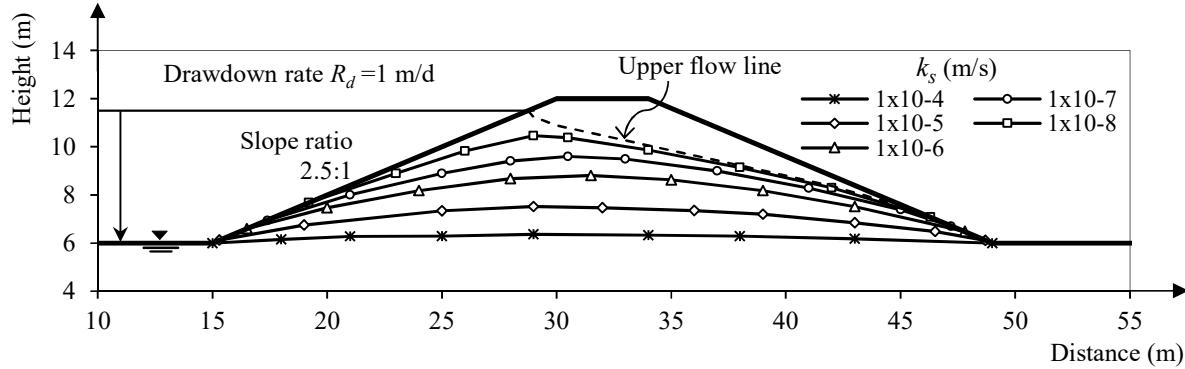
Figure 7. Phreatic surfaces (desaturation lines) at the end of the water drawdown stage in a dike with variable hydraulic conductivities k_s (López-Acosta et al. 2015)

These analyses evaluated several homogeneous and isotropic dikes with a 2.5(H):1(V) slope and total dewatering head of 5.5 m for different hydraulic conductivities. Figure 7 shows the upper flow line for the initial steady-state condition and desaturation lines at the end of water drawdown in dikes with different hydraulic conductivities k_s for the transient-state condition and assuming a constant drawdown rate of $R_d = 1 \text{ m/d}$. As can be seen from this figure, where $k_s = 1 \times 10^{-8} \text{ m/s}$, the desaturation line remains practically in the same position as the upper flow line, which is associated with the *fully rapid drawdown mode*. In this case, it can be assumed that the soil behaves undrained. For $k_s = 1 \times 10^{-4} \text{ m/s}$, the desaturation line inside the dike drops down almost in line with the reservoir water level, which is associated with the *fully slow drawdown mode*. In this case, it can be assumed that the soil behaves drained. It can also be assumed that the desaturation lines between these two extreme modes represent the *transient drawdown mode* in which a curvilinear water line is generated in the soil structure, the position of which depends on the drawdown rate and the constitutive material properties. The remaining pore pressure in the dike is therefore transient, it varies as a function of time, but also with the soil's ability to retain water. Several authors have recognised the three water drawdown modes described here (examples being Lane & Griffiths, 2000 and Berilgen, 2007).

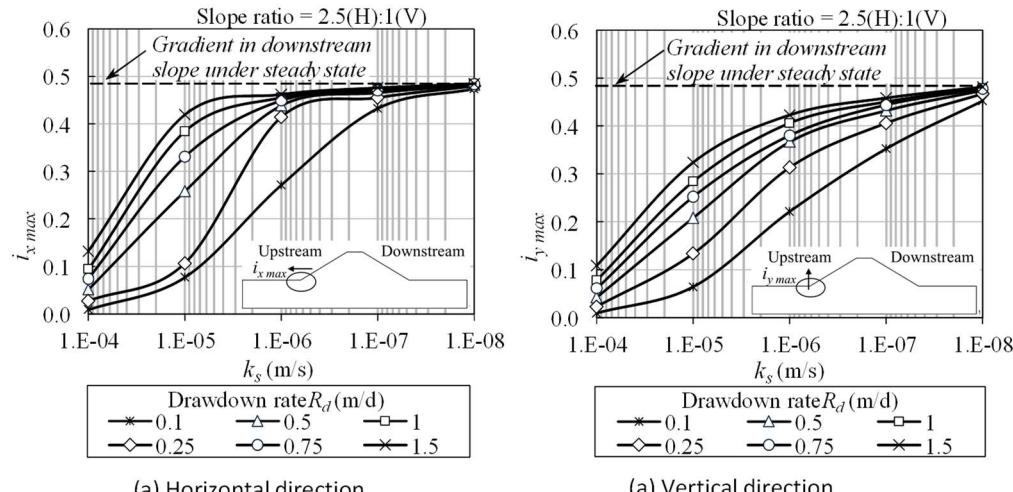
Figure 8 shows the effect of the drawdown rate on exit hydraulic gradients in the horizontal and vertical directions, corresponding to the x and y axes respectively, in both the upstream and downstream slopes of the dikes with variable hydraulic conductivities k_s . In addition, Figure 9 summarizes the results obtained assuming variable permeabilities k_s and a constant drawdown rate ($R_d = 1 \text{ m/d}$). The following conclusions can be drawn on the basis of the results of these parametric analyses:

- Under a steady-state flow, the exit hydraulic gradients in the downstream slope remain constant for all k_s permeabilities studied.
- Changes in the slope ratio of dikes have a more significant effect on the magnitude of the exit hydraulic gradients than changes in the drawdown rate. It was observed that steeper slopes generate greater values for exit gradients.

- The more impermeable a material is, the larger the exit hydraulic gradients. In this sense, the maximum value of the exit gradient in the upstream slope tends to match the value of the computed gradient in the downstream slope under steady-state conditions.

- The exit hydraulic gradients were observed to increase when the drawdown rate increased.
- In general, given the admissible values suggested by several authors for local erosion and piping (for example, Den Adel et al., 1988; Wan & Fell, 2004; Ahlinhan & Achmus, 2010), the magnitude of the gradients computed here is significant. One suitable way of preventing internal erosion or piping is the installation of filters or drains placed strategically in the earth structure.

Figure 8. Effect of drawdown rate R_d on exit hydraulic gradients in dikes for variable hydraulic conductivities k_s . (López-Acosta et al. 2015)

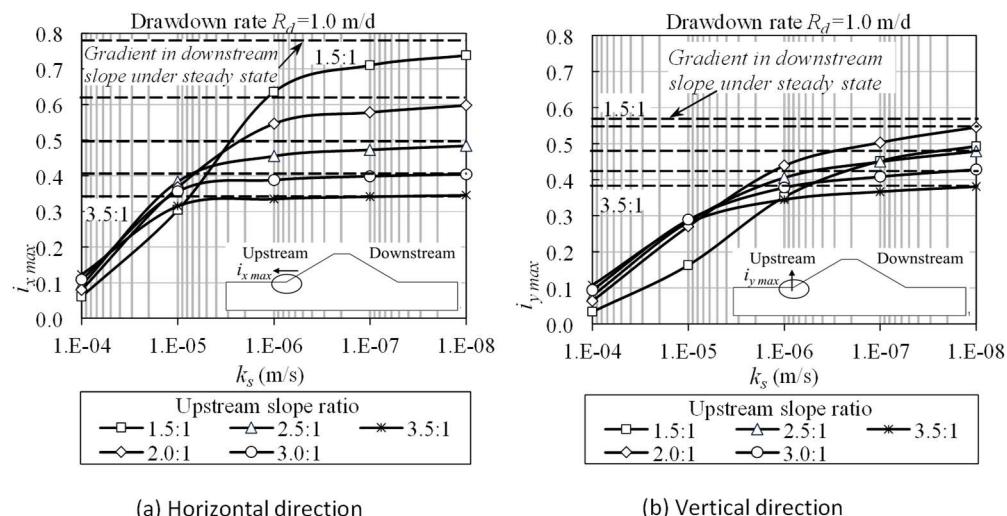
Figure 9. Effect of the slope ratio (H:V) on exit hydraulic gradients in dikes for different hydraulic conductivities k_s . (López-Acosta et al. 2015)

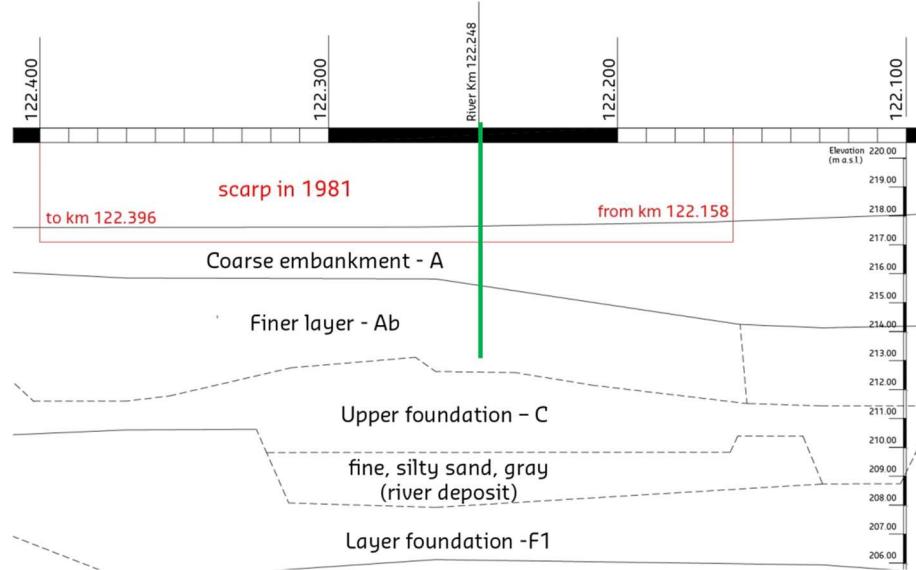
The cross-section at chainage 124.620 km was selected to analyze the hydro-mechanical response of the embankment (Figure 21). Figure 22 shows the longitudinal soil profile that includes the segment of the dike in St Florian affected by instability in 1981 (scarp of about 50 cm). The cross-section at chainage 122.248 km was selected to analyze the hydro-mechanical response of the embankment (Figure 23).

Figure 22. Longitudinal soil profile of the dike segment in St Florian that includes the portion affected by instability in 1981. The location of the representative cross-section is indicated by the green line.

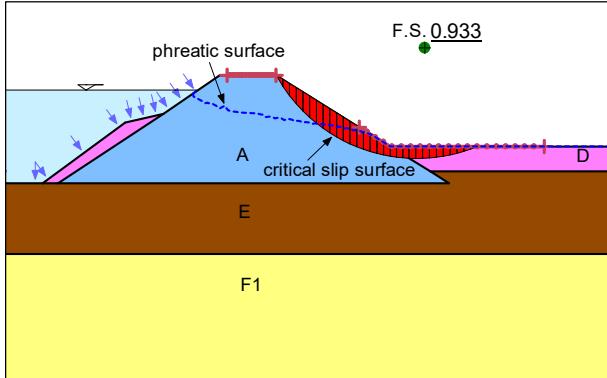
Figure 24. Stability analysis and relevant soil parameters at flood peak and transient flow condition of the section at km 124.62 in Laag; $c' = 0 \text{ kN/m}^2$

where σ_n is the normal stress, ϑ_w is the volumetric water content, ϑ_s is the saturated volumetric water content and ϑ_r is the residual volumetric water content. The results of the stability analyses at flood peak for the two cross-sections based on transient flow conditions are shown in Figures 24 and 25. The stability analysis consistently returns factors of safety < 1 for these sections, which proved to be unstable in 1981.

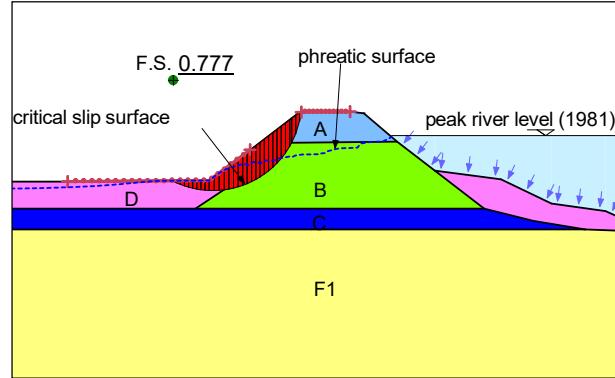
Figure 25. Stability analysis and relevant soil parameters at flood peak and transient flow conditions of the section at km 122.248 in St. Florian; $c' = 0 \text{ kN/m}^2$.

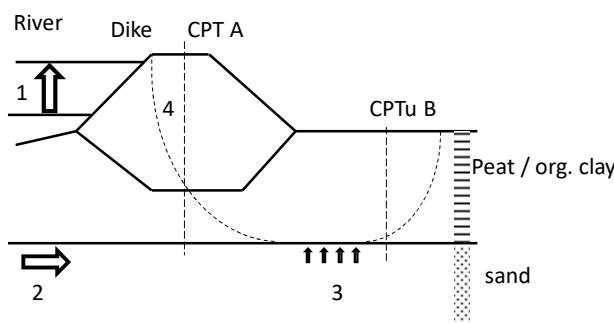
A typical failure mechanism for dikes in this area is loss of stability due to uplift of the soft soil layers at the toe. Figure 28 explains the failure mechanism. There is a hydraulic connection between the river and the Pleistocene sand layer. A rise in the river level (1) results in an increase in the hydraulic head in the Pleistocene sand layers (2) until the pore pressure equals the weight of the Holocene layers on top (3). The shear strength at the transition between the Holocene clay and peat layers on the one hand and the Pleistocene sand deposit on the other is drastically reduced, creating the conditions for a long, deep, slip plane (4). The uplift phenomenon is described in further detail by Cooling & Marsland (1953), Marsland (1961), Bauduin et al. (1989) and Van (2001). Observations of stability loss due to uplift are scarce and it was decided to study the uplift phenomenon at the Bergambacht test site.

Figure 28. Impression of the uplift failure mechanism, 1: river level rise, 2: hydraulic connection to sand layer, 3: pore pressure rise until uplift top layer, 4: failure plane.

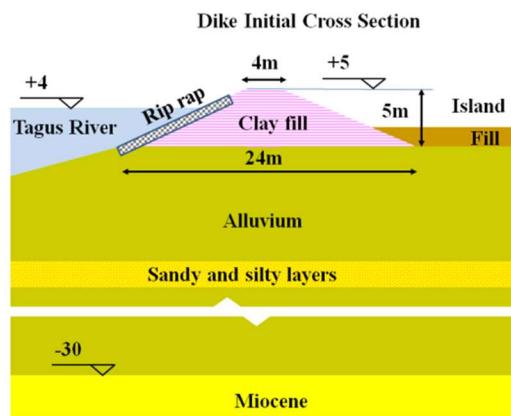
Given the location of the island in the Tagus River delta, one of the widest estuaries in Europe, the geological scenario is very complex: alluvium deposits, mainly very soft clays, with S_u not greater than 20 kPa, sometimes interbedded with silty and sandy layers, with an overall depth of approximately 30 m (Figure 39). The alluvium rests on the bedrock of Miocene sandstone.

The main failure mechanism is related to the erosion of the clay fill due to water inflow and the mechanical action of the waves on the outer face of the dike. Failure originated with the erosion of the riprap revetment (Figure 39). The presence of a permeable sandy layer below the dike foundations also contributed to the failure mechanism. The actual dike failure began during the severe winter of 2015 - 2016 and involved a section with an overall length of approximately 30 m. When the failure occurred, the water level in the Tagus River was approximately Mean Sea Level, MSL, +4.20 m. In October 2016, the overall length of the dike failure line had increased to approximately 80 m.

Figure 39. Initial dike cross-section and geotechnical profile.
