Geotechnical Observations of Dams Failed During the 2015 Historic Flooding in South Carolina

ABSTRACT: This paper presents a description of post-flood reconnaissance and geotechnical investigation of four earthen dams that were breached or damaged following an extreme flooding event in South Carolina in 2015. As a result of unprecedented rainfall and flooding that occurred during a five-day period at the beginning of October in 2015, a total of 51 earthen dams failed and nearly 200 were damaged. Many of these dams failed due to overtopping that led to a breach of the dam. Among the four dams investigated, full breach was observed at three dams; two of which were overtopped, and one was not. The fourth dam was not breached but was severely damaged. For each of these dams, the paper documents background information, pre-flood conditions, post-flood field observations and measurements, and laboratory testing results of collected soil samples. Impacts of vegetation on the dams and the effects of dam failure on critical infrastructure are also presented. The detailed descriptions and geotechnical investigations of the dam failures presented herein serve as case histories that can be us

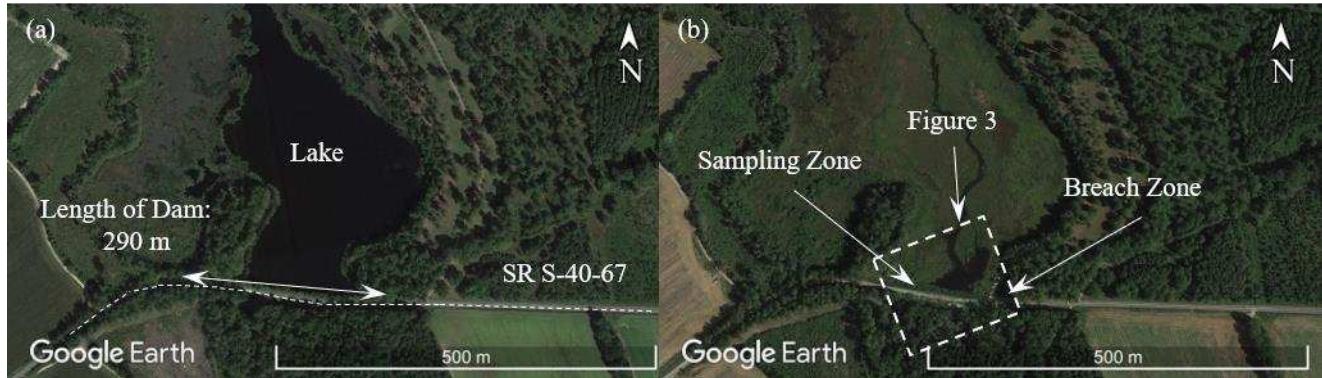
Dam A is located 28 km southeast from downtown Columbia, South Carolina. The dam was constructed around 1932 (USACE 2016). Satellite imagery of the dam before and after failure are shown in Figure 2. The crest width was measured to be 16 m, and the upstream side slope was measured to be 30°. The downstream side slope was completely washed out and could not be measured. According to USACE (2016), the height of the dam is 4 m, which is defined as the vertical distance from the lowest point on the crest to the lowest point in the original streambed. The original length of the dam is approximately 290 m. A two-lane roadway that is 16 m wide (including shoulders) runs along the crest of the dam. The dam impounds a lake with a surface area of about 0.06 km² under normal storage conditions (USACE 2016). The dam allows normal and maximum storage capacities of 178,000 m³ and 400,000 m³, respectively. SCDHEC (2016) considers this dam to be a low-

Figure 2. Dam A (a) before and (b) after failure (Google Earth, accessed on April 8, 2018).

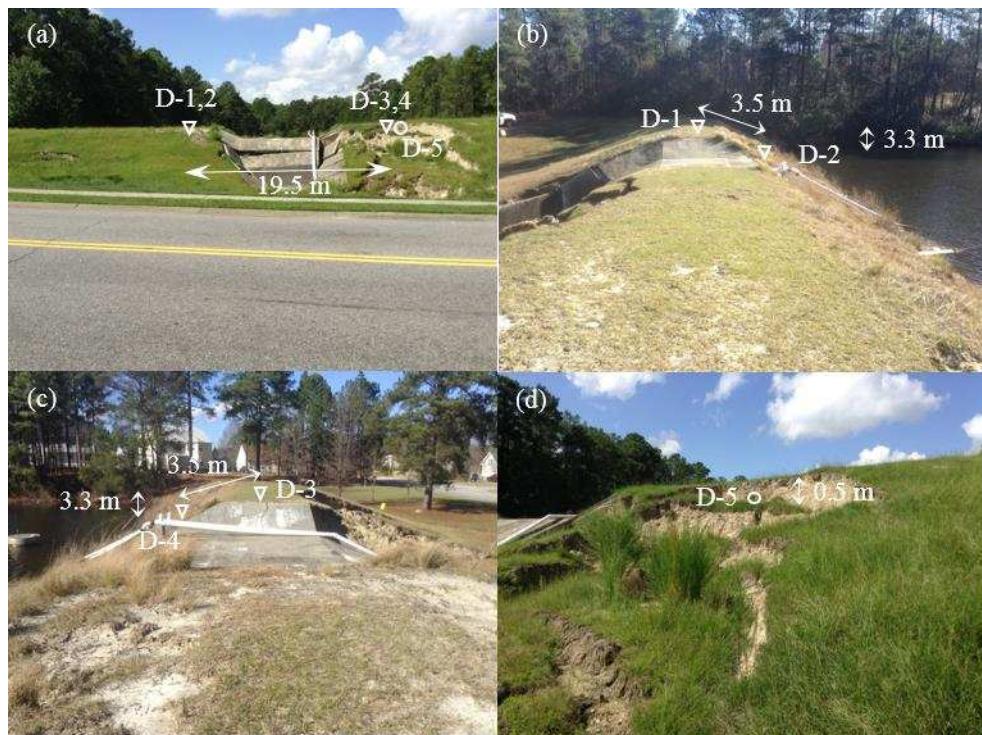
zone adjacent to the emergency spillway. Even though sample location D-5 is expected to be closer to the core of the dam (see Figure 31), pre-failure information provided by the dam owner indicates that Dam D does not have a definable core. In fact, the dam fill materials were consistent across all five sampling locations (primarily silty sands, SM, with little to no plasticity). Test results show that these soils have low to very low permeability (10^{-4} to 10^{-6} cm/s). The erosion rate, based on the characteristics of the soils in this dam, is extremely rapid (Wan and Fell 2004).

Figure 31. Sampling locations in Dam D: a) southwest view from Legion Drive, b) southeast view from the crest, c) northwest view from the crest, and d) southwest view from downstream side slope near the sliding zone (∇ : vertical sample, \bullet : horizontal sample).
