Geotechnical Effects of Hurricane Harvey in the Houston, Beaumont, and Port Arthur Areas

ABSTRACT: The Geotechnical Extreme Events Reconnaissance (GEER) Association deployed multiple teams of engineers from academia and practicing firms to the coast of Texas in late August and early September 2017 following Hurricane Harvey. This report summarizes the observations and data from the GEER team that focused primarily on the inland effects of Hurricane Harvey in the Houston area with some observations in the Port Arthur / Beaumont area east of Houston. Rain, not storm surge or wind, caused the observed damage in Houston, Beaumont, and Port Arthur by overwhelming stormwater management facilities and creating high flows and flooding in and near area waterways. The major Houston-area flood structures, Addicks and Barker Dams, performed well from a geotechnical perspective. Observed damages included shallow slides along levees, severe erosion along riverways, isolated road and culvert erosion and uplift, and area-wide flood effects in low and poorly drained neighborhoods.

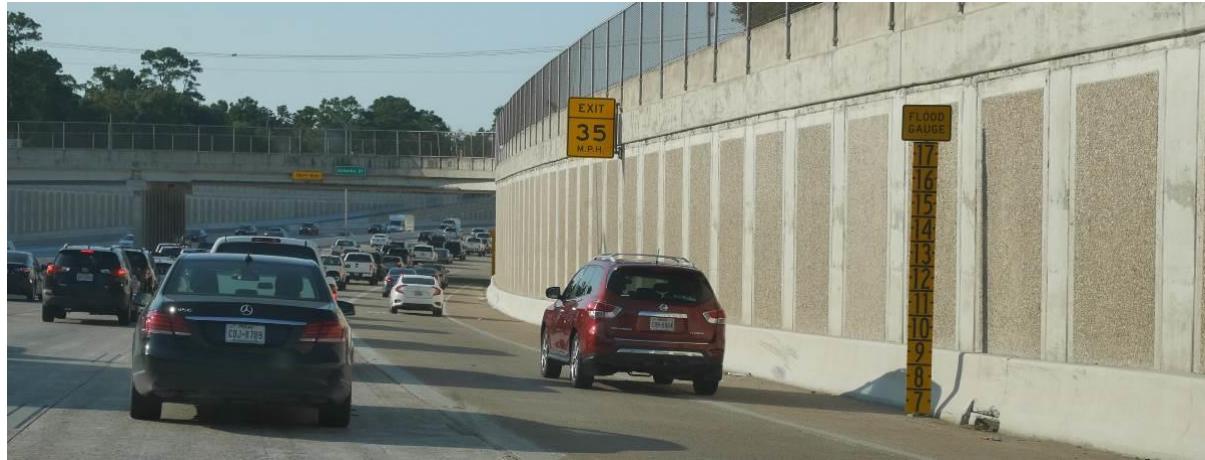
Flooding caused roadway damage to and closure of a major area artery at the underpass intersection of the Sam Houston Parkway / Beltway 8 and Boheme Drive (see Fig. 1 for location, 29.76736° N, 95.56210° W). The parkway is depressed at this intersection and floods often enough that flood depth sign gauges are posted along the road to warn motorists of the standing water depth (see Fig. 31).

Figure 31. Beltway 8 / Boheme Drive underpass and flood depth signs (September 11, 2017, 29.76694° N, 95.56139° W).

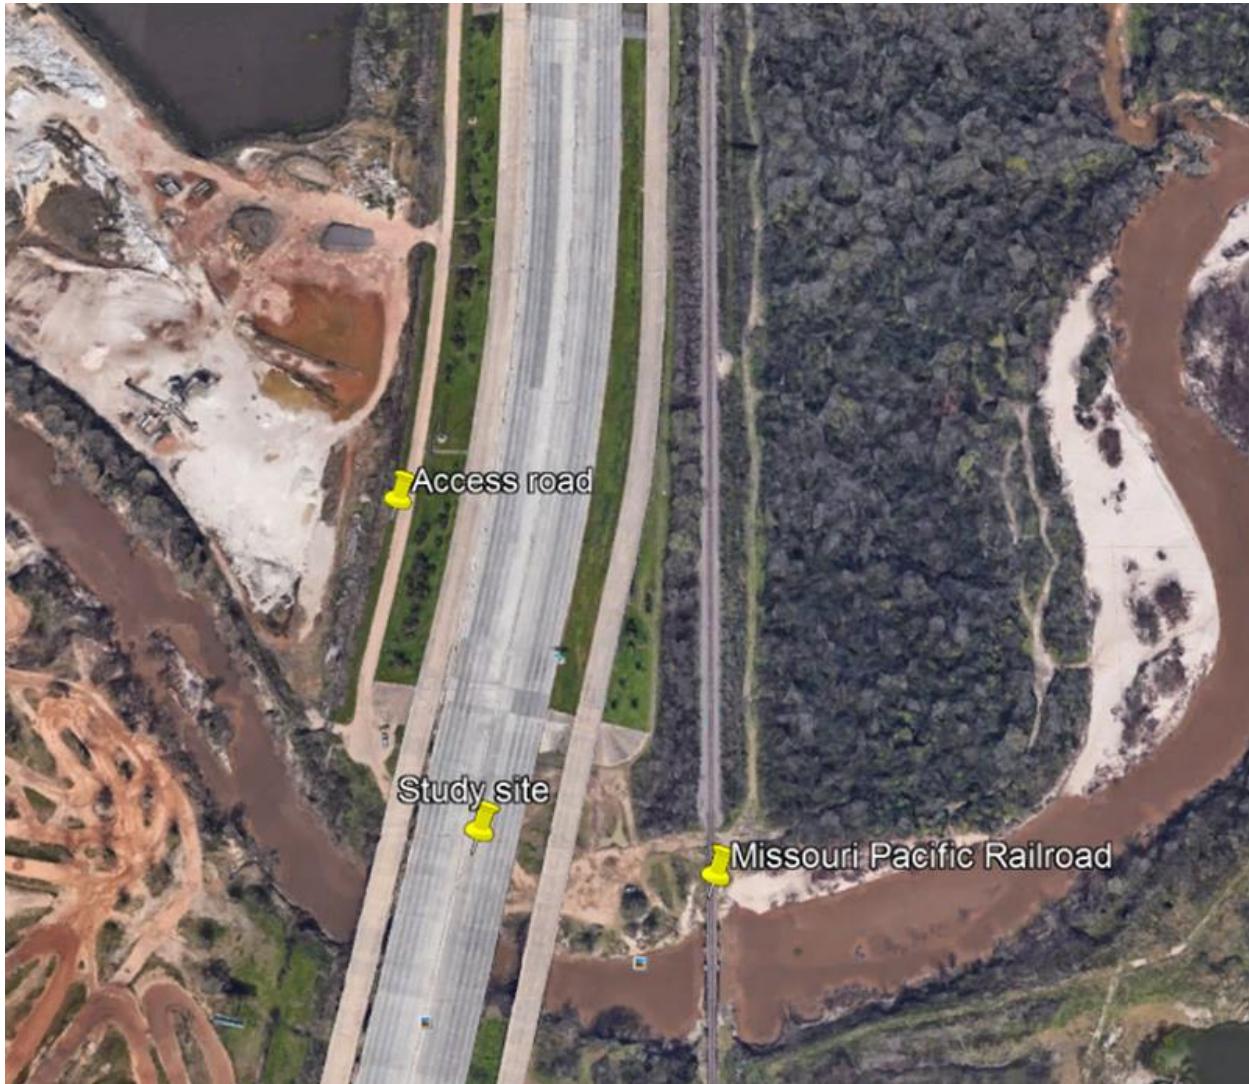
Figure 34. San Jacinto River Area observation locations (Google Earth image for April 2017, 30.24599° N, 95.45722° W).
