Geotechnical Extreme Event Site Reconnaissance in Puerto Rico After The Passage of Hurricane Maria

Francisco Silva-Tulla, Consulting Civil Engineer, GeoEngineering and Environment, Lexington, Massachusetts, U.S.A.; email: silva@alum.mit.edu

Miguel A. Pando, Associate Professor, Department of Civil, Architectural, and Environmental Engineering, Drexel University, Philadelphia, PA, 19104, U.S.A.; email: miguel.a.pando@drexel.edu

Reference: Silva-Tulla F., and Pando M. A. (2020). Geotechnical Extreme Event Site Reconnaissance in Puerto Rico after the Passage of Hurricane Maria. International Journal of Geoengineering Case Histories, Volume 5, Issue 4, pp. 1-25, doi: 10.4417/IJGCH-05-04-01

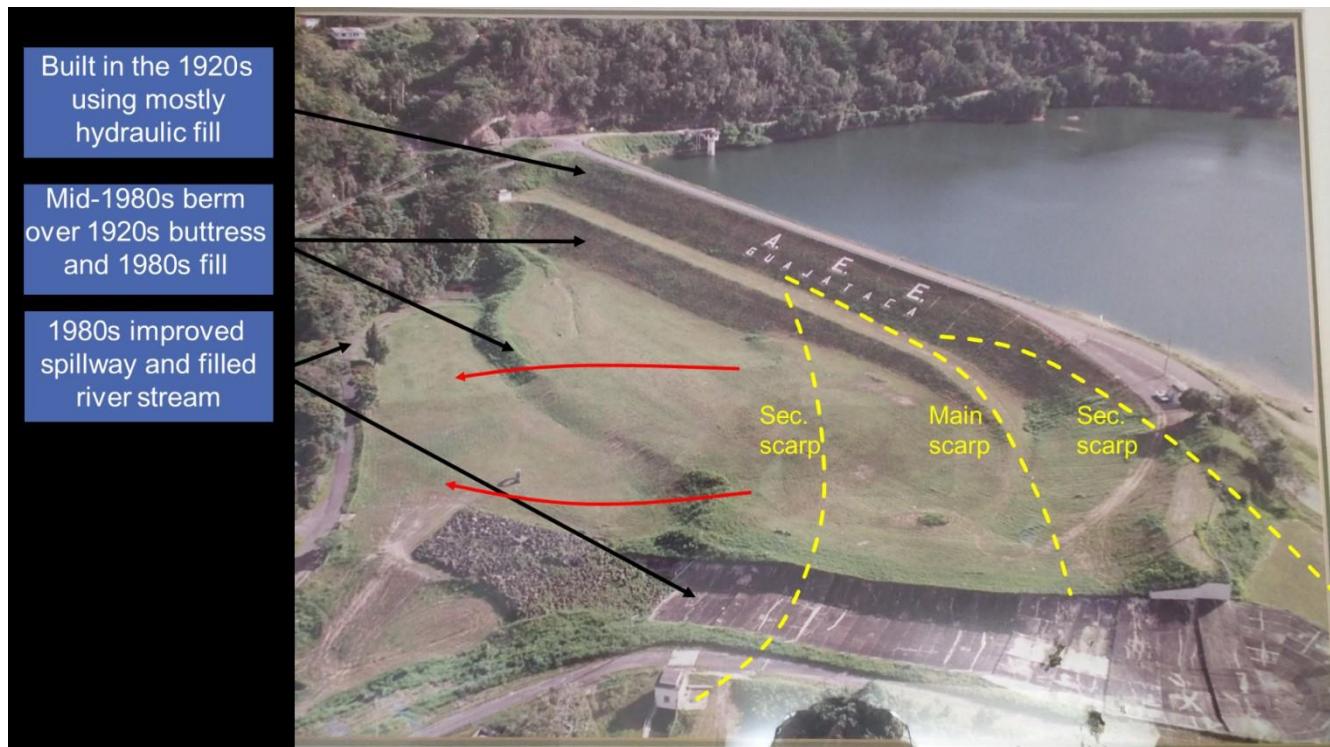
Figure 8. Photo of Guajataca Dam (Lat. +18.397895, Lon. -66.923725), taken a few decades before Hurricane Maria – exact date of photo unknown (adapted from Silva-Tulla et al., 2018).

The GEER mission visited Guajataca Dam, where severe damage to the spillway and dam safety concerns prompted the evacuation of about 70,000 downstream residents. Figure 8 shows Guajataca Dam, an earthfill dam built in the 1920s, mostly by hydraulic fill methods, and modified in the 1980s. The dam has a maximum height of about 37 m (121 ft) and a crest 316 m (1,037 ft) long and 9.5 m (31.2 ft) wide, with a "puddle clay" core sloping at about 0.5 to 1 (horizontal to vertical [H:V]). Its upstream and downstream faces slope at ratios of 2:1 H:V or flatter. According to the National Inventory of Dams (USACE, 2016), Guajataca Dam was designed for and owned by the Puerto Rico Electric Power Authority. A detailed description of the history and construction of the dam can be found in USBR (2002).

Note: Figure shows historical and landslide features remediated in the 1980s.

In 1971, the USBR was requested to evaluate the dam; in 1977, it recommended various remedial measures, including rebuilding the crest and replacing part of the spillway. During an excavation near the toe of the spillway in 1981, movement of the spillway occurred. The excavation revealed a plastic layer with slickensides, and a subsequent investigation resulted in landslides being mapped under the spillway and dam. To increase the stability, the USBR recommended limiting the elevation of the downstream face berm (Figure 9) and filling or buttressing the river channel area. The work included the placement of a 2.44 m (8 ft) diameter pipeline, completed in 1984, to carry outlet flows.

The river is no longer visible in Figure 8, indicating that the photo was taken after completion of the 1980s improvements. Between 1992 and 1993, instrumentation consisting of seven inclinometers was installed (three along the crest, one over the buttress, and three downstream of the toe). Three of the four inclinometers installed on the buttress and downstream of the dam became inoperable within ten years of their installation due to excessive horizontal movements. Although these inclinometers were not completely sheared by 2002, we understand that they currently are. Movement was reported to our GEER team to have occurred at a depth of about 19 m (elevation 170 m), where a layer of green clay that slopes at an angle of about 4° exists. The appearance of piezometers in the field suggests they are contemporaneous with the slope indicators (i.e., installed in the early 1990s) (Silva-Tulla et al., 2018).

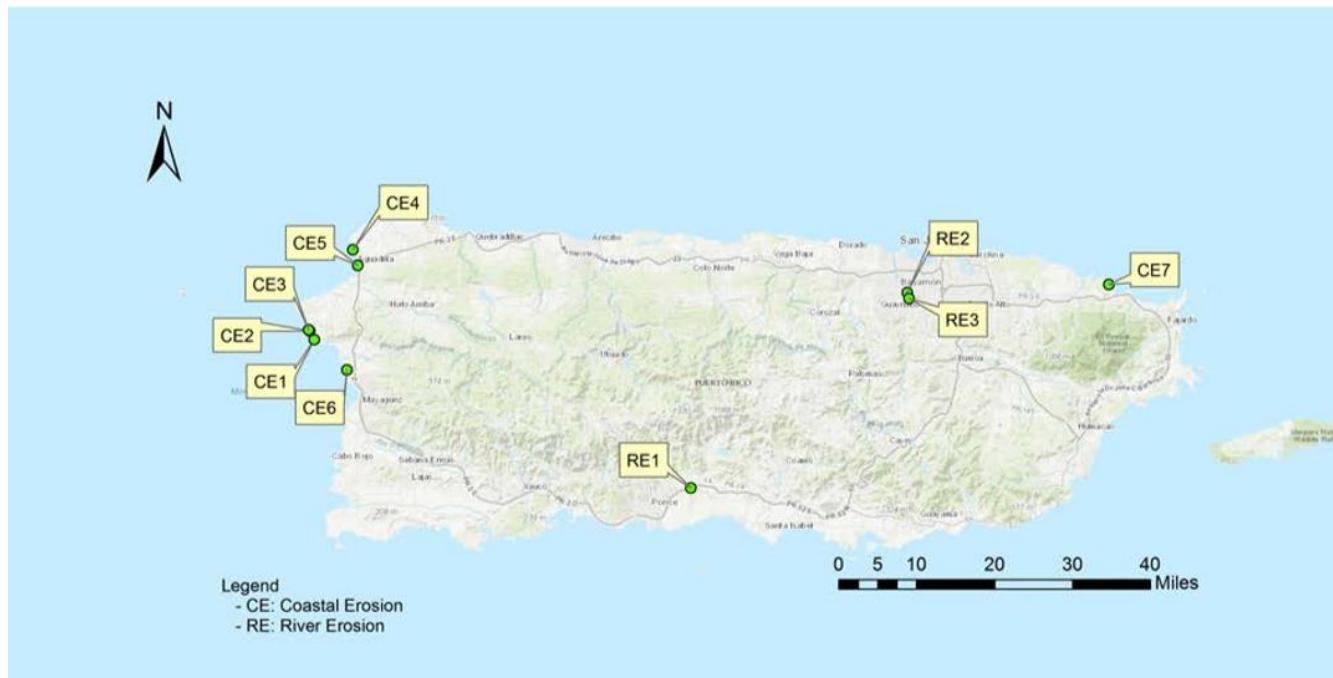
Figure 18. Location of coastal and river scour sites visited by GEER team (Silva-Tulla et al., 2018).

GEER reconnaissance observations showed ample evidence of coastal erosion and scour where storm waves destroyed or damaged facilities which had been built near (and many in close proximity to) the shoreline. Similarly, river erosion and scour-related damage was also prevalent throughout PR. Much of the river damage was associated with high flows and large accumulations of storm debris. Several critical bridges were destroyed while others were significantly damaged by the

resulting thrust from the debris pushing on their upstream sides. Figure 18 shows the coastal and river scour sites visited by the GEER team. For the sake of brevity, only a couple of these sites are presented herein. A detailed description of all sites shown in this figure appear in the GEER report (Silva-Tulla et al., 2018).
