Lack of Maintenance Compromises Tunnel Structural Safety

ABSTRACT: *The Chekka tunnels represent a critical section of the Northern Lebanon Highway. The approximately 350-m long twin tunnels are the most important tunnels in the country. They are used by regular and freight traffic and are a vital link to the capital, Beirut. The tunnels were completed in the early 1970s on the eve of the Lebanon civil war. Given the state of affairs in the country for about two decades of strife, the tunnels were not maintained nor did they undergo any regular inspection. This unique condition of near-abandonment continued up until recently, when the first signs of distress were documented. These consisted of severe and extensive cracking, particularly in the portal approach of the southbound tunnel, along with significant deterioration of the tunnel lining and radial section joints. The danger to traffic and, potentially, to the structure itself was evident. In this paper, the results of an extensive site inspection and evaluation program are presented. The underlying causes of the observed damage are analyzed and discussed using a modeling approach of the progressive loading conditions. Remedia

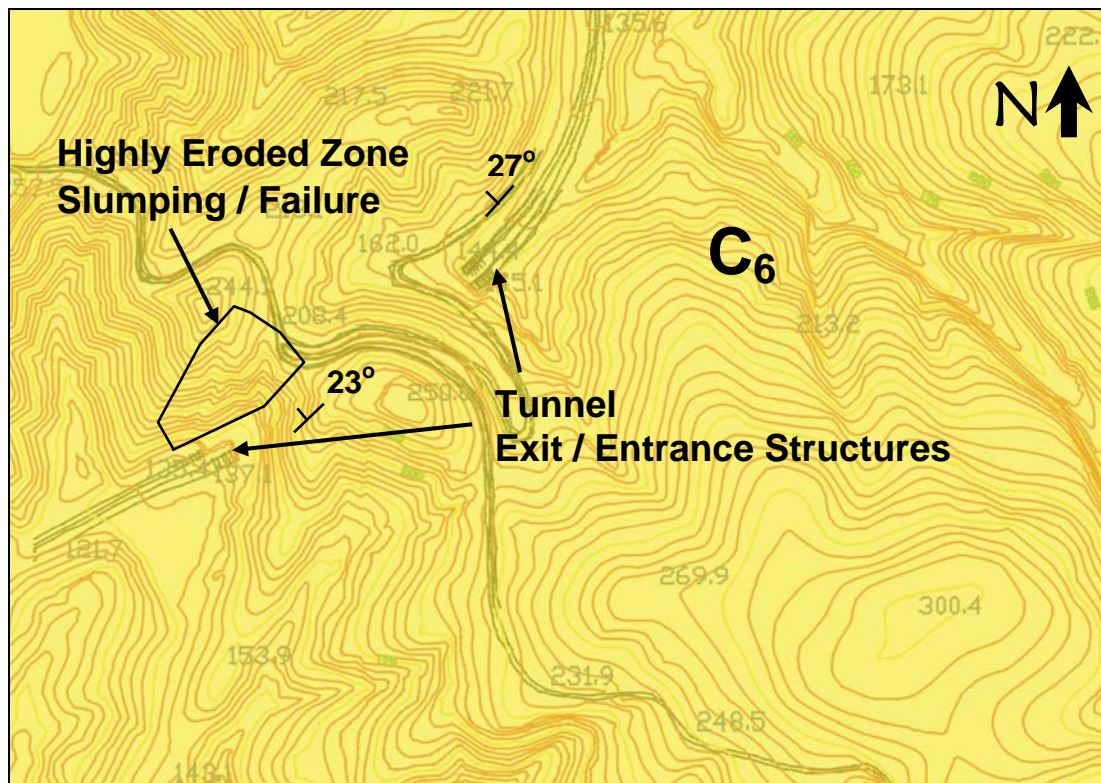
Based on the topographic and geological surveys, it is clear that the prevailing strata are prone to erosion and mass wasting, and that significant slopes are evident in the vicinity of the tunnels with adverse dips identified towards the tunnel exit and entrance points.

Figure 5. Geology of Area: The Only Outcropping Unit is the Chekka Formation C6.

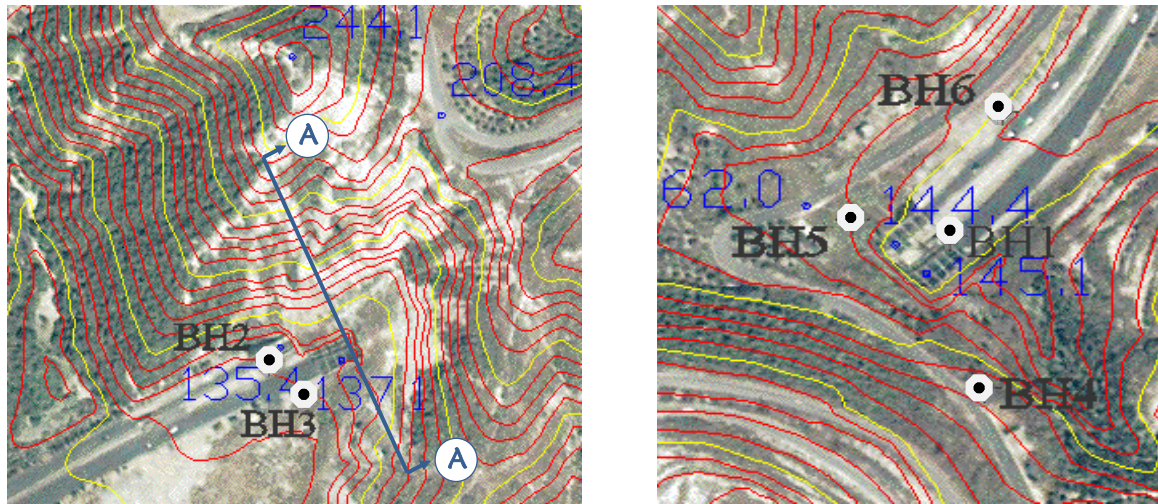
A total of six boreholes, approximately 10 m deep, were drilled in addition to a number of shallow pits. The locations of the boreholes were restricted to accessible areas and are indicated in Fig. 7. The exploration pits complemented the boreholes and were located primarily above the southern entrance/exit points.

Figure 7. Location of Exploration Boreholes BH-1 Through BH-6.

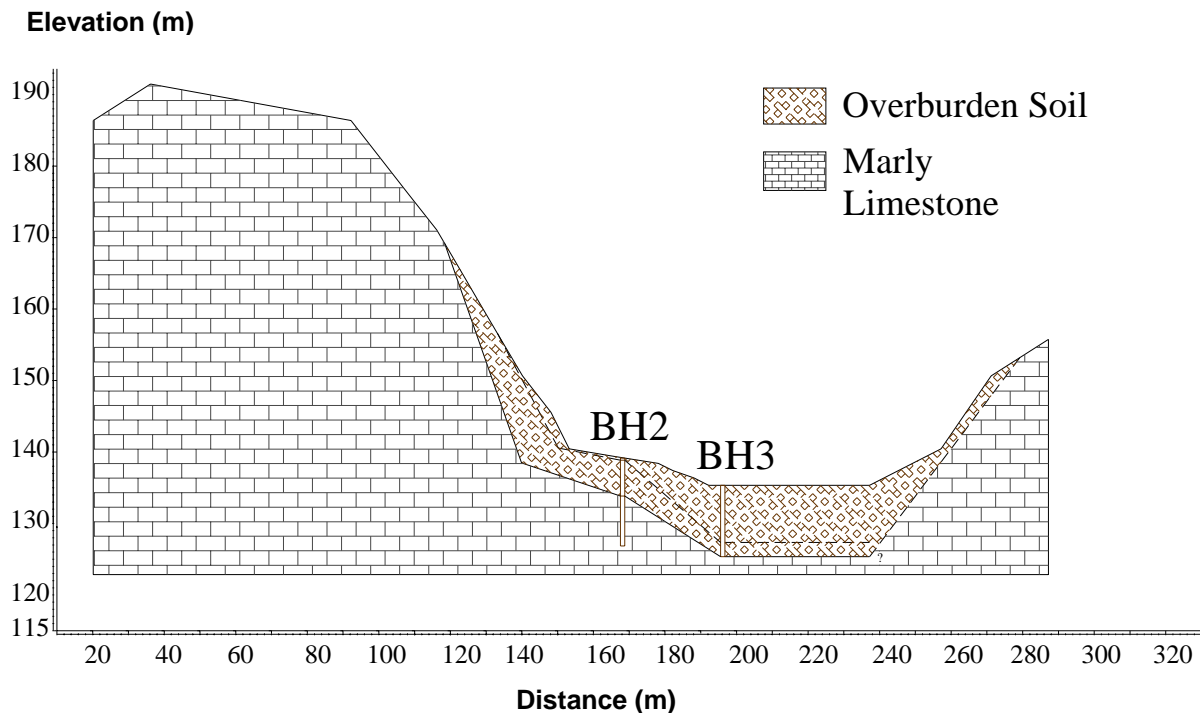
Figure 8. Transverse Section Across South tunnel (A-A in Fig. 7). Tunnel Portal Between Two Hills.

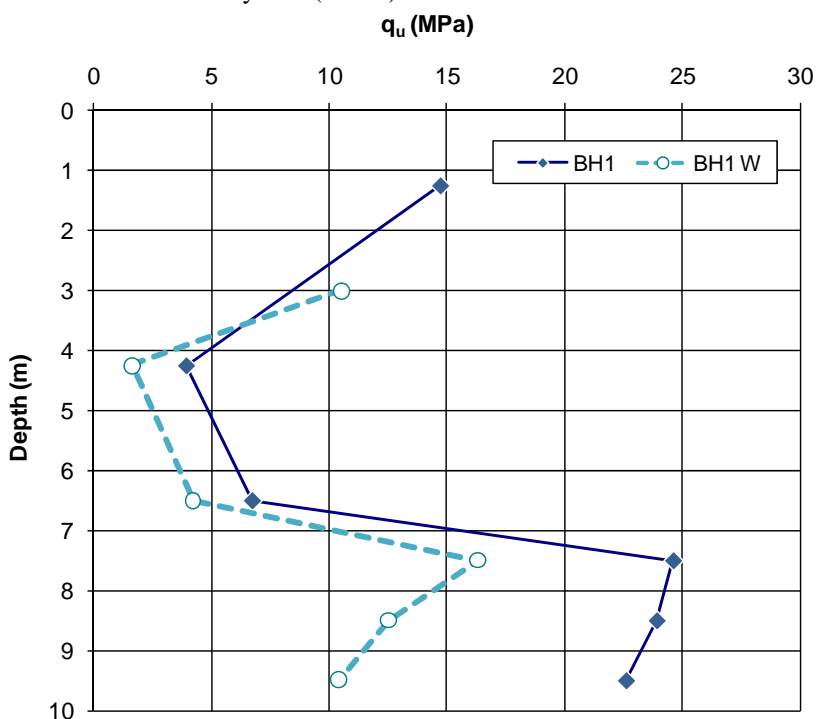
Unconfined compression tests were conducted on rock cores according to ASTM D2166. Some of the samples were submerged in water for 48 hours prior to testing in order to explore the effect of increased water content on the strength of the marlstone/rock samples. The elastic deformation modulus values obtained from the laboratory tests on the cores extracted from the material above the southbound tunnel cross-section are relatively low (from about 5800 to 15000 kPa), which was expected given their higher degree of weathering. The results of the unconfined compression tests showed a significant decrease in strength for the wetted samples. The average unconfined compression strength values from samples from BH-1 and BH-5 for the marly limestone layers are shown in Table 1. The unconfined compressive strengths above the southbound tunnel cross-section suggested an average value of $q_u \sim 19.5$ MPa for the natural condition samples, and a value of $q_u \sim 7.0$ MPa for the wetted samples. Typical results from BH1 samples are presented in Fig. 9.

Figure 9. Unconfined Compressive Strength Results From BH1: Natural Water Content and Wetted Samples (w).
