# Geotechnical Damage Caused by the 2016 Kumamoto Earthquake, Japan

**ABSTRACT:** On the 16<sup>th</sup> of April 2016, the Kumamoto earthquake ( $M_w$  7.0) hit the Central Kyushu Region, Japan, following a  $M_w$  6.2 shock on the 14<sup>th</sup> of April. The earthquake sequences caused severe damage in Kumamoto Prefecture. This paper presents quick reconnaissance results focusing on geotechnical damage features, which were observed during field investigations immediately after, one, and two weeks after the main shock. The damage surveys were carried out in southern Kumamoto City, Mashiki Town, Aso Caldera area and their suburbs. In southern Kumamoto City, evidence of liquefaction was found at many locations, and some buildings and river levees suffered from significant settlement and deformation; damage to an embankment of Kyushu Highway also seemed to be the result of liquefaction. The majority of the damaged residential houses were found in Mashiki Town and its suburbs, which may be linked to intense earthquake motions associated with the seismic fault location. In Aso Caldera area, a number of moderate to large scale landslides and their significant impact to structures wer

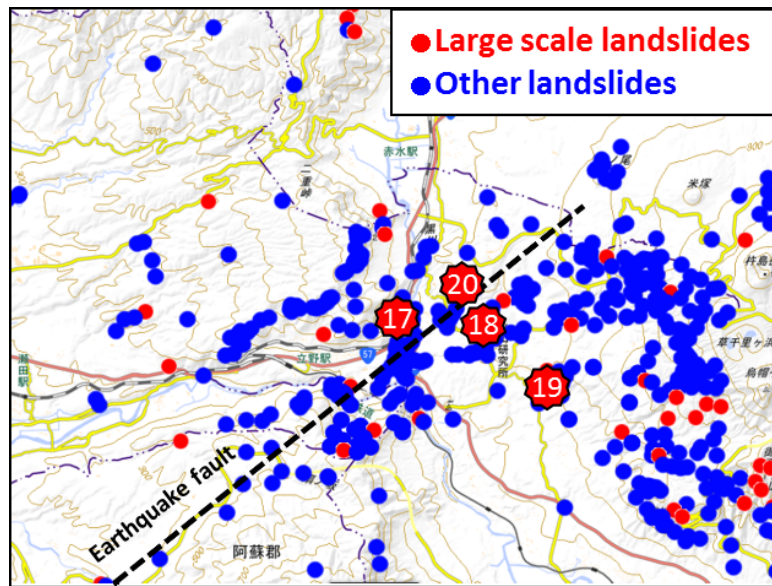
A large number of natural slopes and road embankments failed in Aso Caldera area. Figure 27 shows the positional relationship between earthquake fault and landslides caused by the Kumamoto earthquake. The landslides in the figure were mapped by GSI (2016), and the data is available on their website. Aerial photos taken before and after the earthquake were used to generate this map. A spatial distribution of earthquake-induced landslides is affected by the fault mechanism (Hasi et al., 2011). The map shows that the landslides are on both sides of the seismic fault. This may be because a strike-slip component was the dominant fault movement of the earthquake.

Figure 27. Positional relationship between fault and landslides in and around Aso Caldera area  
(Modified from landslide map of GSI, 2016).
