Geological Engineering Reconnaissance of Damage Caused by the October 15, 2006 Hawaii Earthquakes

Edmund W. Medley, Senior Consultant, Geosyntec Consultants Inc., Oakland, CA, USA, Email: emedley@geosyntec.com

KEYWORDS: Geological Engineering, Hawaii, Earthquake Damage, Rock Mass, Basalts, Rock Block Structures

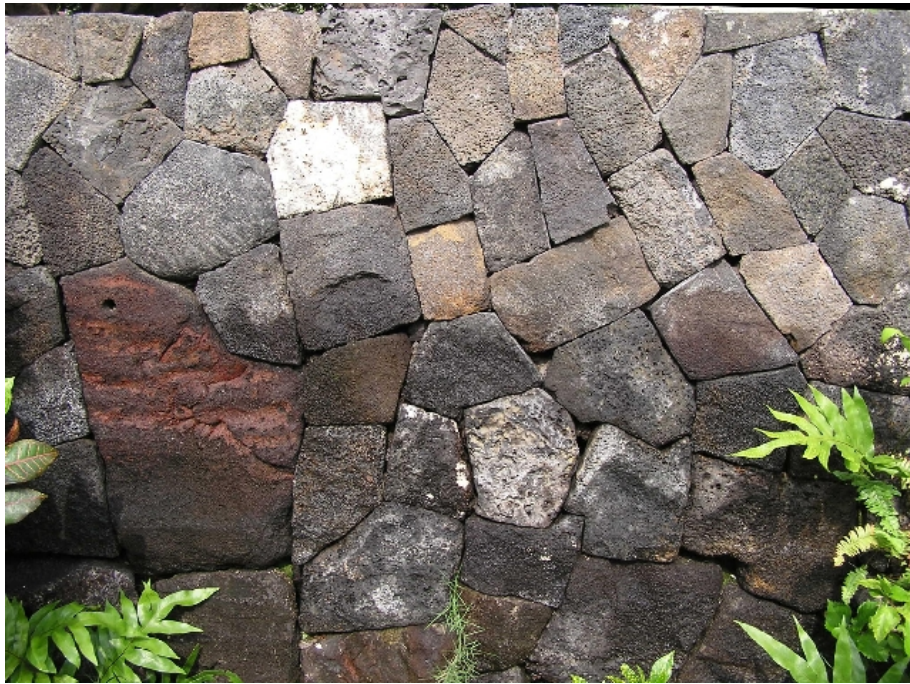
Figure 41. Location 33, Moku 'aikaua Church, Kailua-Kona. Finely constructed stacked rock perimeter wall.
