# Geological Engineering Reconnaissance of Damage Caused by the October 15, 2006 Hawaii Earthquakes

**Edmund W. Medley**, Senior Consultant, Geosyntec Consultants Inc., Oakland, CA, USA, Email: [emedley@geosyntec.com](mailto:emedley@geosyntec.com)

**ABSTRACT:** Two strong earthquakes shook the Island of Hawaii, Hawaii on the morning of October 15, 2006. Peak Ground Accelerations reached 1.2g, and earthquake felt intensity of MMI VIII. Earthquake damage of public and private property totaled about \$200 million, with no fatalities. Geological engineering reconnaissance of earthquake damage resulting from the earthquakes focused on the apparent relationships between the observed geology and the damage. Some roadway embankments failed causing temporary closure of Island highways. Landslides were common at steep coastal cliffs. Liquefaction and lateral spreading occurred in coralline fill at Kawaihae Harbor. There were extensive road cut failures, in which the performance of road cuts in soil slopes was generally better than that of rock slopes. Where a'a clinker underlay massive a'a basalt blocks in road cut slopes, the loose clinker dislodged thereby undermining the blocks, and cau

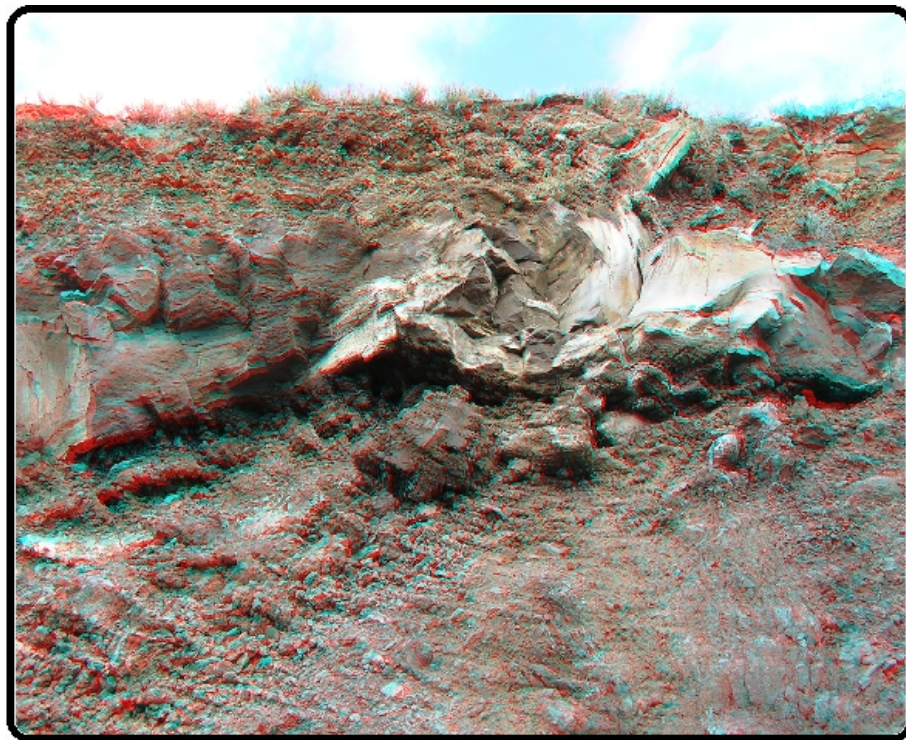
*Figure 14. Location 2, near Kohala Ranch Estates, Hwy 270. Anaglyph 3-D image version of Figure 12. Road cut in mixed massive a'a and clinker.*

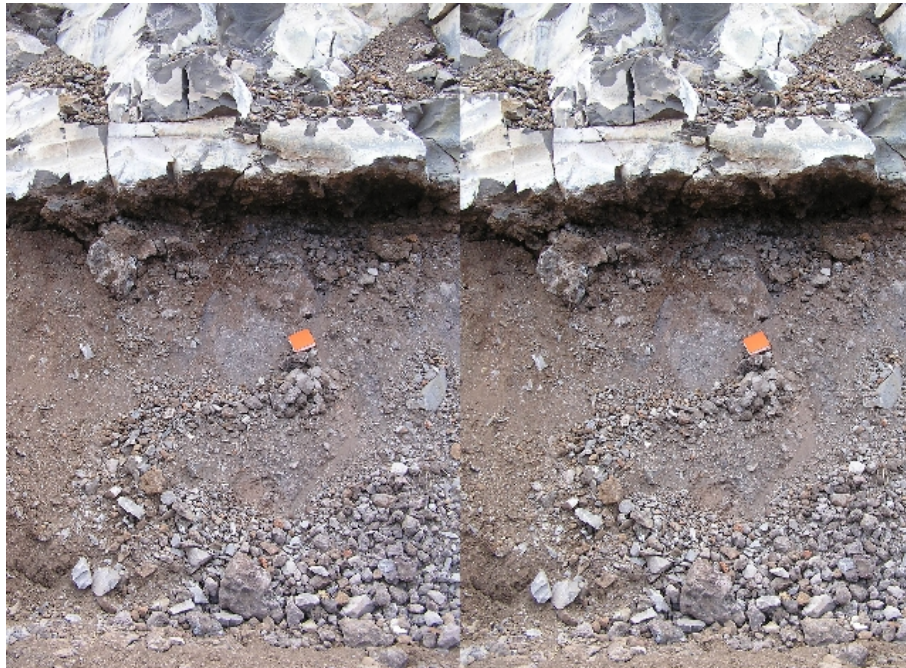
*Figure 16. Location 25, Hwy 270 north of Kawaihae. 3-D stereo pair version of Figure 15. Cantilevered block of massive a'a basalt, undermined by clinker that raveled during the earthquakes.*

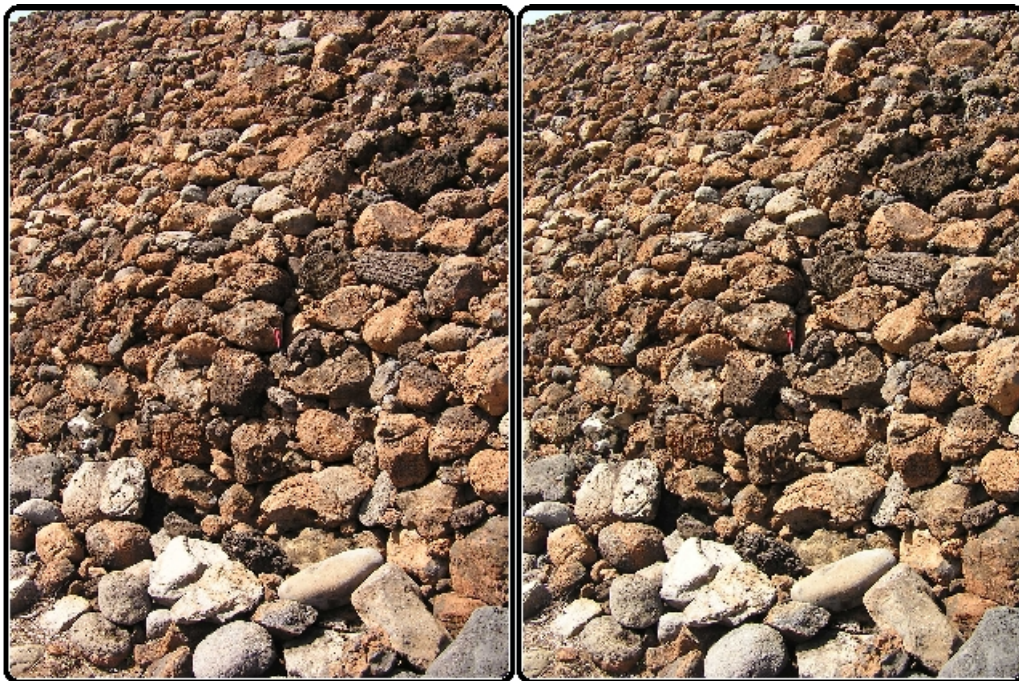
*Figure 54. Location 29, bulge at NE corner of Pu'ukoholā heiau. 3-D stereo pair version of Figure 53.*
