Geological Engineering Reconnaissance of Damage Caused by the October 15, 2006 Hawaii Earthquakes

Edmund W. Medley, Senior Consultant, Geosyntec Consultants Inc., Oakland, CA, USA, Email: emedley@geosyntec.com

KEYWORDS: Geological Engineering, Hawaii, Earthquake Damage, Rock Mass, Basalts, Rock Block Structures

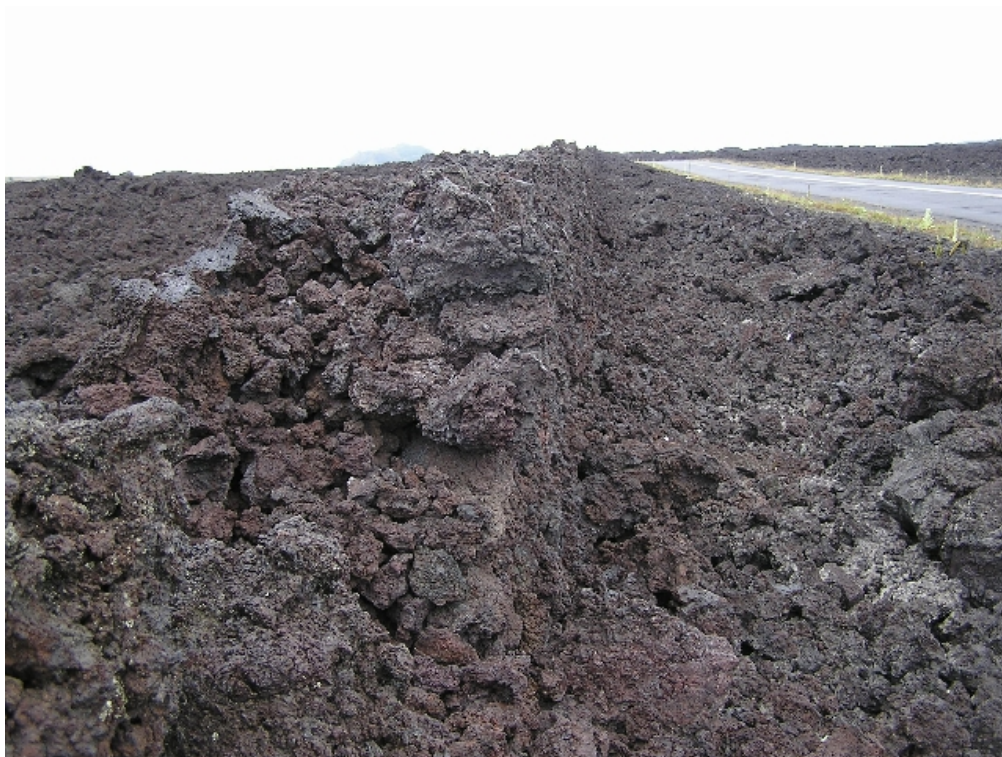
Figure 9. Location 11, Saddle Road (Hwy 200). Lava flow of a'a clinker and dry stacked wall of clinker composed of a'a blocks.

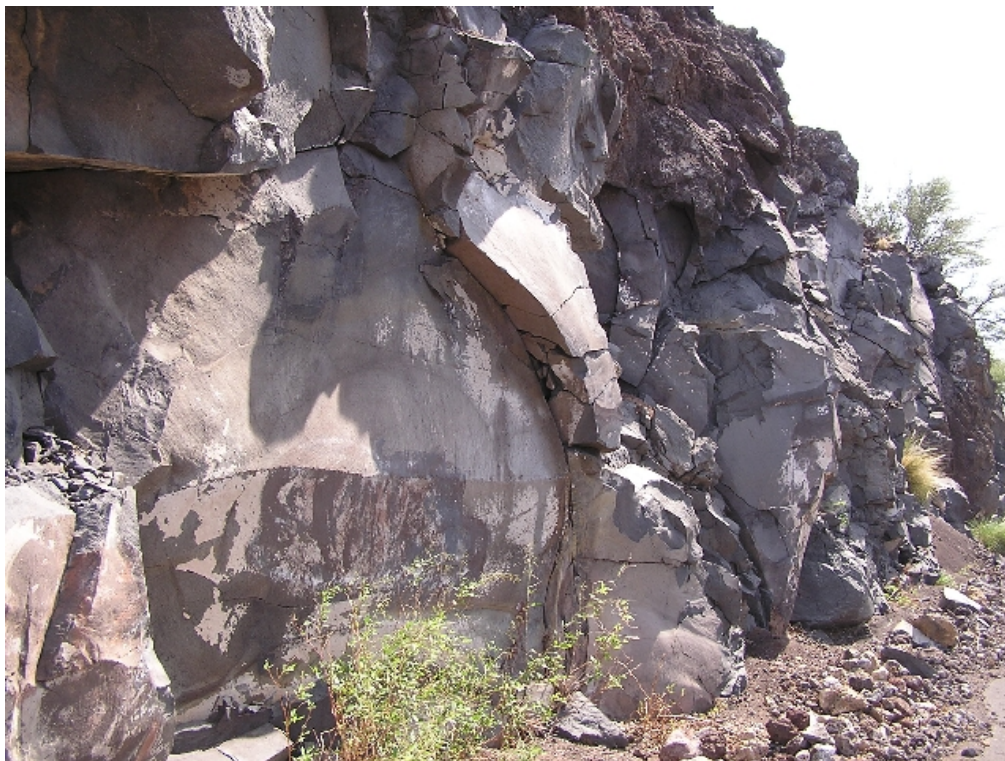
Figure 10. Location 32, road cut at Hwy 11. Massive basalt in a'a flow.

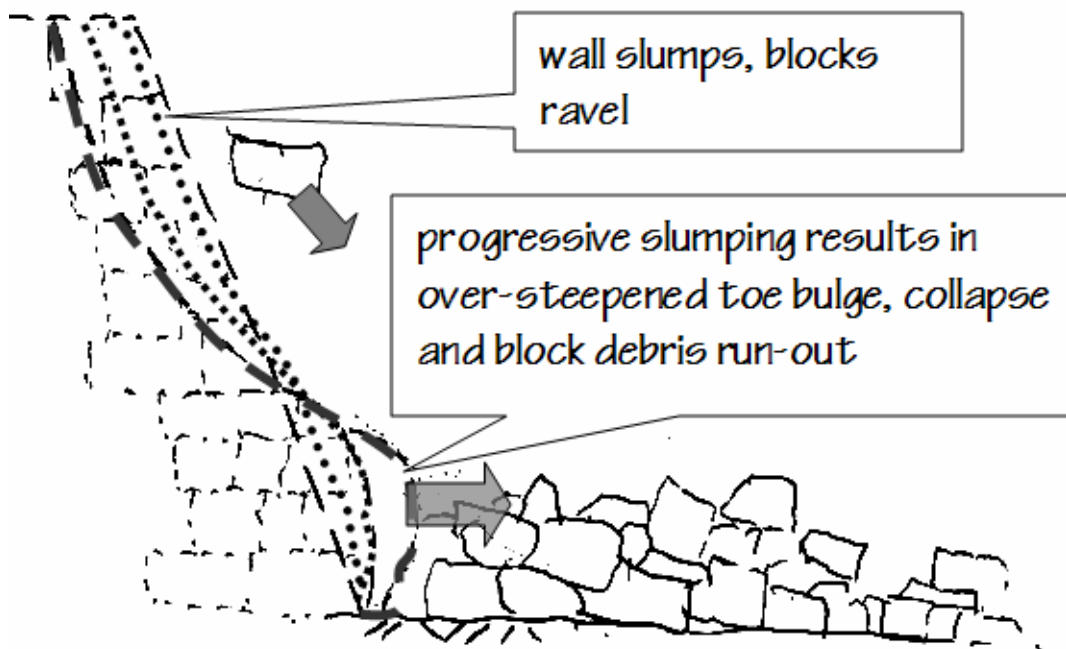
figure 58 and stereo Figure 59). The slumps apparently occurred in much the same fashion as sketched in Figure 60. The angle of repose for the slumps was about 30 degrees, with run-outs extending to more than 5 m from the original toes of the walls (Figure 52 and Figure 56).

Figure 60. Raveling, bulging and slumping of the face of a rock block edifice (Medley and Zekkos, 2007).
