Lack of Maintenance Compromises Tunnel Structural Safety

ABSTRACT: *The Chekka tunnels represent a critical section of the Northern Lebanon Highway. The approximately 350-m long twin tunnels are the most important tunnels in the country. They are used by regular and freight traffic and are a vital link to the capital, Beirut. The tunnels were completed in the early 1970s on the eve of the Lebanon civil war. Given the state of affairs in the country for about two decades of strife, the tunnels were not maintained nor did they undergo any regular inspection. This unique condition of near-abandonment continued up until recently, when the first signs of distress were documented. These consisted of severe and extensive cracking, particularly in the portal approach of the southbound tunnel, along with significant deterioration of the tunnel lining and radial section joints. The danger to traffic and, potentially, to the structure itself was evident. In this paper, the results of an extensive site inspection and evaluation program are presented. The underlying causes of the observed damage are analyzed and discussed using a modeling approach of the progressive loading conditions. Remedia

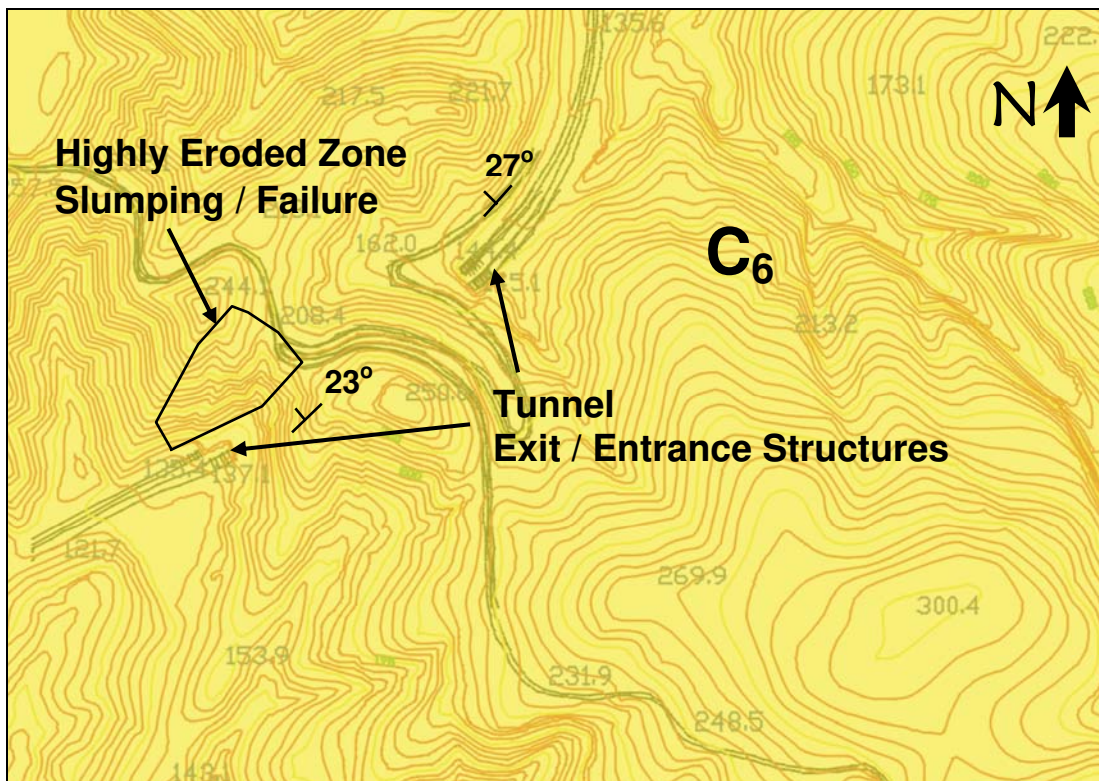
Based on the topographic and geological surveys, it is clear that the prevailing strata are prone to erosion and mass wasting, and that significant slopes are evident in the vicinity of the tunnels with adverse dips identified towards the tunnel exit and entrance points.

Figure 5. Geology of Area: The Only Outcropping Unit is the Chekka Formation C6.

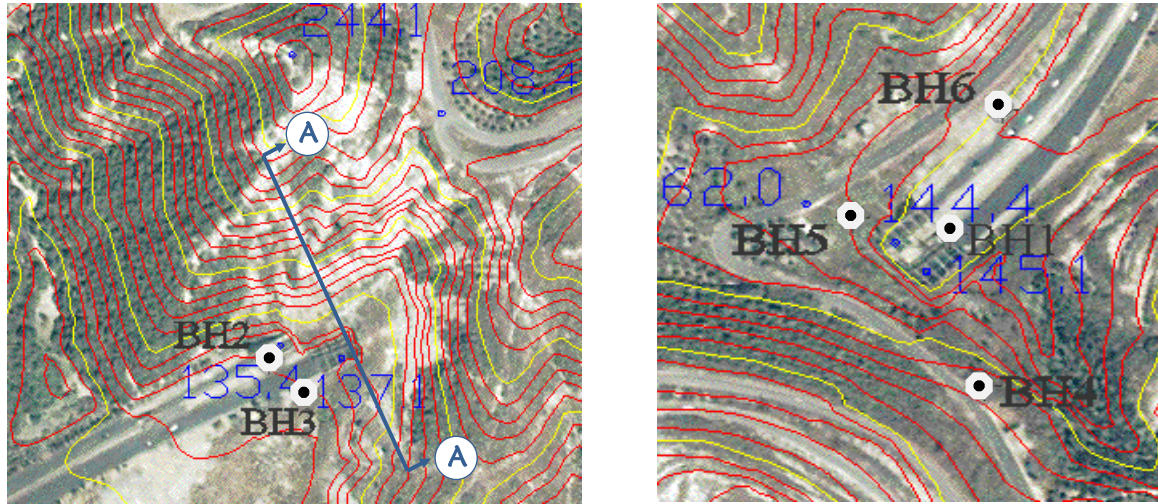
A total of six boreholes, approximately 10 m deep, were drilled in addition to a number of shallow pits. The locations of the boreholes were restricted to accessible areas and are indicated in Fig. 7. The exploration pits complemented the boreholes and were located primarily above the southern entrance/exit points.

Figure 7. Location of Exploration Boreholes BH-1 Through BH-6.

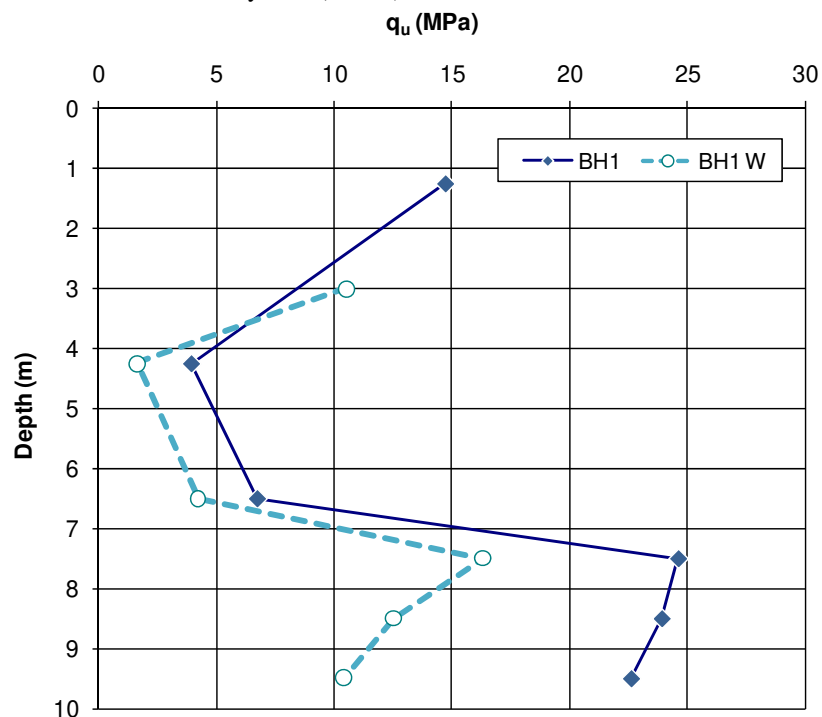
Unconfined compression tests were conducted on rock cores according to ASTM D2166. Some of the samples were submerged in water for 48 hours prior to testing in order to explore the effect of increased water content on the strength of the marlstone/rock samples. The elastic deformation modulus values obtained from the laboratory tests on the cores extracted from the material above the southbound tunnel cross-section are relatively low (from about 5800 to 15000 kPa), which was expected given their higher degree of weathering. The results of the unconfined compression tests showed a significant decrease in strength for the wetted samples. The average unconfined compression strength values from samples from BH-1 and BH-5 for the marly limestone layers are shown in Table 1. The unconfined compressive strengths above the southbound tunnel cross-section suggested an average value of $q_u \sim 19.5$ MPa for the natural condition samples, and a value of $q_u \sim 7.0$ MPa for the wetted samples. Typical results from BH1 samples are presented in Fig. 9.

Figure 9. Unconfined Compressive Strength Results From BH1: Natural Water Content and Wetted Samples (w).
