Leaning Tower of Pisa: Behaviour after Stabilization Operations

ABSTRACT: It is well known that the foundations of the Leaning Tower of Pisa were stabilised using the method of underexcavation to reduce the southward inclination of the Tower by about 10 percent in combination with controlling the seasonally fluctuating water table beneath the north side. Having been closed to the public since early in 1990, the Tower was re-opened in December 2001. The paper summarises the response of the Tower during the period of implementation of the stabilisation works. Monitoring of the movements of the Tower has been continuing and the observations obtained since 2001 are presented. It is shown that over the six years between 2003 and 2008 the induced rate of northward rotation of the Tower has been steadily reducing to less than 0.2 arc seconds per year. Similarly the rate of induced settlement of the centre of the foundation has been steadily reducing and is approaching the background rate of settlement of the Piazza. Piezometer measurements close to the north side of the foundation shows that the drainage system has been successful in stabilising the groundwater levels beneath the north s

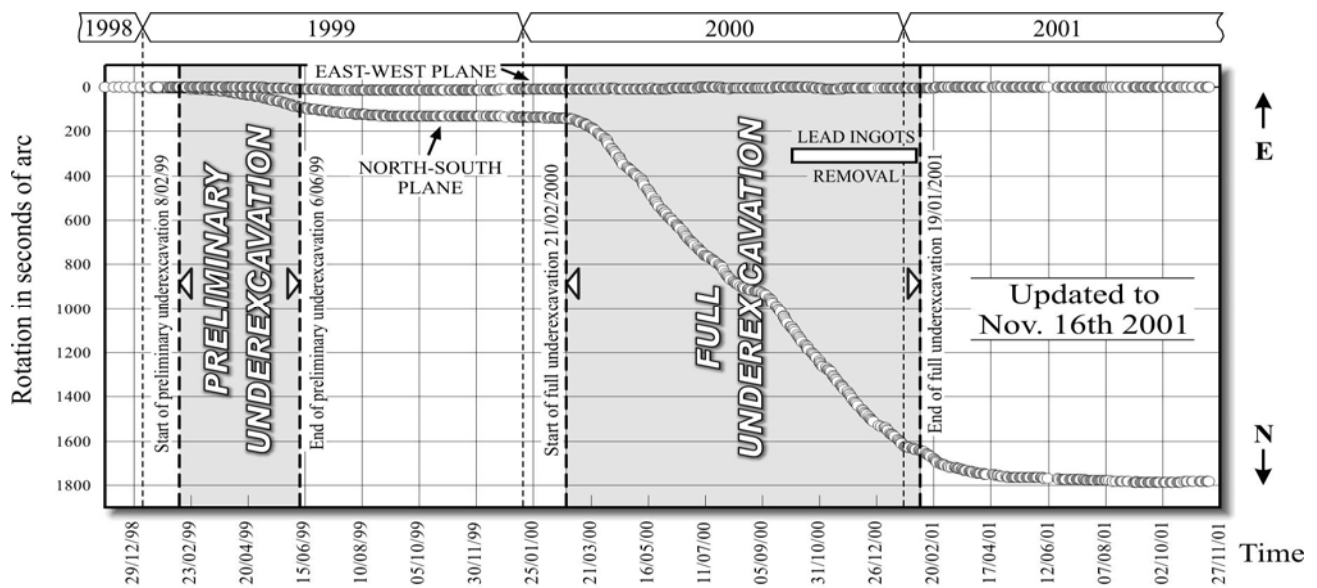
Figure 11. Rotation of Tower plinth during underexcavation.

The success of the preliminary underexcavation persuaded the Committee that it was safe to undertake soil extraction over the full width of the foundation. Accordingly, between December 1999 and January 2000, 41 extraction holes were installed north of the Tower at 0.5m spacing with a dedicated auger and casing in each hole (Fig.10). Full underexcavation commenced on 21st February 2000 and the Tower was steered northwards in a remarkably straight path. Towards the end of May 2000 progressive removal of the lead ingots was commenced. Although this resulted in an increase of overturning moment the soil extraction continued to be effective.

On 16th January 2001 the last lead ingot was removed from the post-tensioned concrete ring and thereafter only limited soil extraction was undertaken. In the middle of February 2001 the concrete ring itself was removed and at the beginning of March progressive removal of the augers and casings commenced with the holes being filled by a bentonitic grout. The final extraction and auger removal took place on 6th June 2001 at which time the Tower had been rotated northwards by about 1800 arc seconds, see Fig. 11. Full details of the soil extraction operation and the associated response of the Tower are given by Burland et al, (2003).

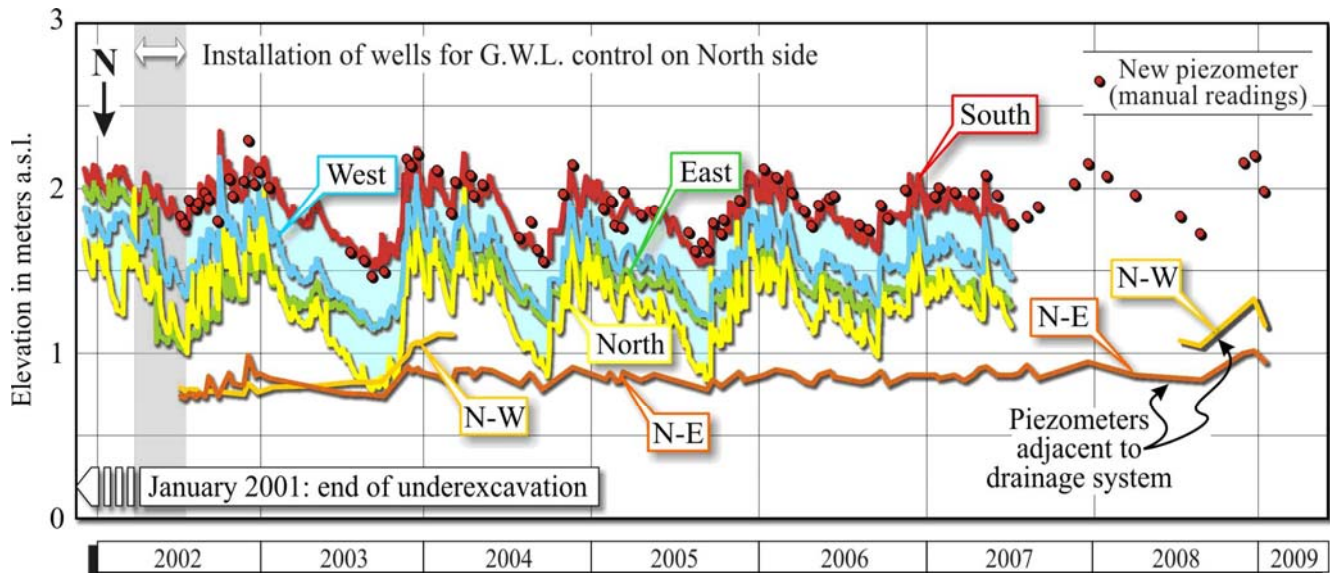
As mentioned previously, the deduced motion of the Tower foundation shown in Fig. 5 led to the conclusion that the seasonal fluctuating water table in Horizon A during intense periods of rain was the main factor responsible for this continuing movement, see Fig. 6. It is also of significance that, apart from these intense periods of rain, the average ground water levels close to the South side of the Tower in Horizon A are 200mm to 300mm higher than those to the North, as shown in Fig. 6. This difference generates a small, but not negligible stabilising moment for the Monument which is so close to falling over. In the autumn and winter, when rainfall events are more intense, the water table rises sharply, reduces the difference in piezometric level and thereby produces southward rotations of the Tower which are not fully recoverable. To minimise this effect it was necessary to eliminate the fluctuations of the water table and, with this objective, a drainage system was installed consisting of three wells sunk on the north side with radial sub-horizontal drains running into them from beneath the north side of the catino, (Fig. 13). The water levels in the wells are controlled by the level of the outlet pipes. The drainage system was implemented in April and May 2002 and led to a decrease in the pore water pressure as well as a significant reduction in its seasonal fluctuations, as shown in Fig. 14. The installation of this drainage system induced a further northward rotation of the Tower as can be seen in Fig. 15.

Figure 14. Perched ground water table in horizon "A".
