Reconstruction of Konstantinovsky Palace in a Suburb of Saint Petersburg

ABSTRACT: *This article describes a complex approach to the condition survey and design executed as part of the remedial works on Konstantinovsky palace in the suburb of Strelna (Saint Petersburg)--one of the most beautiful historic monuments of 18th century Russia. The palace was almost completely destroyed in the 1940s. In 2000 the decision was made to reconstruct the palace, and the project for palace reconstruction was developed. The project was completed in 2003. The following important stages of the project are discussed in this paper: palace condition survey and site investigations, analyses of the palace retaining structures, design project of palace reconstruction, and phases of the remedial works.*

PALACE CONDITION SURVEY AND SITE INVESTIGATION

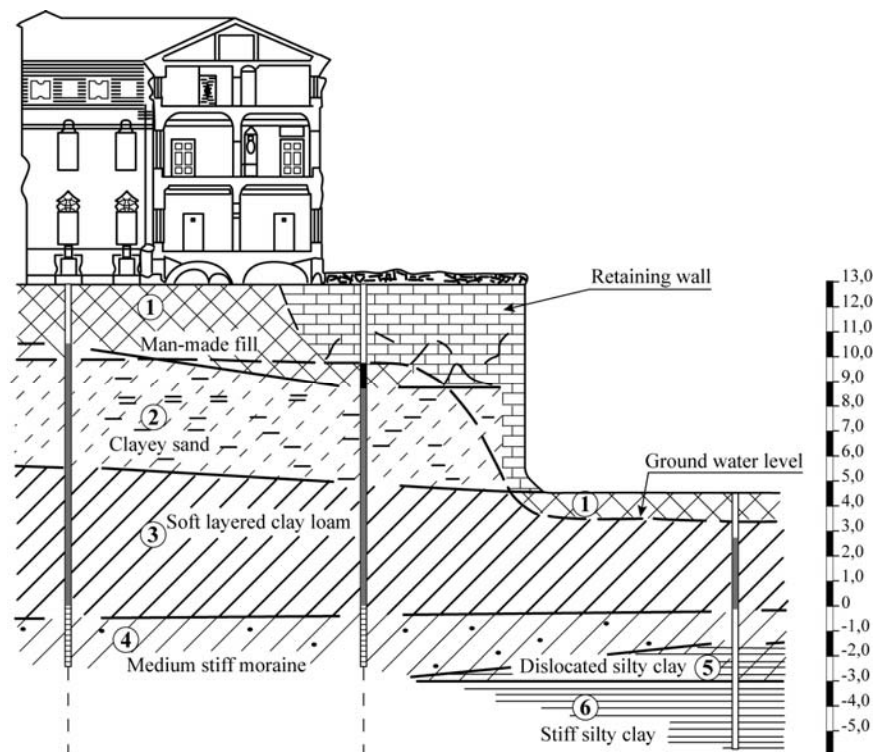
Figure 8. Cross-section of the palace and subsoil profile: 1. Made-up fill, 2. Clayey sand, 3. Soft varved clay loam, 4. Medium-stiff moraine clay loam, 5. Dislocated stiff Cambrian silty clay, 6. Stiff silty Cambrian clay.

As attested by site investigation in the park, underneath 1 m of fill there is a 3-m layer of soft varved clay loam, underlain by medium stiff moraine clay loam (Fig. 8). Still deeper, at the level of around 14.0 m (absolute – 1.3 m), there are medium stiff and stiff deep Cambrian clays.
