Reconstruction of Konstantinovsky Palace in a Suburb of Saint Petersburg

ABSTRACT: *This article describes a complex approach to the condition survey and design executed as part of the remedial works on Konstantinovsky palace in the suburb of Strelna (Saint Petersburg)--one of the most beautiful historic monuments of 18th century Russia. The palace was almost completely destroyed in the 1940s. In 2000 the decision was made to reconstruct the palace, and the project for palace reconstruction was developed. The project was completed in 2003. The following important stages of the project are discussed in this paper: palace condition survey and site investigations, analyses of the palace retaining structures, design project of palace reconstruction, and phases of the remedial works.*

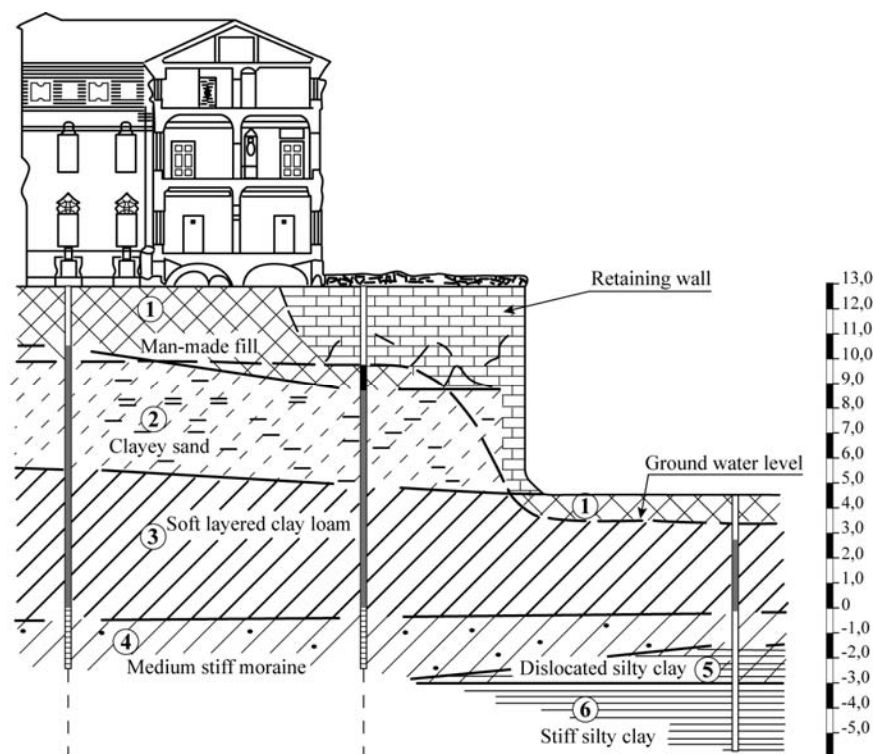
Figure 8. Cross-section of the palace and subsoil profile: 1. Made-up fill, 2. Clayey sand, 3. Soft varved clay loam, 4. Medium-stiff moraine clay loam, 5. Dislocated stiff Cambrian silty clay, 6. Stiff silty Cambrian clay.

As attested by site investigation in the park, underneath 1 m of fill there is a 3-m layer of soft varved clay loam, underlain by medium stiff moraine clay loam (Fig. 8). Still deeper, at the level of around 14.0 m (absolute – 1.3 m), there are medium stiff and stiff deep Cambrian clays.

not be entirely ruled out that the discovered brickwork is demonstrative of a bond between the courtyard foundations and the retaining structure. Above the clayey sand there is a layer of man-made ground about 3 m thick (Fig. 8, layer 1).

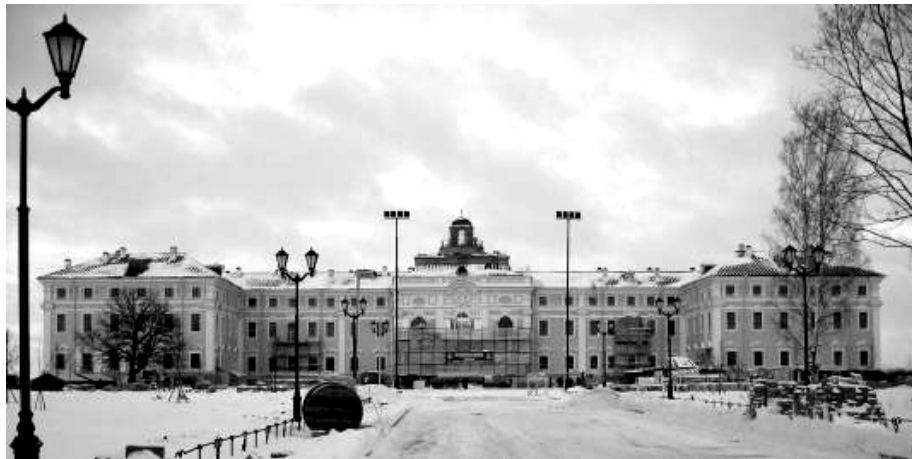
Figure 19. Konstantinovsky Palace, south façade. View of a final reconstruction stage (January 2003).

It took about 1.5 years to completely reconstruct Konstantinovsky Palace in Strelna (Fig. 19). The palace officially opened as the Congress Palace in 2003 during the tercentenary celebrations of Saint Petersburg (Fig. 20, 21).
