Mississippi River Levee Failures: June 2008 Flood

ABSTRACT: *During the spring and summer of 2008, record rainfall in the Midwest United States led to severe flooding as water overtopped the levees bordering the Mississippi River and its tributaries. The erosion associated with the overtopping resulted in levee breaches in many places. After the flooding, a field reconnaissance team was sent to collect time-sensitive data and provide a comprehensive overview of the performance of the levees during the flooding.*

Reference: Bernhardt, M., Briaud, J.L., Kim, D., Leclair, M., Storesund, R., Lim, S.G., Bea, R.G., Rogers, J.D., (2011). *Mississippi River Levee Failures: June 2008 Flood*. International Journal of Geoengineering Case Histories, <http://casehistories.geoengineer.org>, Vol.2, Issue 3, p. 127-162. doi: 10.4417/IJGCH-02-02-03.

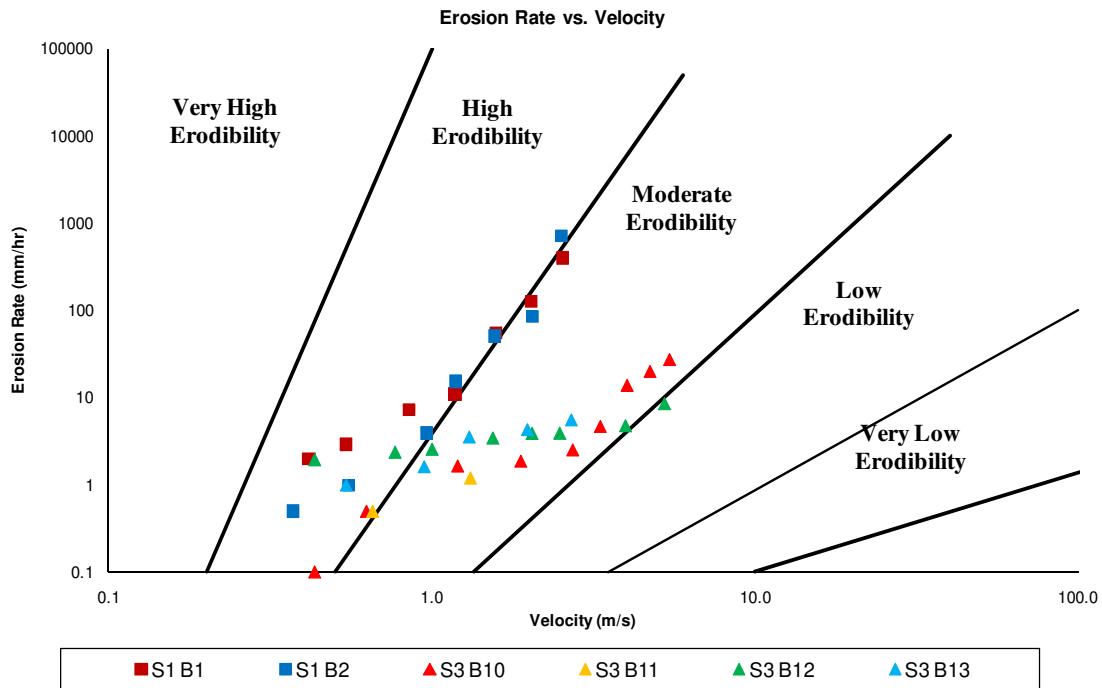
Figure 25. EFA results for Winfield-Pin Oak – S1 and Brevator – S3.

An attempt was made to correlate the erosion resistance with the index properties of the soils tested. The difference in erosion resistance between the two selected sites is clearly seen in Figure 25. Soils from the Brevator site are much more erosion resistant than those from the Winfield-Pin Oak site.

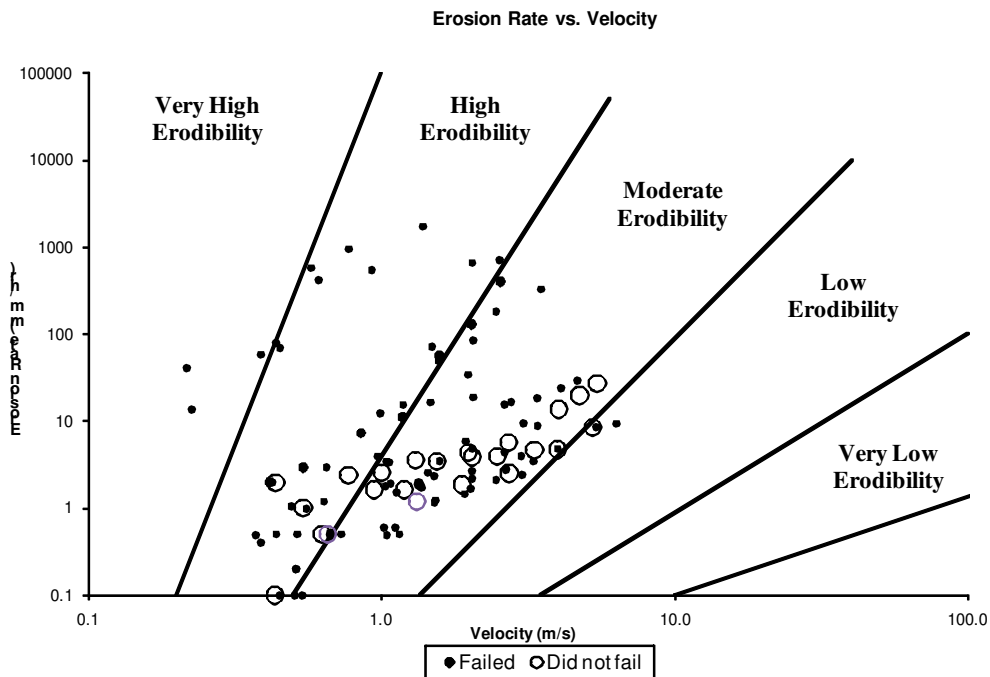
Figure 34. Overtopping comparison of pass vs. fail.

In an attempt to determine a dividing line between the soils that failed due to overtopping and those that passed, the EFA results were plotted with open circles for samples from levees that did not fail and solid circles for samples from levees that failed (Figure 34). Note that the Brevator site was the only site considered to have not failed.

Overall there is no clear division between the two sets of points like what was seen in the Katrina data (Figure 35) given in Briaud et al. (2008). The soils from the Brevator site are among some of the more resistant soils tested; however, there are several sites where the samples are just as resistant yet the sites failed. Comparing the sites that failed to the sites that did not fail based on the plotted points is somewhat deceptive because the EFA tests were limited to the bare soil and did not

account for any of the site conditions, such as vegetation or other variables that may have influenced the sites performance. The strong vegetative cover at the Brevator site would increase the resistance and effectively shift the erosion function towards the low to very low erodibility categories.

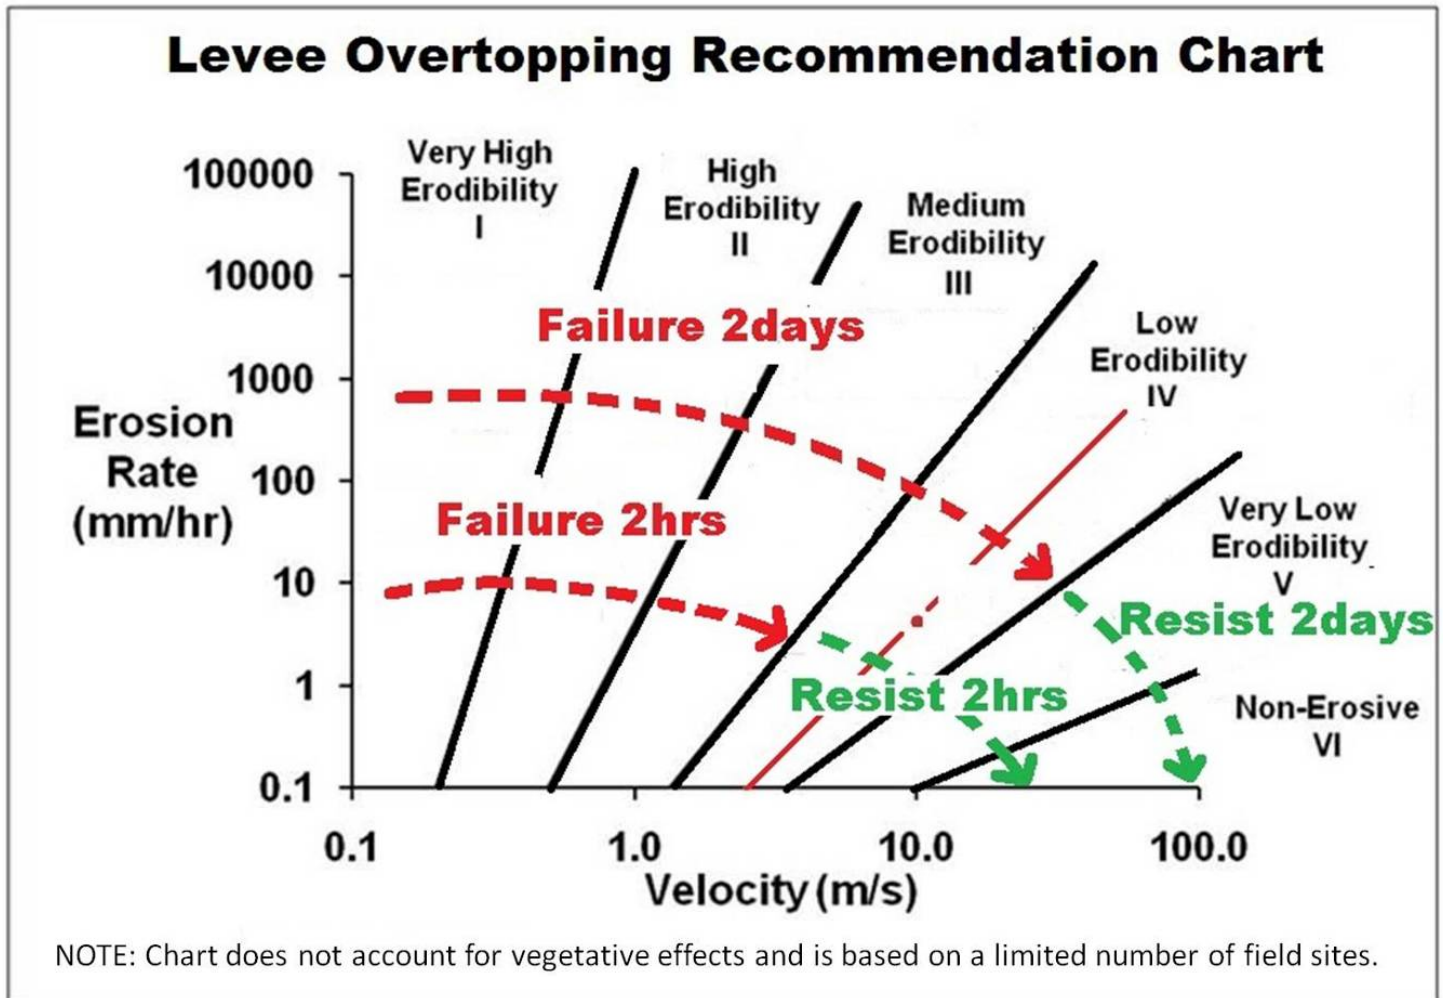
Figure 36. Recommendation chart for overtopping events.

The overtopping recommendation chart given in Briaud et al. (2008) was developed for overtopping periods of less than two hours associated with hurricane events. Based on the findings from this study, the chart was expanded to include the longer overtopping periods of 2 days experienced in flood events (Figure 36). The boundary was determined by considering the data of Figure 34 and setting an erosion limit of 0.3 m over two days for a velocity of 10 m/s. This velocity represents an average value for levees at the bottom of the dry side of the levee. To satisfy this criterion, the erosion rate has to be less than 6 mm/hr (red dot and thin red line shown on Figure 36). It is important to note that the EFA tests used to develop this chart were conducted on barren soil and therefore the chart does not account for vegetation present at a site. Also, this chart is based on a limited number of field sites and may not be representative of every field case.
