Mississippi River Levee Failures: June 2008 Flood

ABSTRACT: *During the spring and summer of 2008, record rainfall in the Midwest United States led to severe flooding as water overtopped the levees bordering the Mississippi River and its tributaries. The erosion associated with the overtopping resulted in levee breaches in many places. After the flooding, a field reconnaissance team was sent to collect time-sensitive data and provide a comprehensive overview of the performance of the levees during the flooding.*

Reference: Bernhardt, M., Briaud, J.L., Kim, D., Leclair, M., Storesund, R., Lim, S.G., Bea, R.G., Rogers, J.D., (2011). *Mississippi River Levee Failures: June 2008 Flood*. International Journal of Geoengineering Case Histories, <http://casehistories.geoengineer.org>, Vol.2, Issue 3, p. 127-162. doi: 10.4417/IJGCH-02-02-03.

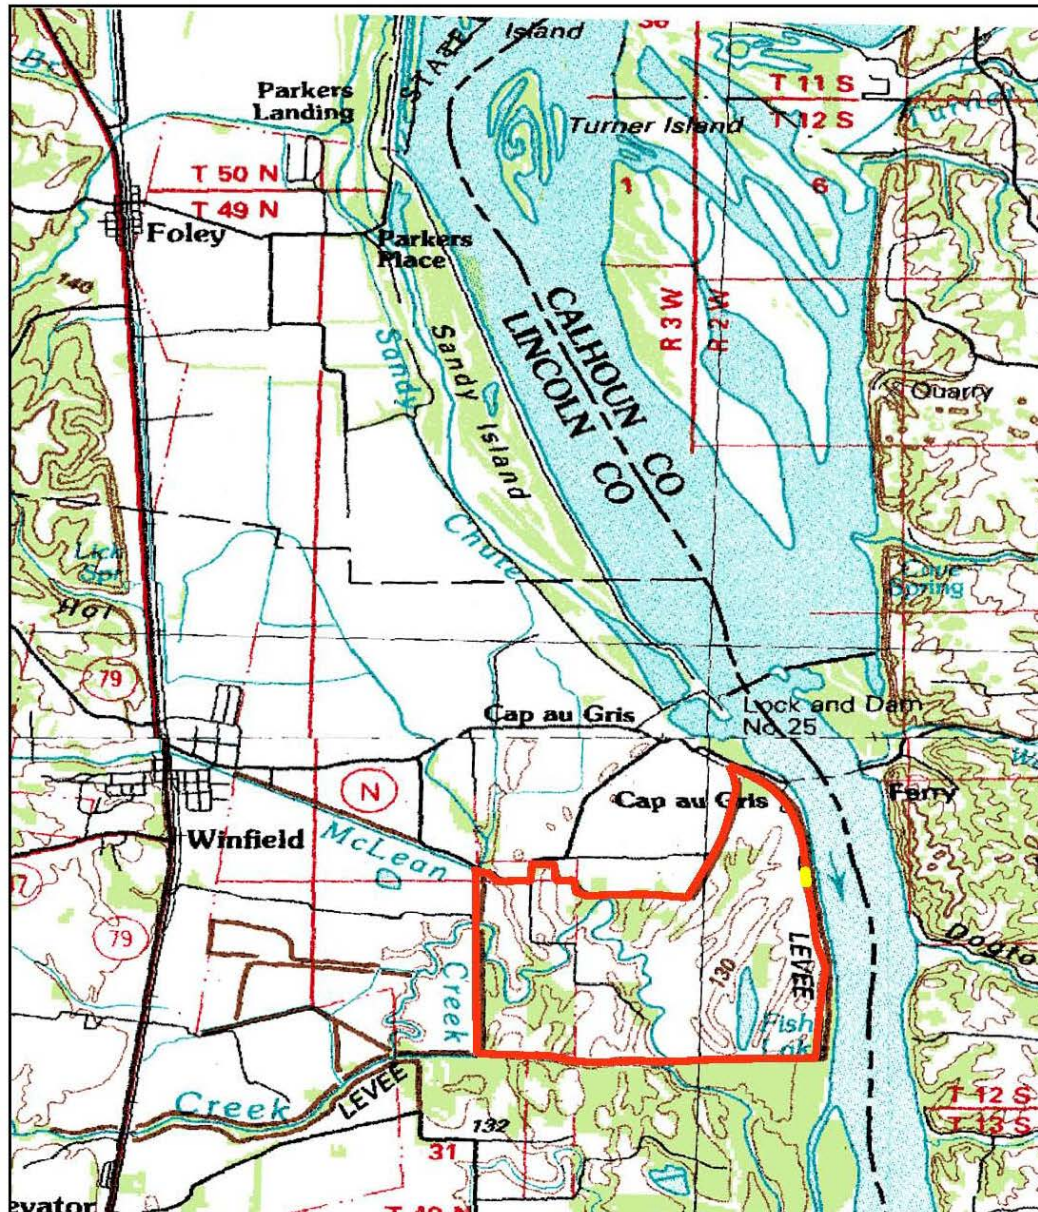
Figure 14. Winfield-Pin Oak levee system and levee breach (Storesund 2009).

The Winfield-Pin Oak levee is maintained by the Cap Au Gris Drainage and Levee District. This levee system is estimated to reduce the risk of flooding of approximately 493 ha up to a 14-year return period flood event on the Mississippi River (Figure 14). This area failed during the 1993 floods, however, the specific location of the breach (or breaches) was not documented (USGS 2006). This site was overtopped for an extended period beginning on June 18th, 2008.

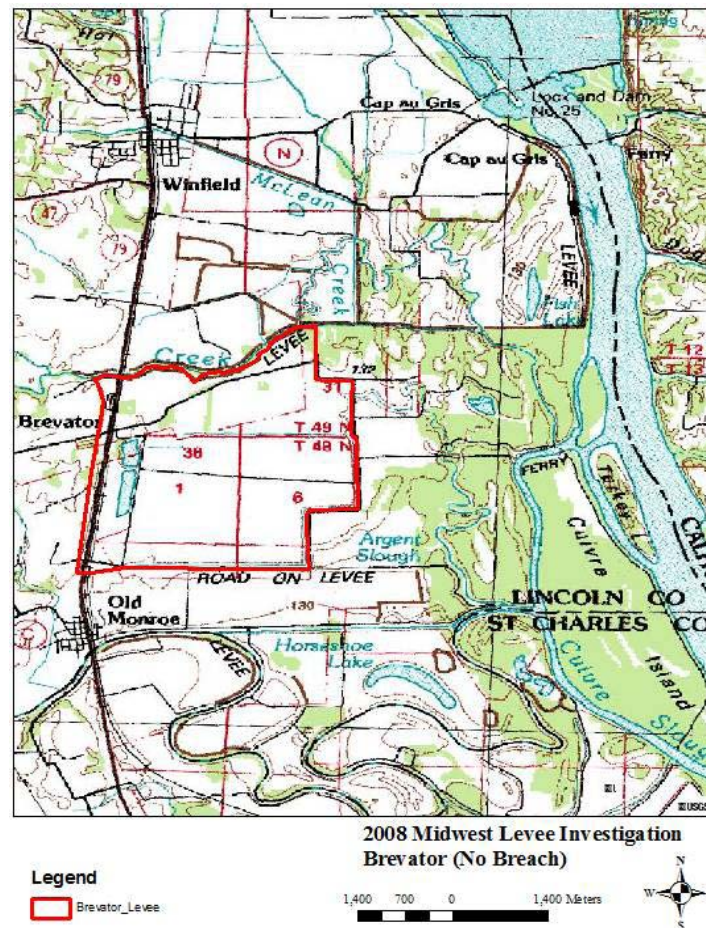
Figure 19. Brevator levee system (Storesund 2009).

This site was unique in the fact that there was no breach in 2008. The only sign of erosion was at a box culvert that was cracked allowing water and soil to seep through. A local resident (Mr. James Pieper) informed the team that the levee was overtopped by nearly 1 m of water for three days and never failed. Four samples were collected from various locations along the levee. Because there was no actual breach, only surficial samples were taken. These samples were much harder to obtain and the soil seemed to be much stiffer than at the previous sites as can be seen by the higher Pocket Penetrometer values (Table 6) obtained at this site compared to the Winfield site. Figure 20 shows the boring locations and Table 6 presents the sample logs for this site.

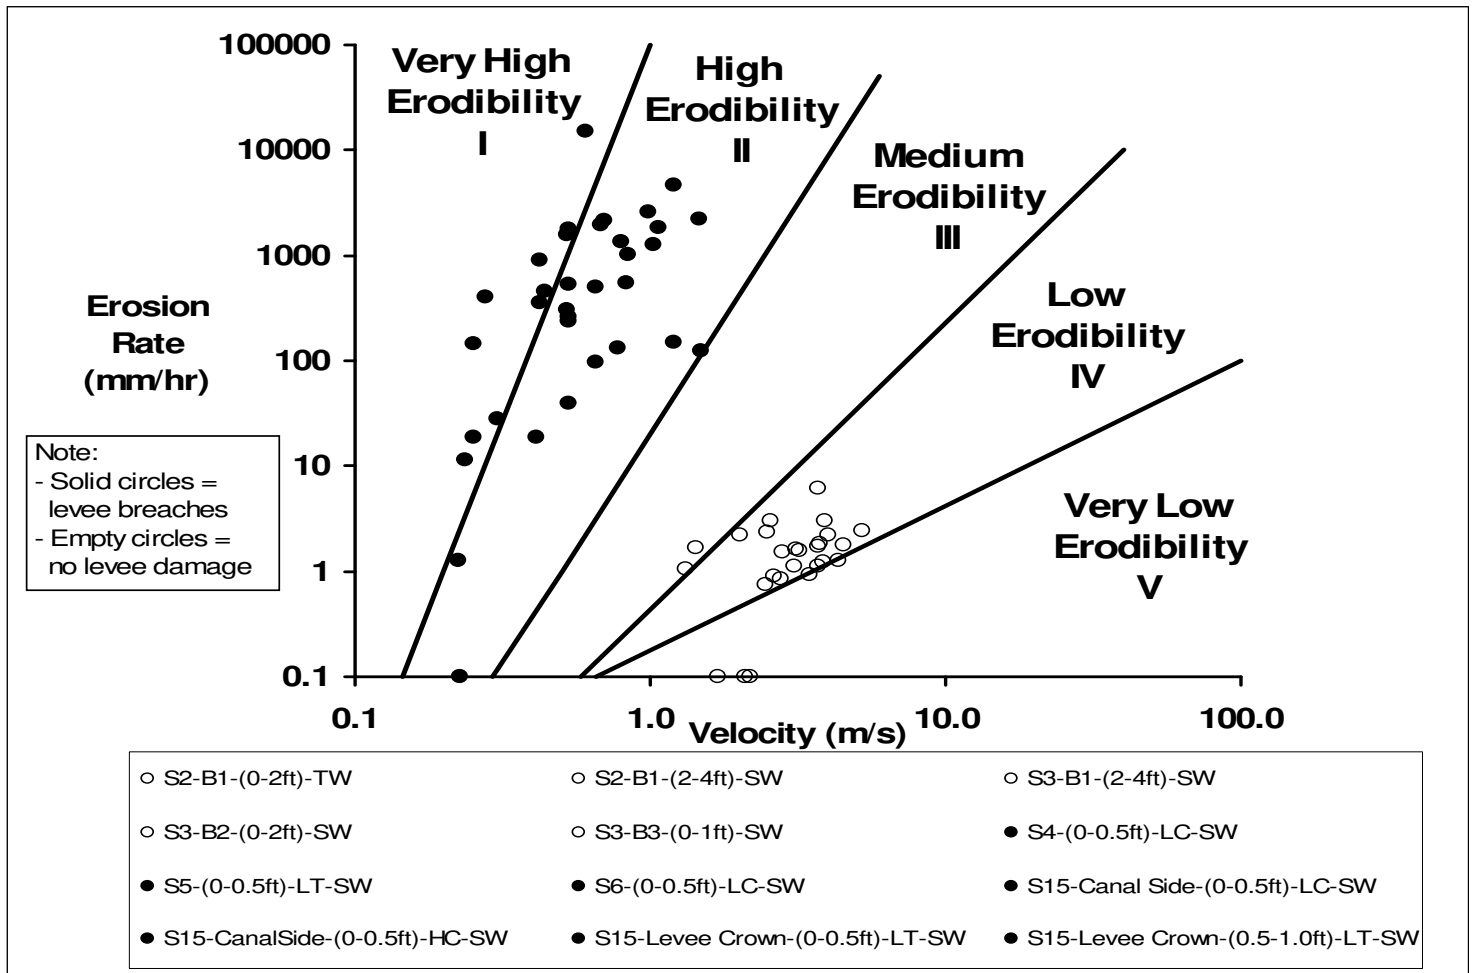
Figure 35. Overtopping comparison - pass vs. fail for Katrina data (Briaud et al. 2008).

Overall there is no clear division between the two sets of points like what was seen in the Katrina data (Figure 35) given in Briaud et al. (2008). The soils from the Brevator site are among some of the more resistant soils tested; however, there are several sites where the samples are just as resistant yet the sites failed. Comparing the sites that failed to the sites that did not fail based on the plotted points is somewhat deceptive because the EFA tests were limited to the bare soil and did not

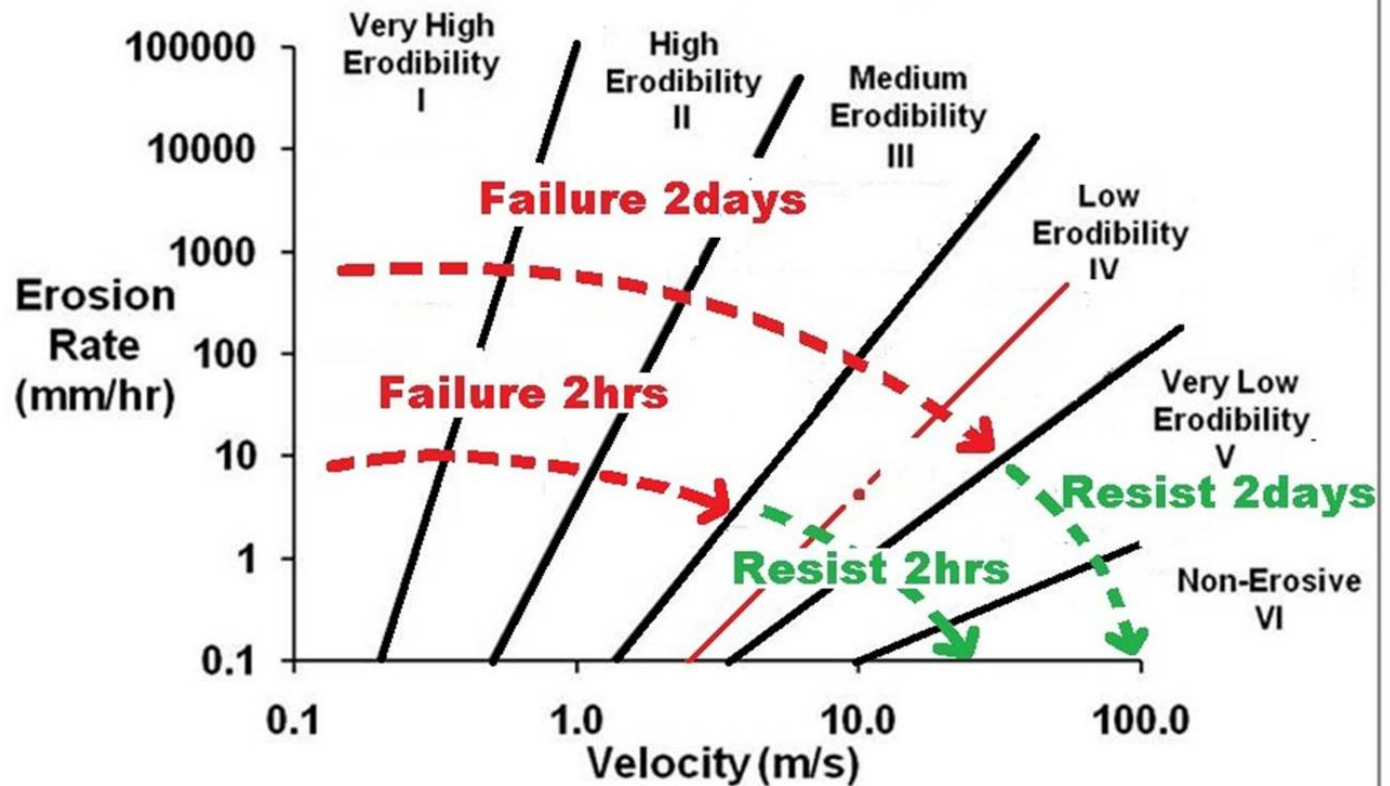
Figure 36. Recommendation chart for overtopping events.

The overtopping recommendation chart given in Briaud et al. (2008) was developed for overtopping periods of less than two hours associated with hurricane events. Based on the findings from this study, the chart was expanded to include the longer overtopping periods of 2 days experienced in flood events (Figure 36). The boundary was determined by considering the data of Figure 34 and setting an erosion limit of 0.3 m over two days for a velocity of 10 m/s. This velocity represents an average value for levees at the bottom of the dry side of the levee. To satisfy this criterion, the erosion rate has to be less than 6 mm/hr (red dot and thin red line shown on Figure 36). It is important to note that the EFA tests used to develop this chart were conducted on barren soil and therefore the chart does not account for vegetation present at a site. Also, this chart is based on a limited number of field sites and may not be representative of every field case.

NOTE: Chart does not account for vegetative effects and is based on a limited number of field sites.

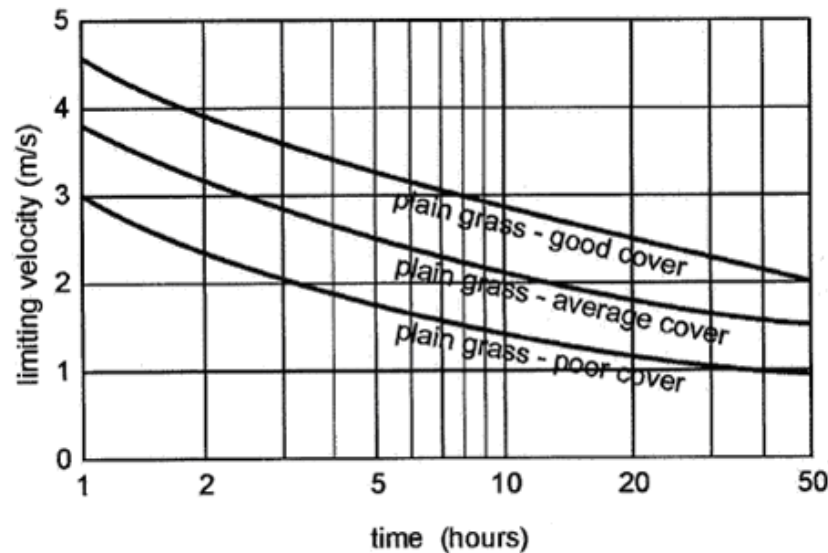
Figure 37. Limiting velocities for plain grass (Seiffert and Verheij 1998).

Levee performance under wave action and overtopping has been a major area of interest in the Netherlands after the disaster of 1953 in which many levees failed from inner slope shearing following overtopping. The primary purpose of the vegetation is to prevent erosion caused by hydraulic forces (Seijffert and Verheij 1998). Normal grass cover can resist velocities up to 2 m/s with little or no erosion; however, higher velocities can become problematic (Figure 37). This chart shows the importance of the duration of the overtopping. As the number of hours of overtopping increases, the benefit gained from having increased vegetative cover decreases. For normal flooding events like those experienced in the Midwest it is not unreasonable to assume that the overtopping lasts 20 hours or more. Velocities at the toe of a levee can reach 10 m/s depending on the levee height. This point (20 hours at 10 m/s) plots much higher than the limiting cases shown in Figure 37. Since the Brevator site survived at least 2 days of overtopping, it is likely that Figure 37 is conservative.

The grasses found at the Brevator site seemed to satisfy all of these criteria. The recommended grasses for the Midwest include: Switchgrass, Tall Fescue, Smooth Brome and Reed Canarygrass. A percent coverage of at least 90 percent is desirable. It is also recommended that the grasses on the levee be allowed to grow to taller heights during the flood season (0.5 to 1 m). While most of the erosion prevention depends on the root system, it is not always adequate for the magnitude and duration of flows experienced during overtopping flood events.
