Quarry-Induced Slope Instability at a Broadcasting Transmission Plant near Valcava, Lombardia, Italy

Monica Barbero, Assistant professor, Politecnico di Torino (Torino, Italy); email: monica.barbero@polito.it
Fabrizio Barpi, Assistant professor, Politecnico di Torino (Torino, Italy); email: fabrizio.barpi@polito.it

ABSTRACT: *Since 2006, a broadcasting tower and ancillary buildings on the top of a hill adjacent to a large, active limestone quarry, in northern Italy near the village of Valcava, has been heavily damaged by ground deformation due to slope instability. In 2005, the quarry began to work the slope toward the broadcasting plant, releasing bedding planes that affected the tower site: a number of fractures occurred in the warehouse and in the ground around it, that grew particularly during significant rainfalls. In October 2006 a landslide occurred in the quarry area, close to the broadcasting site. In order to understand what induced the fracture process in the buildings and define a support system to stabilize the broadcasting site, a detailed geotechnical survey and a number of numerical slope stability analyses were carried out. One of the main goals of the paper is t

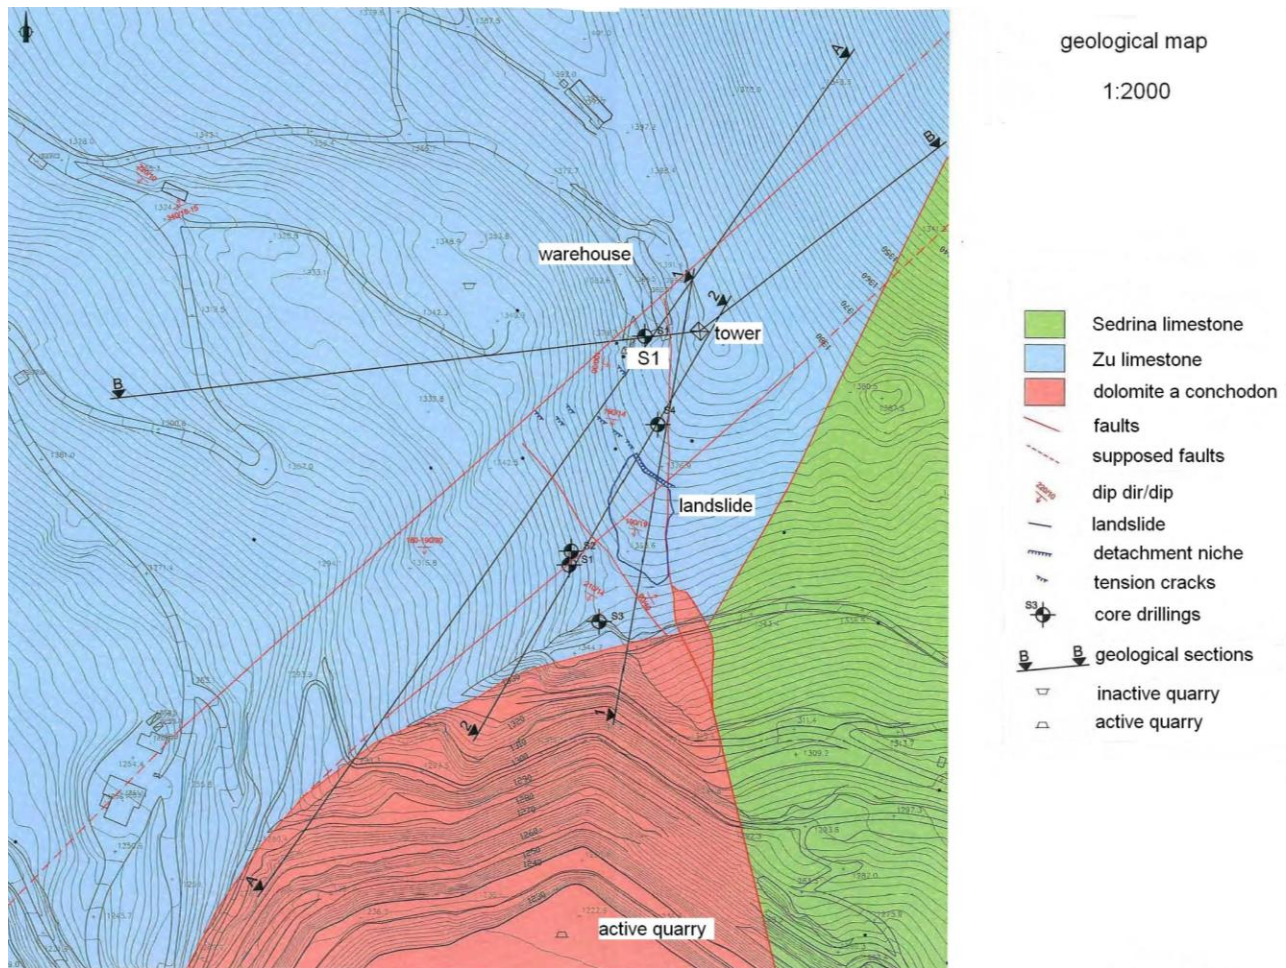
Figure 1. Geological map of the site.

The analysis of the geological map (Figure 1) and the results of the geological survey concluded that:

3. Fault A marks the eastern boundary of the landslide in the pit area. This involves a 30 m slope height and has a crown length of about 35 m;
4. In the west side of the edge and in the toe of the landslide, many opened cracks were observed, suggesting that the instability phenomenon is not completed yet and potential landslide progression toward the plant is possible;

A drill core was taken from a 45 m deep hole drilled adjacent to the building (labeled S1 in Figure 1), near the top of the slope (about 1392 m asl). The core drilling analysis allowed to define the rock mass stratigraphy. Four main geological levels were observed, from the plane of the site: a 3 m thick layer of filling material, about 11 m thick eluvium-colluvial sheet, highly fractured limestone until the depth of about 20 m and limestone bedrock. In situ observation of the main scarp depth suggested that the movement occurred at a depth of about 16 m. Comparing these data it was possible to assert that the contact between the 20 m deep weaker layer and the undamaged bedrock is a preferential sliding zone. At the depth of about 20 m, a cavity with air inside was found, indicating the absence of water bed above the depth of 20 m.
