Quarry-Induced Slope Instability at a Broadcasting Transmission Plant near Valcava, Lombardia, Italy

Monica Barbero, Assistant professor, Politecnico di Torino (Torino, Italy); email: monica.barbero@polito.it
Fabrizio Barpi, Assistant professor, Politecnico di Torino (Torino, Italy); email: fabrizio.barpi@polito.it

ABSTRACT: *Since 2006, a broadcasting tower and ancillary buildings on the top of a hill adjacent to a large, active limestone quarry, in northern Italy near the village of Valcava, has been heavily damaged by ground deformation due to slope instability. In 2005, the quarry began to work the slope toward the broadcasting plant, releasing bedding planes that affected the tower site: a number of fractures occurred in the warehouse and in the ground around it, that grew particularly during significant rainfalls. In October 2006 a landslide occurred in the quarry area, close to the broadcasting site. In order to understand what induced the fracture process in the buildings and define a support system to stabilize the broadcasting site, a detailed geotechnical survey and a number of numerical slope stability analyses were carried out. One of the main goals of the paper is t

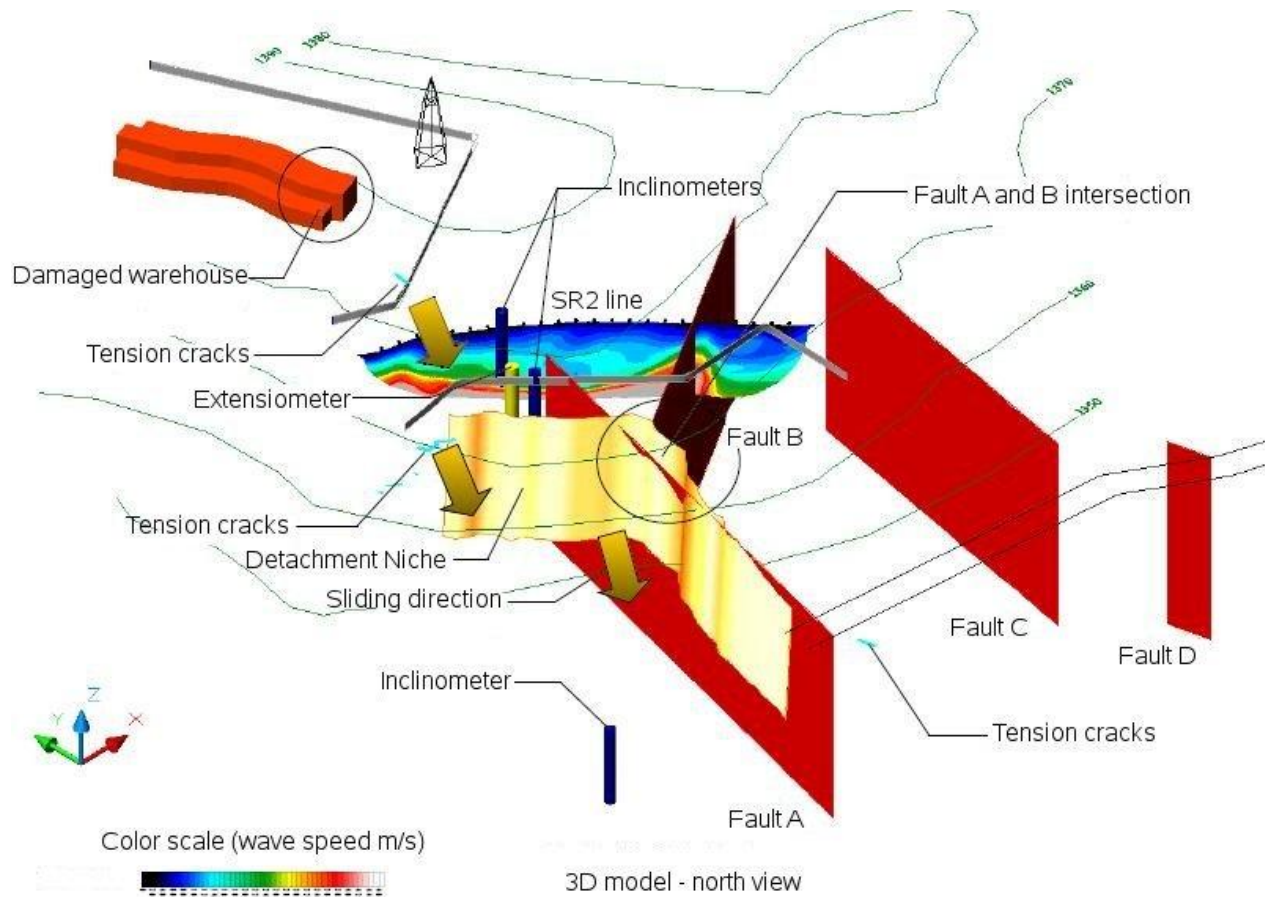
Figure 7. Three dimensional model for the seismic and geo-electrical survey.

The data were processed with tomographic technique (Hampson & Russel, 1984; Olsen, 1989) and then interpreted considering the conventional exploration with core-drilling data. Similar results were generated in the slope and in the tower area. Upslope of the warehouse, in the tower area, there is a superficial layer of fill about 3 m deep, underlain by a layer of fractured limestone overlying apparently intact bedrock at a depth of about 16 m, as shown in Figure 8. Near the warehouse, upslope from the landslide, a pit showed the same stratigraphic sequence is observed in the tower area, as well as evidence of the two main faults A and B (Figure 9). Because of fault B, the apparently intact limestone is found at a depth of more than 20 m. The seismic survey thus confirmed the likelihood that the sliding surface was located above a depth of 20 m.
