## Embankment Failure in Residual Soils at Nivsar, Ratnagiri

**ABSTRACT:** *The Nivsar Yard embankment was constructed by the Konkan Railways in 1994. Near the station building, the 22m high embankment runs parallel to the Kajali River for a stretch of about 100m. This stretch has experienced failure and settlement related problems since the record-breaking July 2005 rainfall. Corrective ground improvement measures were implemented immediately after the monsoon. However, these measures were inadequate because the failure surface reappeared during the following monsoon. The failure surface mirrored the shape and size of the failure observed in 2005. Since then after nearly every monsoon, the embankment has moved despite precautionary measures taken by the railway to arrest the movement. The hydrogeological and geotechnical properties which affect slope stability are first discussed. The stability of the embankment is then evaluated at 5 sections drawn along the slope. Two cases are considered. In the first case, the stability of the unreinforced slope is calculated. In the second case, calculations are done using the slope reinforced with soil nails and micropiles installed in 2005

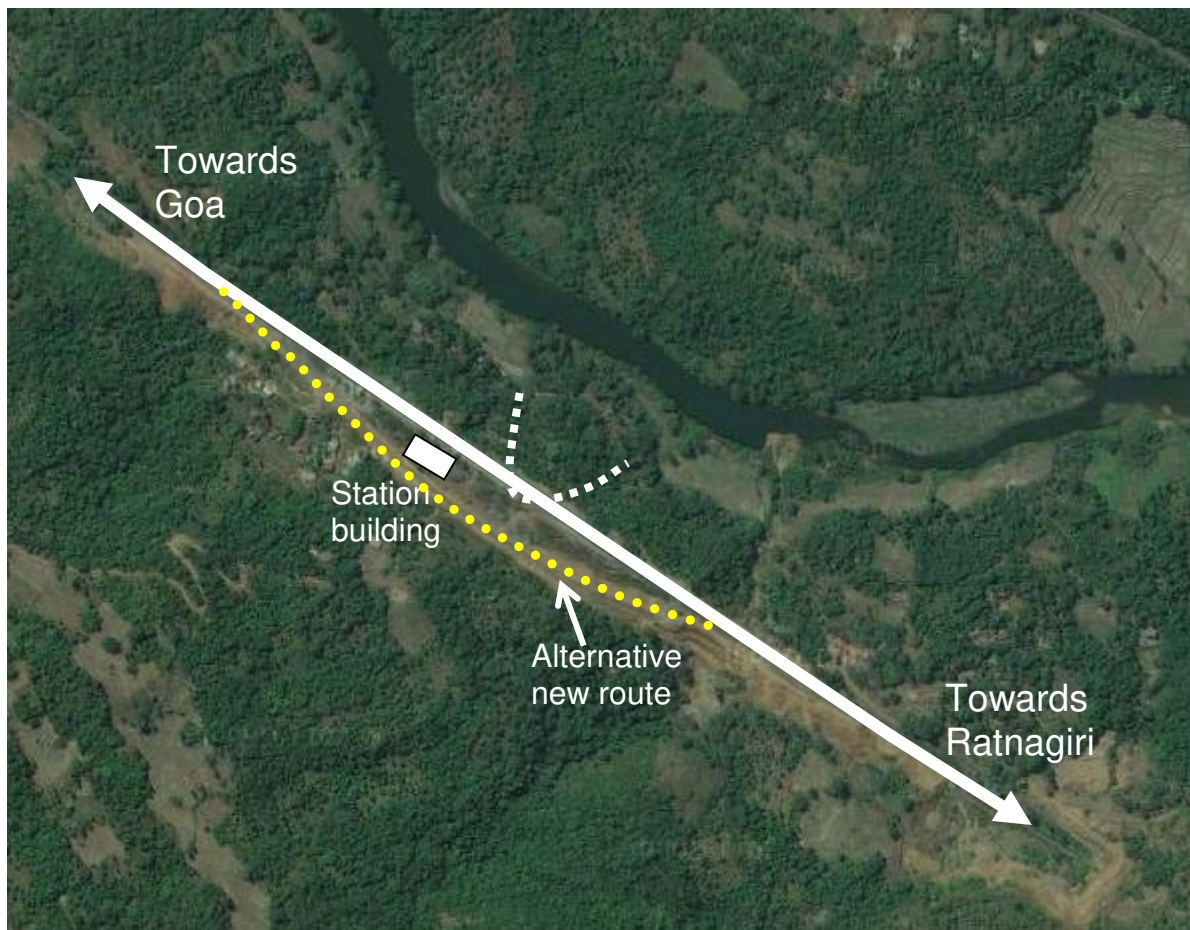
Figure 1. Nivsar Station in Ratnagiri District of Maharashtra (Source: Google earth). Note: The dashed line shows the approximate location of the embankment failure .

In 2010, the rail track was realigned to bypass the failure surface. This arrangement provided immediate relief to the rail-traffic. Figure 1 also shows the new alternate route used by the Konkan Railways. Since then, three other lines have been realigned to follow this alternate route. Irrespective of the above change in the rail alignment, Figure 3 also shows that the rate of settlement of the embankment has reduced since the 2009 monsoon. It is plausible to assume that the slump accumulated at the toe has reduced the gradient and hence affected the soil movement over this period (Figure 5). The site was re-investigated in 2010. The results of the re-investigation are part of this present study. The objective of this paper is to investigate the slope failure at Nivsar as recorded since the year 2005. Stability of the embankment before and after the ground improvement works is discussed. Railway loads from the old as well as the new rail alignment were used in the analysis. The critical failure circle for each case is shown to be affected by the geometry of the slope and the hydrogeological conditions at the site.

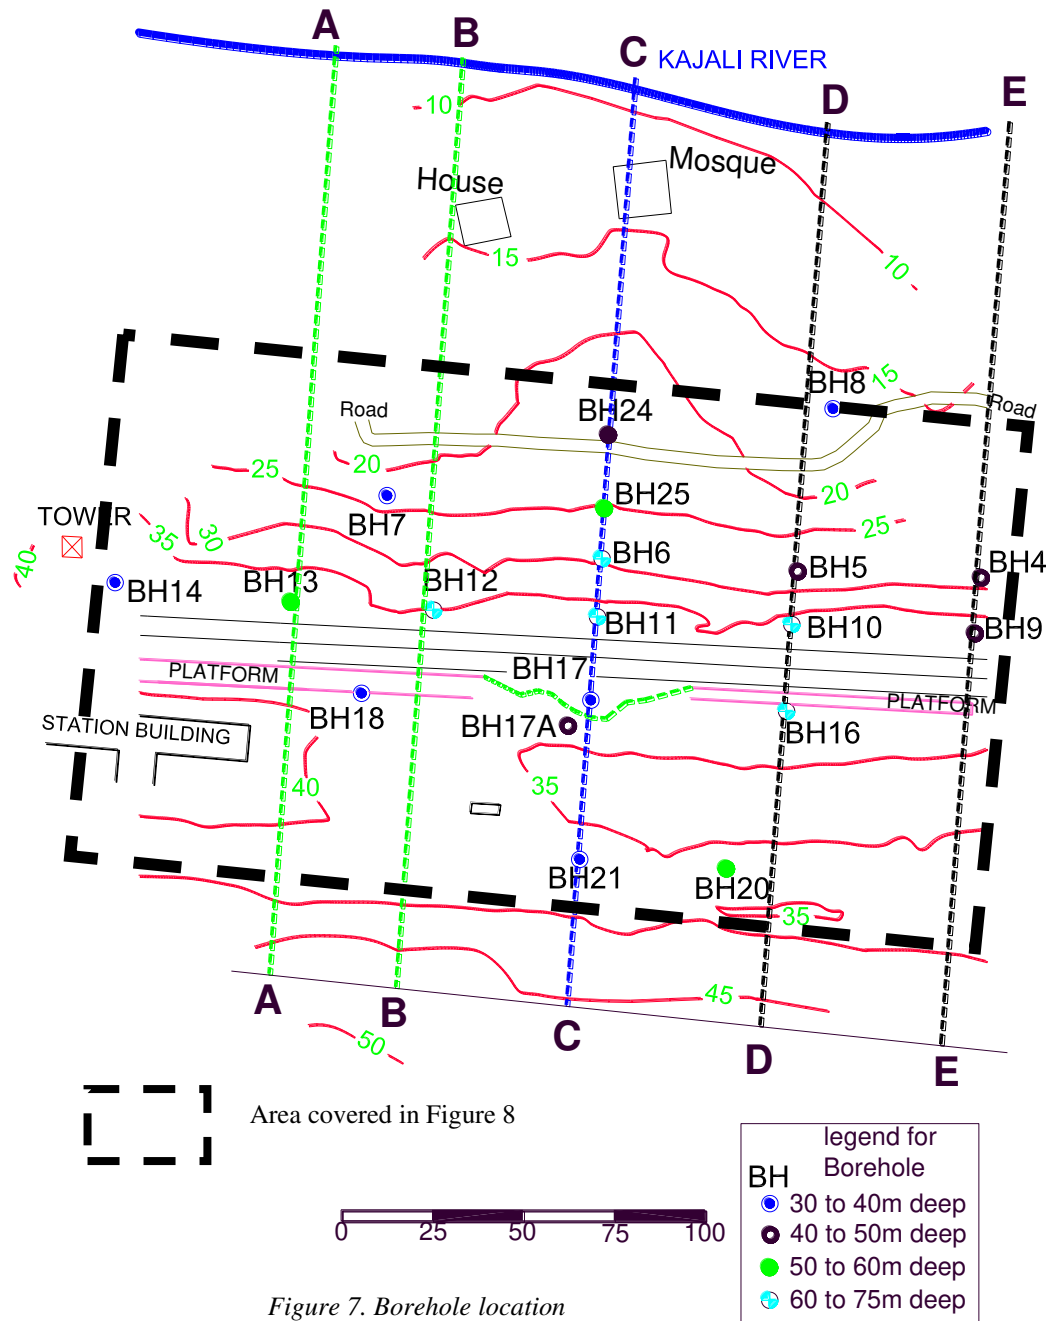
Figure 7. Borehole location

Geotechnical data was collected from 19 boreholes drilled at the top and bottom of the embankment. These boreholes were drilled in the year 2010. Figure 7 shows the location of the boreholes. All boreholes, except for BH-20 and BH-21, were

drilled at the location of the failure. These two boreholes were located near the new alignment. Boreholes BH17 and 17A were drilled adjacent to the vertex of the failure surface; while care was taken to drill all other boreholes through the undisturbed zone. Many boreholes were of 50m depth. However, some boreholes were drilled deeper to over 60m depth at locations where the rock mass was highly fractured. Table 3 summarises the thicknesses of the soil and rock layers in each borehole. Using the data presented in the table, the 3-dimensional cross-section of the subsurface profile shown in Figure 8 was developed. A brief description of the layers in this profile is presented below. This description follows the order in which the layers were encountered in the boreholes.
