Embankment Failure in Residual Soils at Nivsar, Ratnagiri

ABSTRACT: *The Nivsar Yard embankment was constructed by the Konkan Railways in 1994. Near the station building, the 22m high embankment runs parallel to the Kajali River for a stretch of about 100m. This stretch has experienced failure and settlement related problems since the record-breaking July 2005 rainfall. Corrective ground improvement measures were implemented immediately after the monsoon. However, these measures were inadequate because the failure surface reappeared during the following monsoon. The failure surface mirrored the shape and size of the failure observed in 2005. Since then after nearly every monsoon, the embankment has moved despite precautionary measures taken by the railway to arrest the movement. The hydrogeological and geotechnical properties which affect slope stability are first discussed. The stability of the embankment is then evaluated at 5 sections drawn along the slope. Two cases are considered. In the first case, the stability of the unreinforced slope is calculated. In the second case, calculations are done using the slope reinforced with soil nails and micropiles installed in 2005 and 20

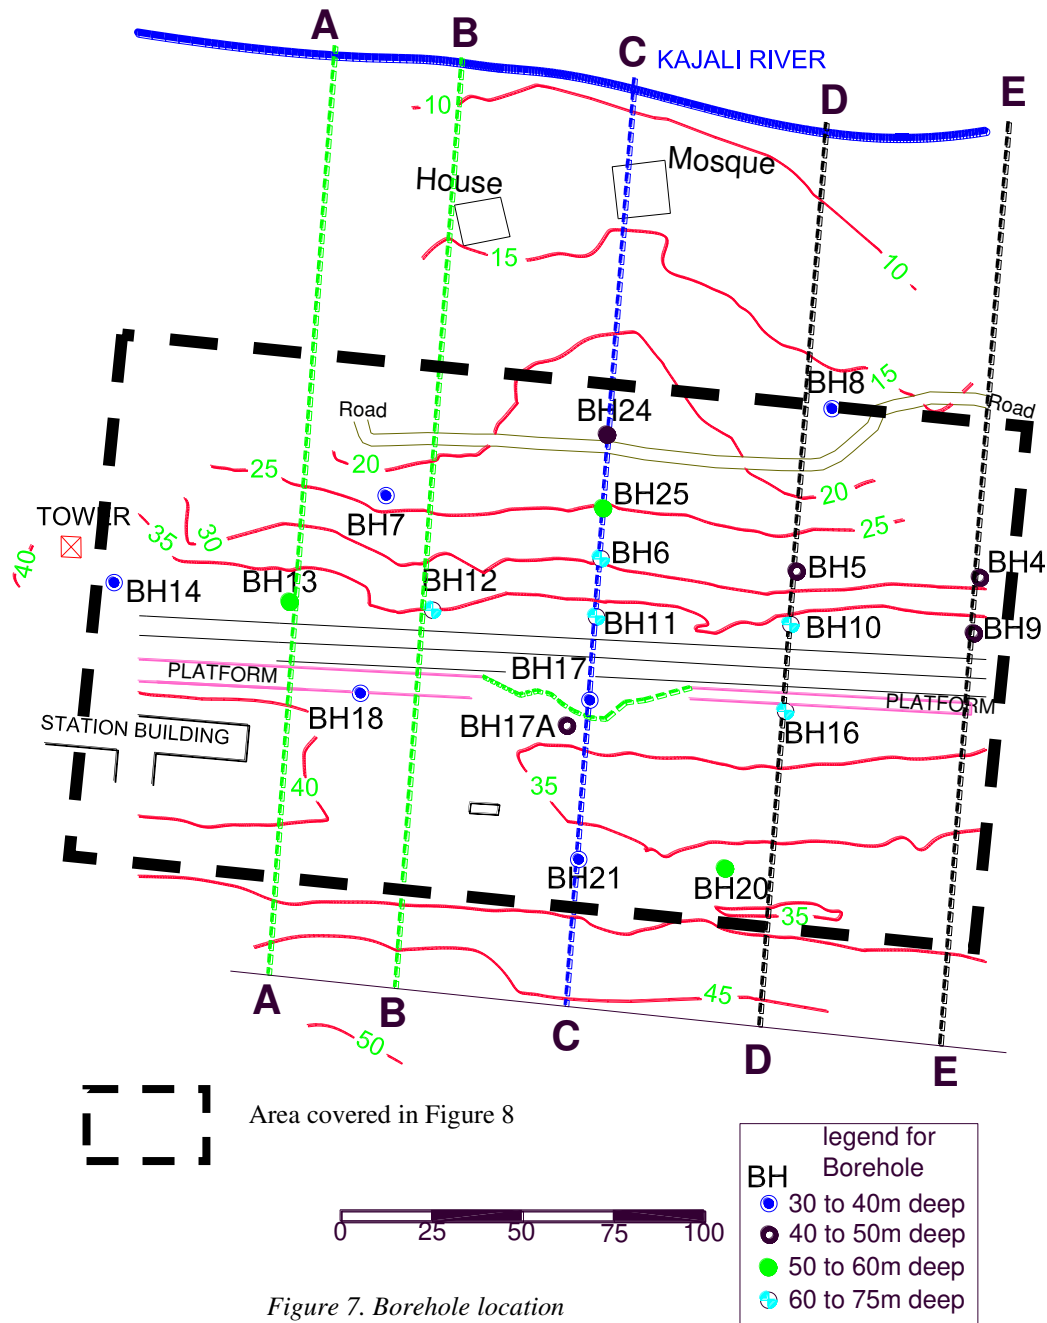
Figure 7. Borehole location

Geotechnical data was collected from 19 boreholes drilled at the top and bottom of the embankment. These boreholes were drilled in the year 2010. Figure 7 shows the location of the boreholes. All boreholes, except for BH-20 and BH-21, were

drilled at the location of the failure. These two boreholes were located near the new alignment. Boreholes BH17 and 17A were drilled adjacent to the vertex of the failure surface; while care was taken to drill all other boreholes through the undisturbed zone. Many boreholes were of 50m depth. However, some boreholes were drilled deeper to over 60m depth at locations where the rock mass was highly fractured. Table 3 summarises the thicknesses of the soil and rock layers in each borehole. Using the data presented in the table, the 3-dimensional cross-section of the subsurface profile shown in Figure 8 was developed. A brief description of the layers in this profile is presented below. This description follows the order in which the layers were encountered in the boreholes.

Using the borehole data, five cross-sections were drawn to interpret the subsurface profile of the site. The five sections are marked as A-A to E-E in Figure 7 and are shown in Figure 9. Sections B-B to D-D were chosen to represent the edges and centre of the failure zone. Laterites were nearly absent in section A-A and had the maximum presence in section D-D. The average geotechnical properties at each section are shown in Table 4. The material properties in Table 4 were obtained from the field and laboratory testing programme monitored jointly by Konkan Railways and IIT Bombay. Direct shear tests were conducted to obtain c' and ϕ' . Unconsolidated undrained (UU) triaxial tests were conducted to obtain c_u . The secant Young's modulus, E , of selected samples was obtained from stress-strain curves on UU samples confined with 50 to 200 kN/m² mean stress. Unconfined compression tests were conducted to obtain the c_u of laterites and basalt.

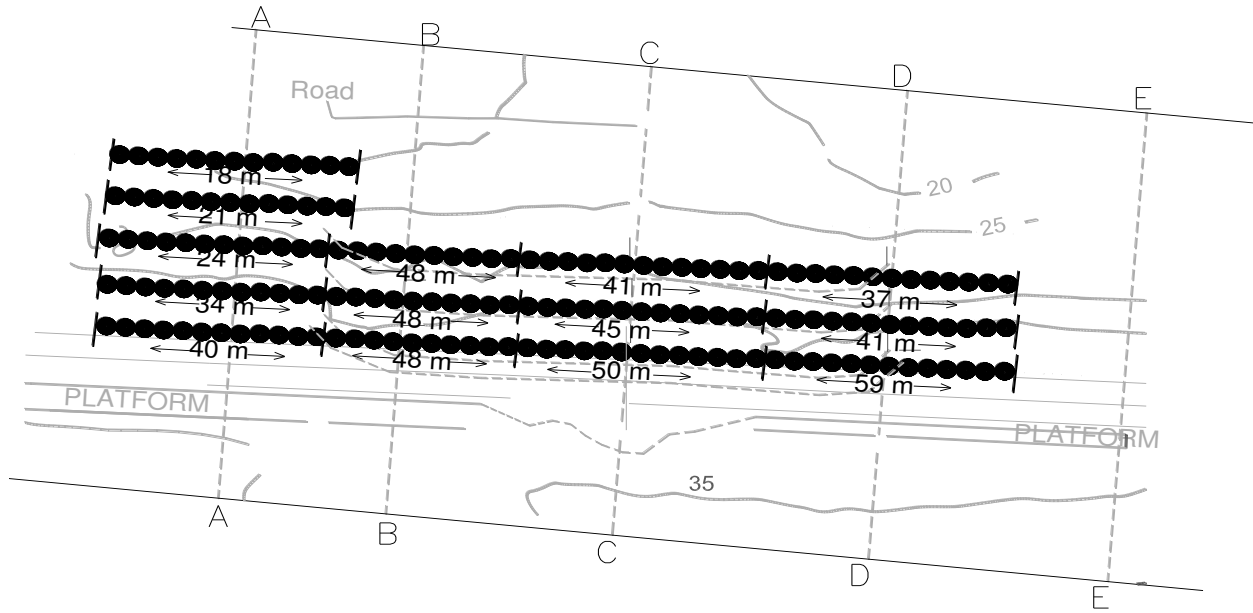
Figure 16. Schematic layout of the proposed 1.2m diameter bored pile wall at 1.2m c/c (contiguous bored pile wall). Note: Numbers below the piles indicate length of the piles.

One possible solution to enhance the stability of the slope was with the use of large diameter piles to retain the (failed) soil mass. In this case, safety factors of sections A-A to E-E were also deduced by assuming that the slope was reinforced with single or multiple rows of contiguous bored pile wall constructed parallel to the platform. Figure 16 shows the schematic layout of the proposed bored pile wall. The 1.2m diameter piles terminated below the slightly-to-moderately weathered basalt rock because of which sections B-B and C-C had long piles to provide adequate anchorage (Table 3). Table 9 shows the location and length of the piles used in the analysis. Figures 17a-d show the minimum safety factor and the location of critical circles in sections A-A to D-D for the wet season when the slope is reinforced with contiguous bored pile wall. As can be seen, the minimum safety factor increased up to 1.2 and 1.38 with the use of contiguous bored pile wall.
