Embankment Failure in Residual Soils at Nivsar, Ratnagiri

ABSTRACT: *The Nivsar Yard embankment was constructed by the Konkan Railways in 1994. Near the station building, the 22m high embankment runs parallel to the Kajali River for a stretch of about 100m. This stretch has experienced failure and settlement related problems since the record-breaking July 2005 rainfall. Corrective ground improvement measures were implemented immediately after the monsoon. However, these measures were inadequate because the failure surface reappeared during the following monsoon. The failure surface mirrored the shape and size of the failure observed in 2005. Since then after nearly every monsoon, the embankment has moved despite precautionary measures taken by the railway to arrest the movement. The hydrogeological and geotechnical properties which affect slope stability are first discussed. The stability of the embankment is then evaluated at 5 sections drawn along the slope. Two cases are considered. In the first case, the stability of the unreinforced slope is calculated. In the second case, calculations are done using the slope reinforced with soil nails and micropiles installed in 2005 and 20

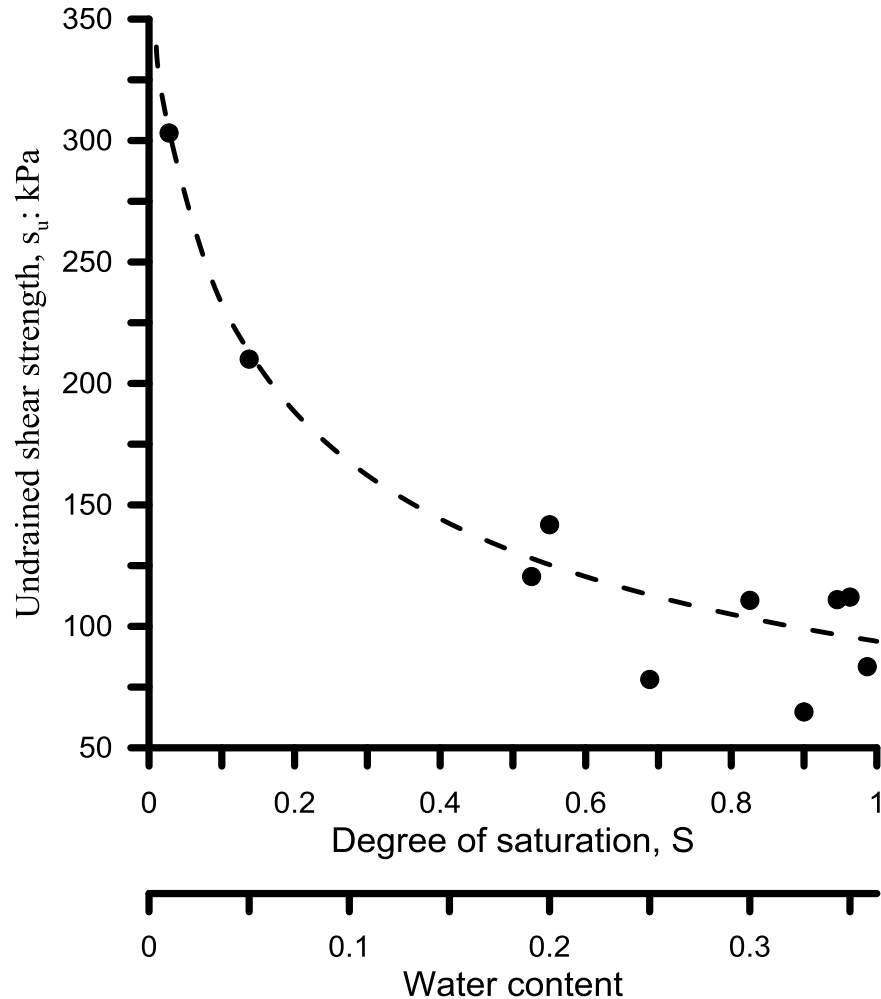
The above slope stability analysis only permits the estimation of the safety factor using the effective (or drained) shear strength parameters. It does not account for the change in strength of the soil due to the change in the degree of saturation as the rainwater percolates. An experimental programme was therefore designed to also study the effect of the change in the degree of saturation on the strength of the residual soils. A series of routine UU-triaxial shear tests were conducted on remoulded and reconstituted samples at 100 to 200 kN/m² cell pressure. The samples were compacted at constant void ratios but different degree of saturation. The dry unit weight of all the samples was within the range of 13.5 to 14 kN/m³. The tests were carefully conducted to avoid any change in water content during the testing procedure. However, it must be noted that since most of the samples were partially saturated, the tests were not truly undrained. There was no arrangement to measure the pore pressure suction because its effect was considered to be insignificant in view of the short duration of the test (Vanapalli et al. 1999). Figure 13 shows the variation of the undrained shear strength, s_u with the degree of saturation, S . Despite the scatter of the data points, the results appear to suggest that the water content has significant influence on the strength of residual soils. For instance, the figure shows that an increase in S from 0.1 to 1 caused s_u to decrease by over 100%. Notwithstanding the above, the results also permit a semi-empirical relationship to be fitted to the data:

Figure 13. Variation of undrained shear strength, with degree of saturation at constant void ratio/dry density.
