The July 10 2000 Payatas Landfill Slope Failure

ABSTRACT: *This paper presents an investigation of the slope failure in the Payatas landfill in Quezon City, Philippines. This failure, which killed at least 330 persons, occurred July 10th 2000 after two weeks of heavy rain from two typhoons. Slope stability analyses indicate that the raised leachate level, existence of landfill gas created by natural aerobic and anaerobic degradation, and a significantly over-steepened slope contributed to the slope failure. The Hydrologic Evaluation of Landfill Performance (HELP) model was used to predict the location of the leachate level in the waste at the time of the slope failure for analysis purposes. This paper presents a description of the geological and environmental conditions, identification of the critical failure surface, and slope stability analyses to better understand the failure and present recommendations for other landfills in tropical areas. In addition, this case history is used to evaluate uncertainty in parameters used in back-analysis of a landfill slope failure.*

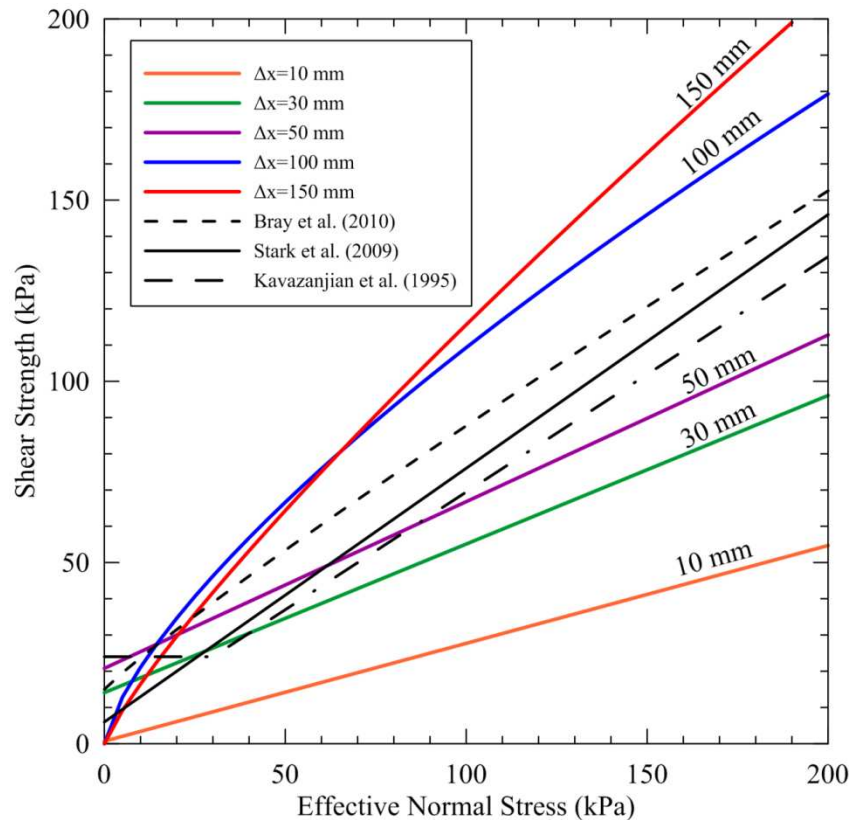
In addition to being dependent on the effective normal stress on the failure plane, the shear strength of MSW is also shear displacement or axial strain dependent and tends to increase with increasing deformation (Eid et al., 2000). Review of existing laboratory data show that most of the laboratory shear tests investigated are not continued to sufficient displacement or strain to mobilize the peak shear strength of the MSW. As a result, Stark et al. (2009) provide MSW shear strength envelopes mobilized at horizontal displacements of 10, 30, 50, 100, and 150 mm. Table 3 shows equations for each strength envelope estimated from direct shear tests, where R^2 values are all above 0.90. Figure 10 compares the shear strength envelopes in Table 2 to envelopes recommended by others (e.g., Stark et al., 2009; Bray et al., 2009; Kavazanjian et al., 1995). As highlighted in Figure 10, all of the recommended envelopes fall between the 50 and 100 mm of shear displacement strength envelopes.

Figure 10. MSW shear strength envelopes.

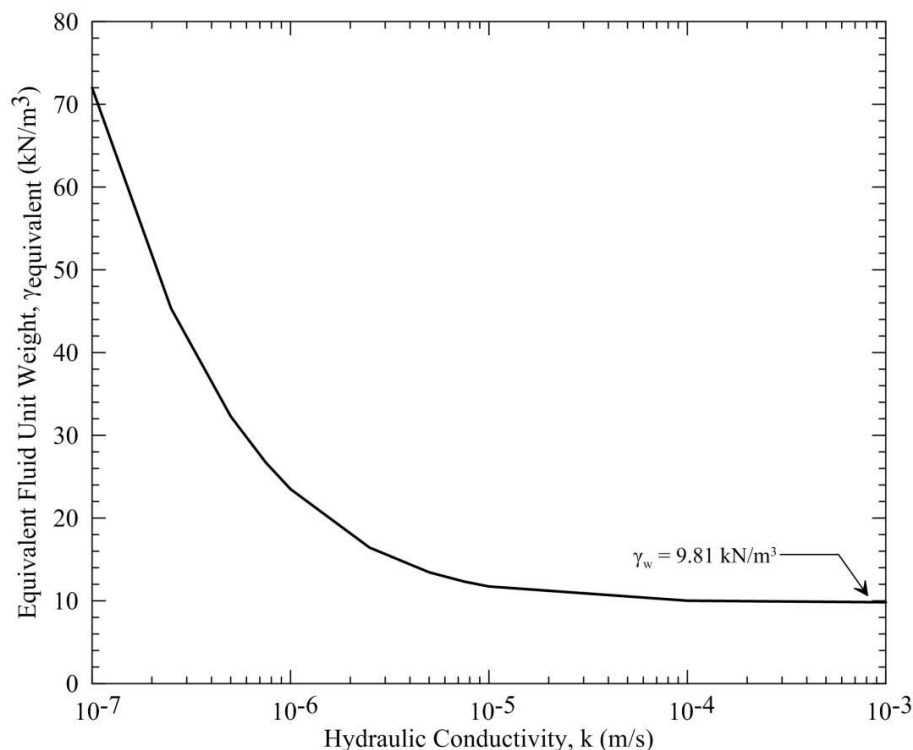
It is hypothesized that landfill gas and leachate pressure reduced the effective stress along the failure surface. Landfill gas, which is dominated by methane and carbon dioxide, is formed as a natural part of anaerobic degradation. In landfills that are sufficiently dry, landfill gas migrates readily through the pore space and is released into the atmosphere with little build-up of pressure in the waste. However, as saturation levels in the waste rise, the permeability of the waste to landfill gas migration decreases. Merry et al. (2006) use a one-dimensional (1-D) column of saturated media where degradable waste exists only in the lowest portion of the column to model this situation. This model shows that below the level of saturation, the steady-state excess gas pressure increases linearly similar to a hydrostatic condition. The combination of hydrostatic leachate pressure and gas-induced pore pressure may be accounted for using an equivalent fluid unit weight for the pore fluid that is artificially higher than water. A subsequent parametric study of the input parameters shows that the equivalent fluid unit weight of the pore fluid is dependent on waste hydraulic conductivity (Merry et al., 2006). The corresponding MSW hydraulic conductivity for this case is assumed to be greater than 1×10^{-5} m/s. Figure 12 shows the relationship between waste hydraulic conductivity and equivalent fluid unit weight of the pore fluid and is used to estimate an equivalent fluid unit weight. The input parameters for Figure 12 are provided in Table 5. The gas generation rate (Q_t) is estimated by Eq. (1):

Figure 12. Dependence of equivalent fluid unit weight, $\gamma_{equivalent}$, on MSW saturated hydraulic conductivity, $K_{waste,sat}$
