Preliminary Field Assessment of Sinkhole Damage in Pokhara, Nepal

ABSTRACT: Since November 2013, numerous sinkholes have been forming in the Armala area of Pokhara Valley, Central Nepal, posing serious threat to local residents. In order to provide measures aimed at reducing sinkhole risk, investigations into the cause and features of the sinkholes are crucial. This paper presents early research results based on two damage surveys conducted in June 2014 and November 2014 in the Armala area. Comparison of photos, taken in the two surveys, clearly indicates not only the formation of new sinkholes, but also the re-activation of filled sinkholes. By means of dynamic cone penetration tests and surface wave method investigations, qualitative characterization of the soil profile was attained, and shallow weak soil layers which are believed to be the location for future sinkholes could be identified. On the basis of the field investigation results, possible sinkhole formation mechanisms are identified for the Armala area. Furthermore, results of a reconnaissance survey conducted in the Armala area in early May 2015 (following the 2015 Gorkha Nepal Earthquake, which occurred on April 25th)

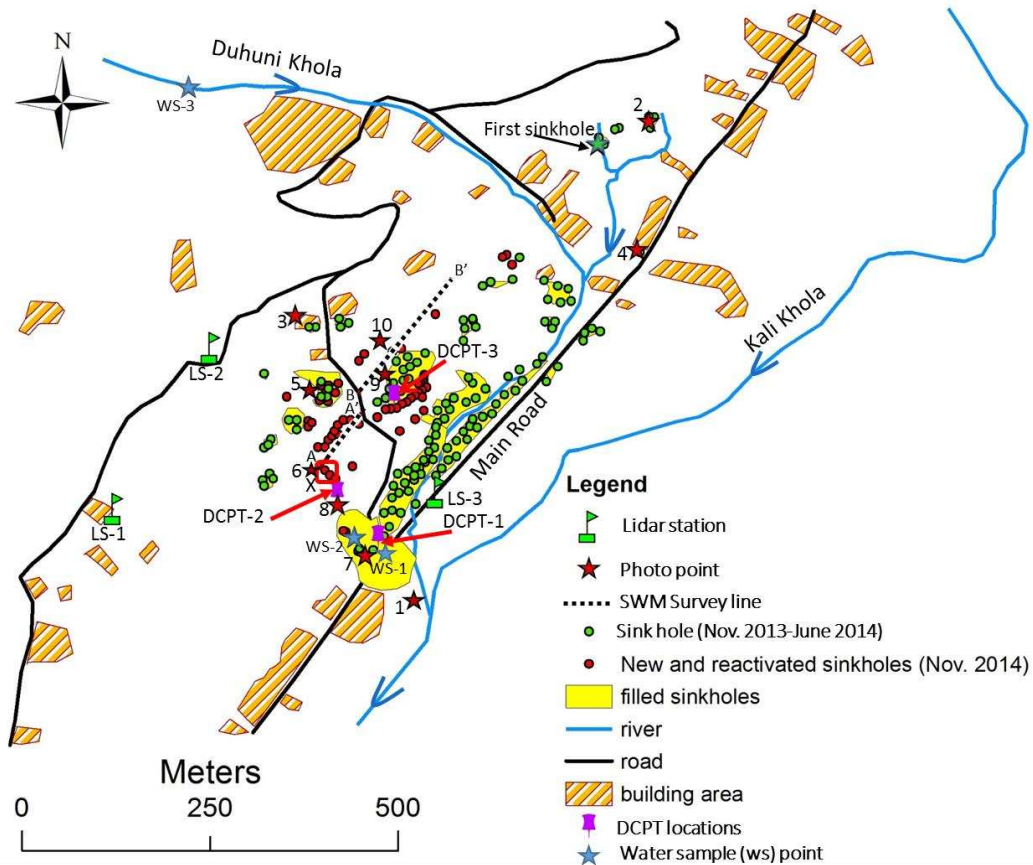
Figure 2. Detailed map of the sinkhole damaged area in Armala.

A detailed map of the study area reporting the location of sinkholes observed in June and November 2014, photo points and field investigations are shown in Figure 2. Topographically, the study area is a low-elevated zone as shown by the bird's eye view presented in Figure 3. This 3D image was obtained by overlapping LiDAR scanning carried out at three different locations (i.e. LS-1, LS-2 and LS-3 reported in Figure 2). There is a very gentle slope in the south-east direction, while a steep slope can be noticed in the north-west part. The black zones enclosed within circles are interconnected sinkholes as observed in November 2014.

During the June 2014 survey, the trace of a number of sinkholes previously formed since November 2013 could be typically observed in both sides of the Duhuni Khola (green dots in Figure 2). All the sinkholes were completely back filled, except for the sinkholes at photo points 7 and 8 (see also Figures 10 and 11). Originally, they had a diameter of about 10m and a depth of about 7 m. However, at the time of the survey, the upper part was already partially filled by sediments, and the measured depth was less than 4 m.

During the November 2014 survey, a number of sinkholes of recent formation (known to have formed in August 2014) were mostly observed in the west side of the surveyed area. In the map shown in Figure 2, it can be seen that the new sinkholes (shown as red dots) are concentrated on the western side of the old sinkholes. Some of the new sinkholes may be old sinkholes re-activated during the rainy season in 2014.

Immediately after the occurrence of the sinkholes, a wide area affected by the cave-in was backfilled by using gravelly soil retrieved from nearby quarries, which is identified by a yellow color filled area in Figure 2. Though, at the time of the first damage survey in June 2014, most of the sinkholes had been fully backfilled (Figure 7a corresponding to photo point 5), the photos taken in November 2014 at the same location clearly show that the backfilling was not an adequate solution as most of the former sinkholes were re-activated (Figure 7b) likely in August 2014 during the peak rainy season in Pokhara Valley.
