The May 25th 2011 Railroad Embankment Failure in Ann Arbor, Michigan, As a Means for Teaching Geotechnical Engineering

ABSTRACT: A 30-m long railroad embankment failure that occurred on May 25 2011 in the city of Ann Arbor, Michigan, is presented. Emphasis is given on the field observations of the failure, the characterization of the site conditions and the seepage and slope stability analyses, all of which represent important components of the training and practice of a geotechnical engineer. The failure occurred following a record wet season that resulted in ponding water against the embankment and high enough water pressures and exit gradients that resulted in instability of the railroad embankment. Detailed background material and the methodology for using the case history in geotechnical engineering education are presented.

International Journal of Geoengineering Case histories, Vol.3, Issue 4, p.234-245. doi: 10.4417/IJGCH-03-04-03

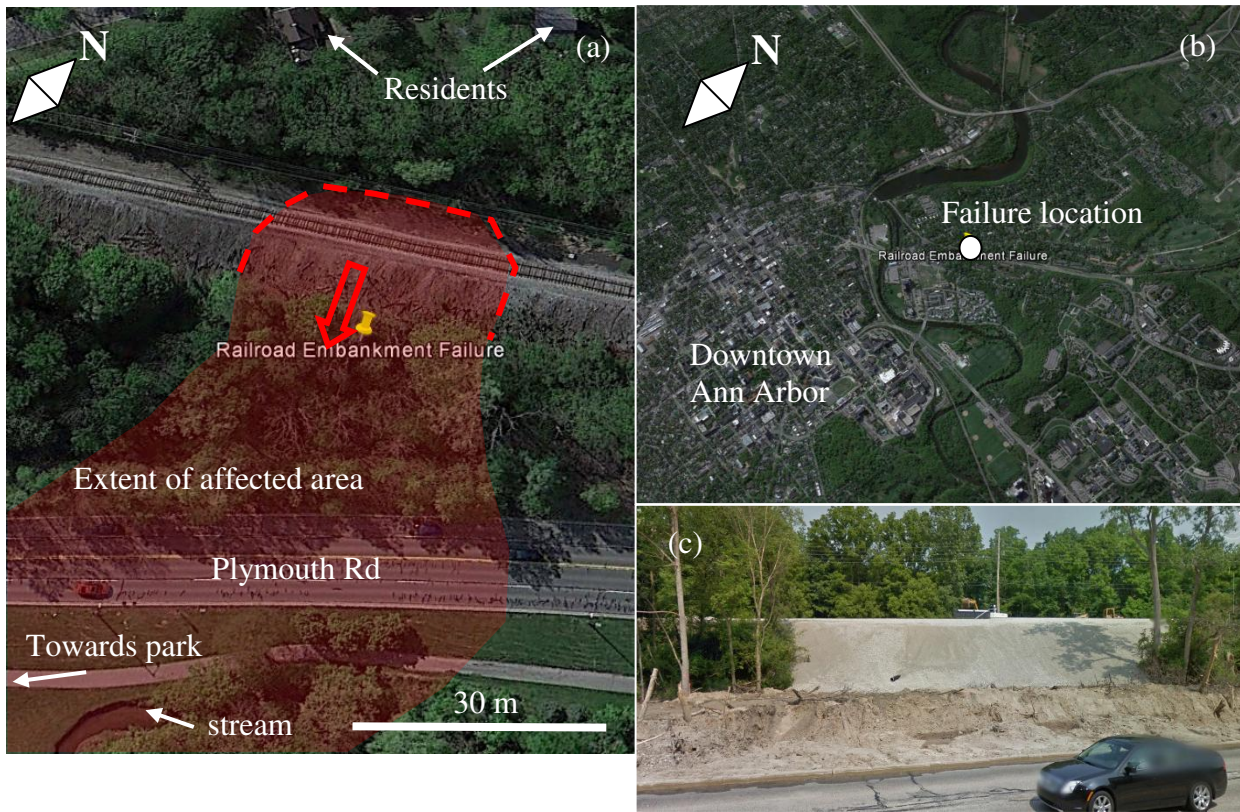
The failure site is located to the north of downtown Ann Arbor in Michigan, USA, as shown in Fig. 2b. The failure took place on the railroad embankment that is heading parallel to Plymouth Rd and adjacent to residential structures. Fig. 3 illustrates an intact portion of the embankment immediately to the East from the failure location. The failure resulted in:

Figure 2. (a) Satellite imagery of the railroad embankment at the failure location; (b) location of the failure; (c) View of the repair works as recorded by coincidence by the Google Earth Camera.
