Remediation of The Pissouri Landslide in Cyprus

Argyris Alexandris, Archirodon NV, Athens, Greece, (form. OTM SA); email: a.alexandris@archirodon.net,
Irini Katsipi Griva, OTM SA, Athens, Greece; email: otmate@otenet.gr
Maria Abarioti, OTM SA, Athens, Greece; email: otmate@otenet.gr

Pissouri Landslide in Cyprus. International Journal of Geotechnical Engineering Case histories, Vol.4, Issue 1, p.14-28. doi: 10.4417/IJGCH-04-01-02

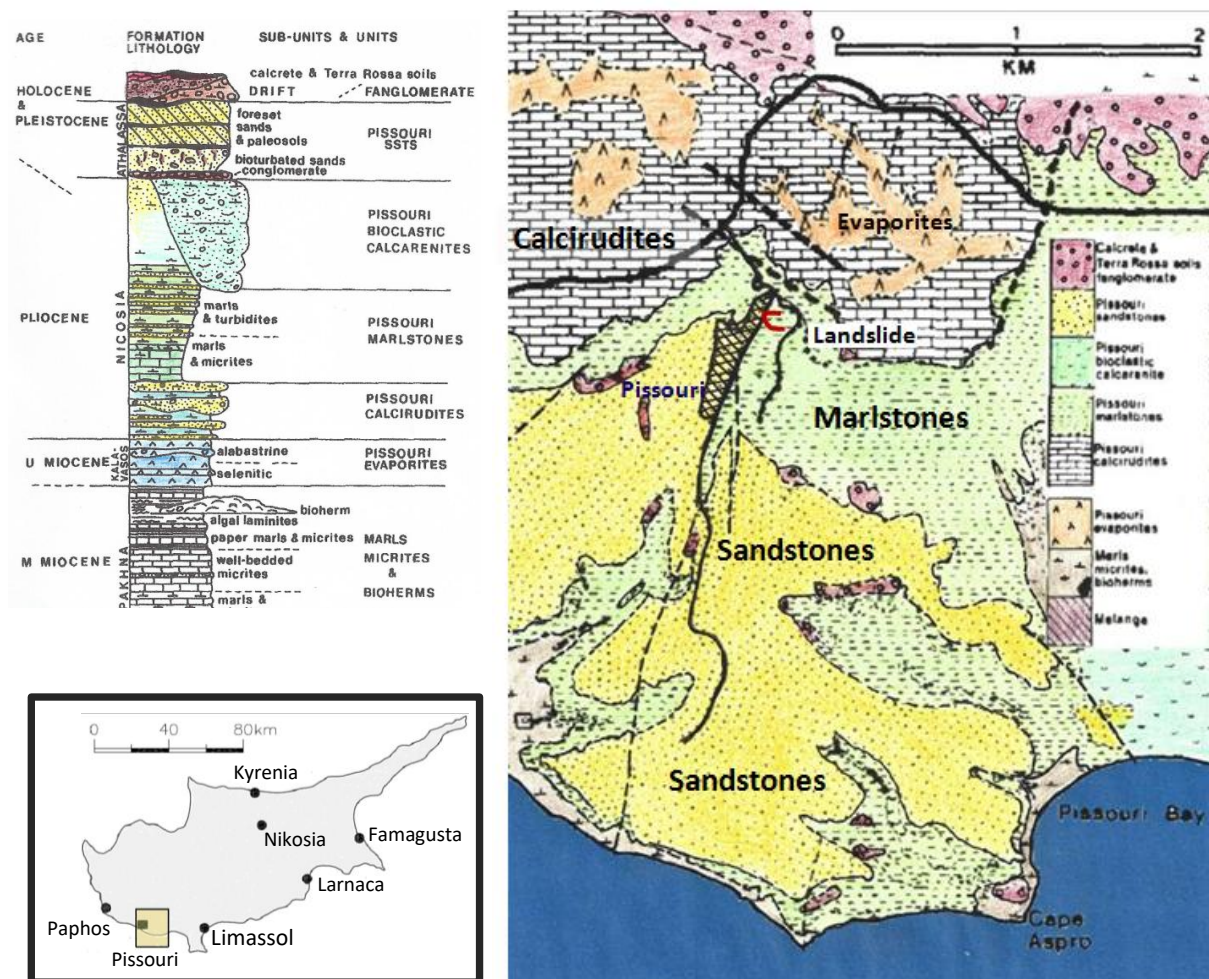
reddish - brown rock which in places disintegrates into a compound of marl blocks within a matrix of stiff fissured silty/clayey soil. The regional distribution of the aforementioned sedimentary units is depicted in Figure 3 (after Stow et al., 1995). The location of the landslide is also noted on the map.

Figure 3. Regional Geology of the Pissouri area. The village is developed on sandstones (yellow) underlain by the Pissouri marls (olive green). Geology after Stow et al., (1995)

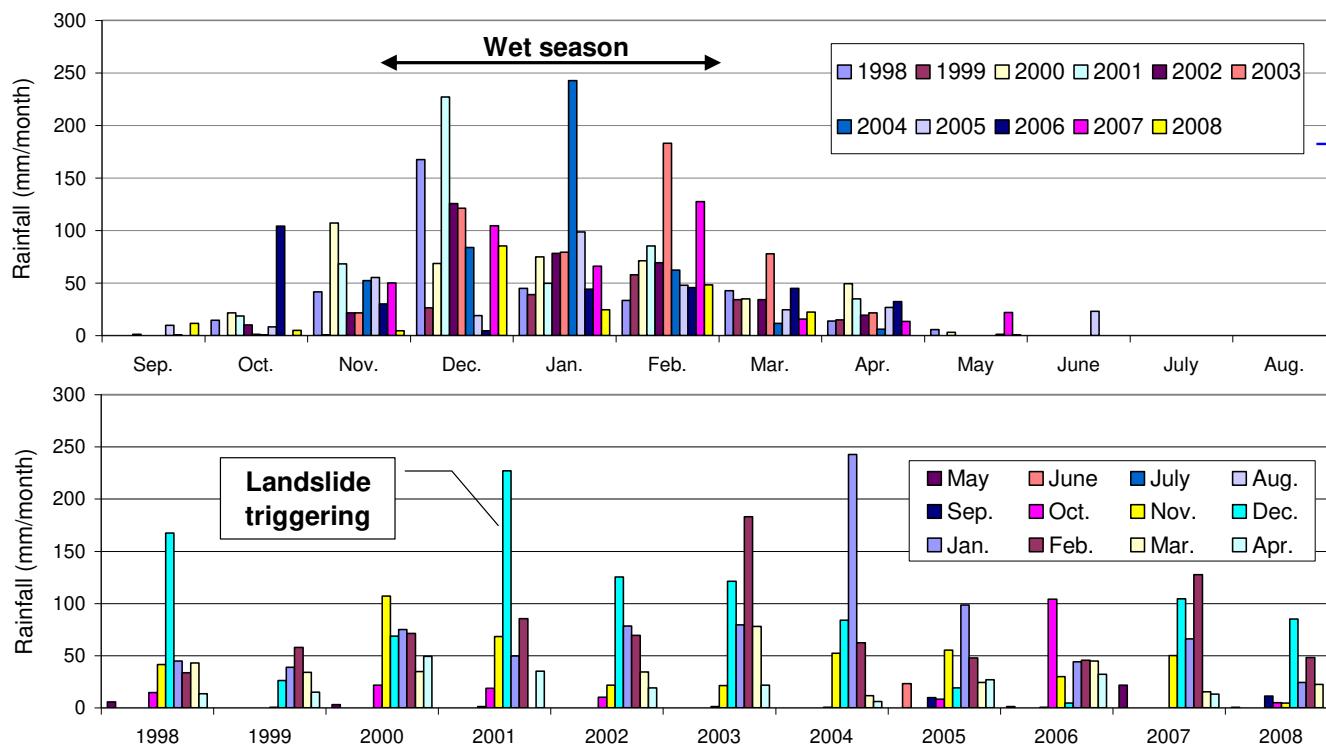
In the Limassol prefecture in particular, the annual precipitation is low, averaging 300-400 mm per year. The monthly rainfall time series retrieved by the Pissouri meteorological station during the 1998-2008 decade is presented in Figure 4. It is observed that during the December of 2001, when the Pissouri landslide was mobilized, precipitation was indeed high, exceeding 230 mm, but not a unique event in the decade. High precipitation undoubtedly triggered the landslide, but the contribution of other factors to slope instability should also be investigated. The high precipitation of December 2001 is associated with subsequent landslide events that took place in other parts of the island, as reported by Hadjigeorgiou et al., (2006) and Kyriakou & Hadjigeorgiou (2008).

Figure 4 Seasonal (upper figure) and annual (lower figure) distribution of monthly precipitation for the decade 1998 ~ 2008. Data from the "Pissouri" meteorological station.

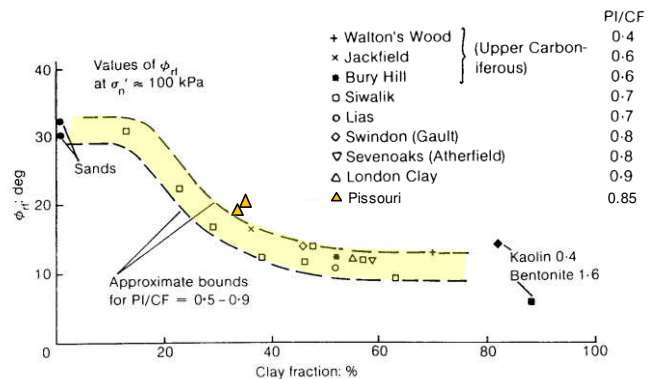
The shear strength parameters of the weathered marl, where the slip surface eventually developed, was investigated in the laboratory by means of a few slow (drained) shear box tests, which averaged to $c'=30$ kPa and $\phi'=21^\circ$ as shown in figure 7. Residual shear strength parameters, were obtained from ring shear tests (Broamhead ring shear apparatus) which yielded values of $c_r'=0$ and $\phi_r'=21^\circ$. The values of the residual angle of shearing resistance determined directly by the ring shear tests are compared with the dataset presented by Skempton (1985) (Figure 8) and are found to be in the upper bound of the scatter. This is probably due to the fact that the particular ring shear tests were carried out on fairly silty samples (classified as MH) and not on clayey ones.

Figure 8. A comparison of the residual angle of shearing resistance of the weathered Pissouri marl with the dataset presented by Skempton (1985).

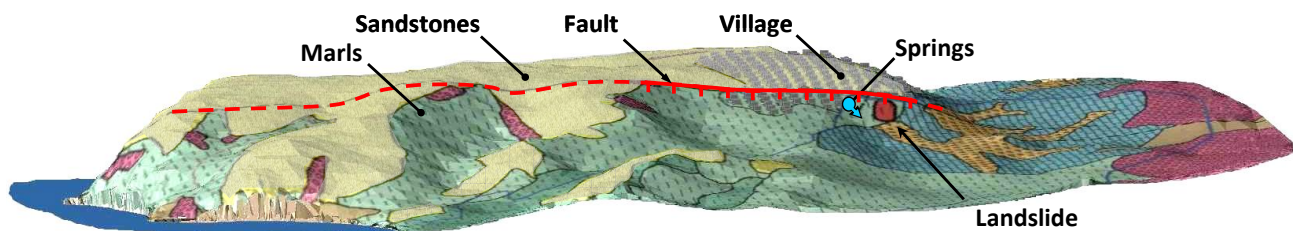
A field survey of the broader landslide area, led to the location of a number of natural springs and a few manmade wells, as well the mapping of distinct stratigraphic and tectonic features. The hydrogeologic regime was further studied by projecting the geological units presented in Figure 3 on a digital elevation model of the broader Pissouri area. Figure 9 presents the outcome of this exercise. The vertical scale of the ground relief is stretched (H/V 2:1) to better depict the interplay of surface drainage patterns and geological structure. From the figure it becomes evident that the more permeable capping sandstones of the Pissouri hilltop comprise the main aquifer of the area. A few wells sunk in the top hill area have been exploited constantly in the past by the villagers and provided the main source of water for the settlement. A study of the drainage pattern indicate that surface water flows in low gradients towards the southeastern edge of the village (Figure 10) and infiltrates the capping sandstone stratum, during the wet season, recharging the aquifer. Subsequently, groundwater seeps towards the slopes surrounding the hill and overflows at specific locations of the contact between the more permeable

Figure 9. Hydrogeologic setting of the Pissouri area. Geological units (after Stow et al., 1995) are projected on the distorted relief of the Pissouri hill (exaggerated vertical scale H/V 2:1). Location of the landslide and the springs with respect to the major hydrogeologic units are also noted.

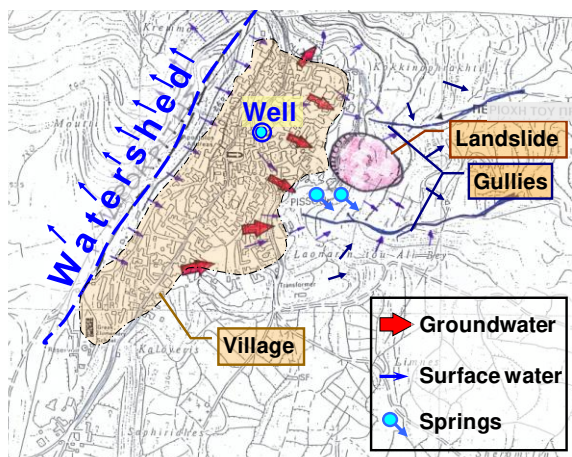
sandstones with the impermeable underlying marls, as shown schematically in Figure 10. A few seasonally discharging springs and water collecting wells have been located at the southeastern edge of the hill, near the landslide site (see Figure 11), which are exploited by local farmers for irrigation. A probable fault trending NNE-SSW, mapped by Stow et al. (1995), is running parallel to the eastern boundary of the village and dissects the sandstone layer. This fault is believed to control the steeper slopes of the Eastern side of the hill and is probably associated with the presence of the water springs down slope.

Figure 10. Surface and subsurface drainage patterns. Arrows indicate surface and subsurface water flow. Springs and wells are also noted.

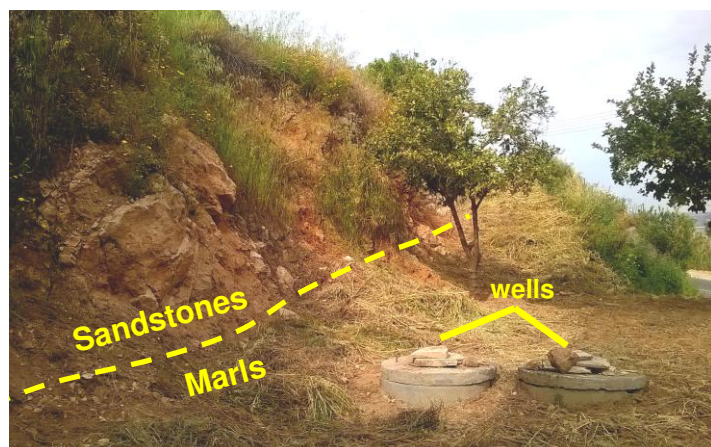
Figure 11. Wells collecting groundwater springing out freely in the sandstone-marl contact area were located a few hundred meters south of the landslide area.

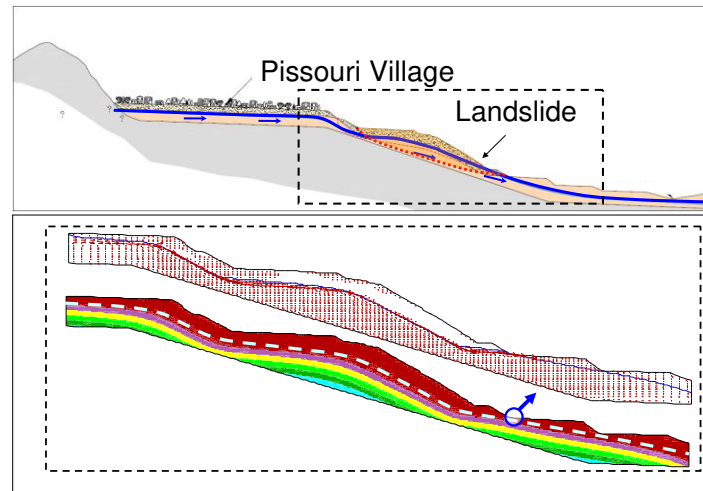
Groundwater flow and pore pressure distribution within the sliding mass was further studied, by analysing simple two dimensional numerical models, which were set up by the finite difference code FLAC. Inflow-outflow equilibrium considerations, in conjunction with the seepage analysis, performed by FLAC, provided an additional means to study and verify the water infiltration, movement and outflow pattern in the landslide area. A typical seepage model representing the eastern slope of the village, is illustrated in Figure 12. The piezometric lines have been computed on a number of transverse and longitudinal sections and were used to build the three-dimensional model presented in Figure 13. The inferred piezometric surface is found at shallow depths, in areas where vegetation growth is more intense, as observed in aerial

Figure 12. Typical results of the seepage analysis (flow vectors and pore water pressures).
