Remediation of The Pissouri Landslide in Cyprus

ABSTRACT: During the winter of 2001-2002, a landslide of 80.000 m³ was activated and moved downslope at the Northeast outskirts of the Pissouri village in Cyprus (Limassol prefecture), displacing a section of a country road that was crossing the upper part of the sliding mass and destroying three newly built residences. This paper presents the geologic and hydrogeologic regime of the landslide and its implication on the landslide's mobilization. Geotechnical site investigation and post failure monitoring, in conjunction with slope stability back analysis formed the basis for the study of the slide and subsequently guided the remediation strategy. Various possible interventions to stabilize the slope and allow the safe reconstruction of the displaced road have been investigated and compared considering both economic and environmental criteria. The performance of the remediation measures has been studied in terms of stability safety, using numerical models previously calibrated via back analyses. Observations made during the execution of the stabilization works provided additional data verifying and supplementing the original design.

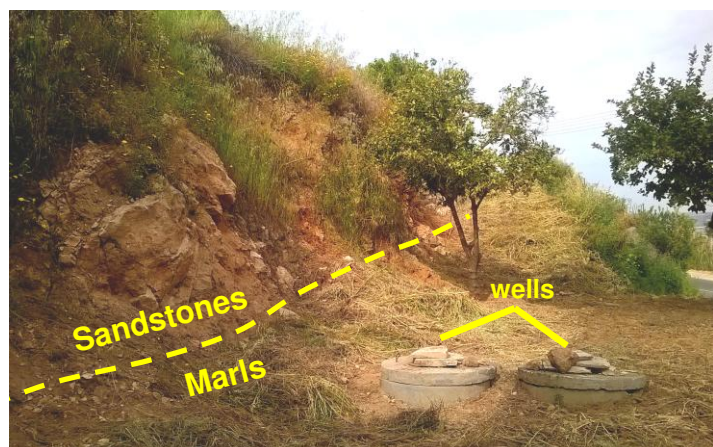
sandstones with the impermeable underlying marls, as shown schematically in Figure 10. A few seasonally discharging springs and water collecting wells have been located at the southeastern edge of the hill, near the landslide site (see Figure 11), which are exploited by local farmers for irrigation. A probable fault trending NNE-SSW, mapped by Stow et al. (1995), is running parallel to the eastern boundary of the village and dissects the sandstone layer. This fault is believed to control the steeper slopes of the Eastern side of the hill and is probably associated with the presence of the water springs down slope.

Figure 11. Wells collecting groundwater springing out freely in the sandstone-marl contact area were located a few hundred meters south of the landslide area.
