Remediation of The Pissouri Landslide in Cyprus

Argyris Alexandris, Archirodon NV, Athens, Greece, (form. OTM SA); email: a.alexandris@archirodon.net,
Irini Katsipi Griva, OTM SA, Athens, Greece; email: otmate@otenet.gr
Maria Abarioti, OTM SA, Athens, Greece; email: otmate@otenet.gr

ABSTRACT: During the winter of 2001-2002, a landslide of 80.000 m³ was activated and moved downslope at the Northeast outskirts of the Pissouri village in Cyprus (Limassol prefecture), displacing a section of a country road that was crossing the upper part of the sliding mass and destroying three newly built residences. This paper presents the geologic and hydrogeologic regime of the landslide and its implication on the landslide's mobilization. Geotechnical site investigation and post failure monitoring, in conjunction with slope stability back analysis formed the basis for the study of the slide and subsequently guided the remediation strategy. Various possible interventions to stabilize the slope and allow the safe reconstruction of the displaced road have been investigated and compared considering both economic and environmental criteria. The performance of the remediation measures has been studie

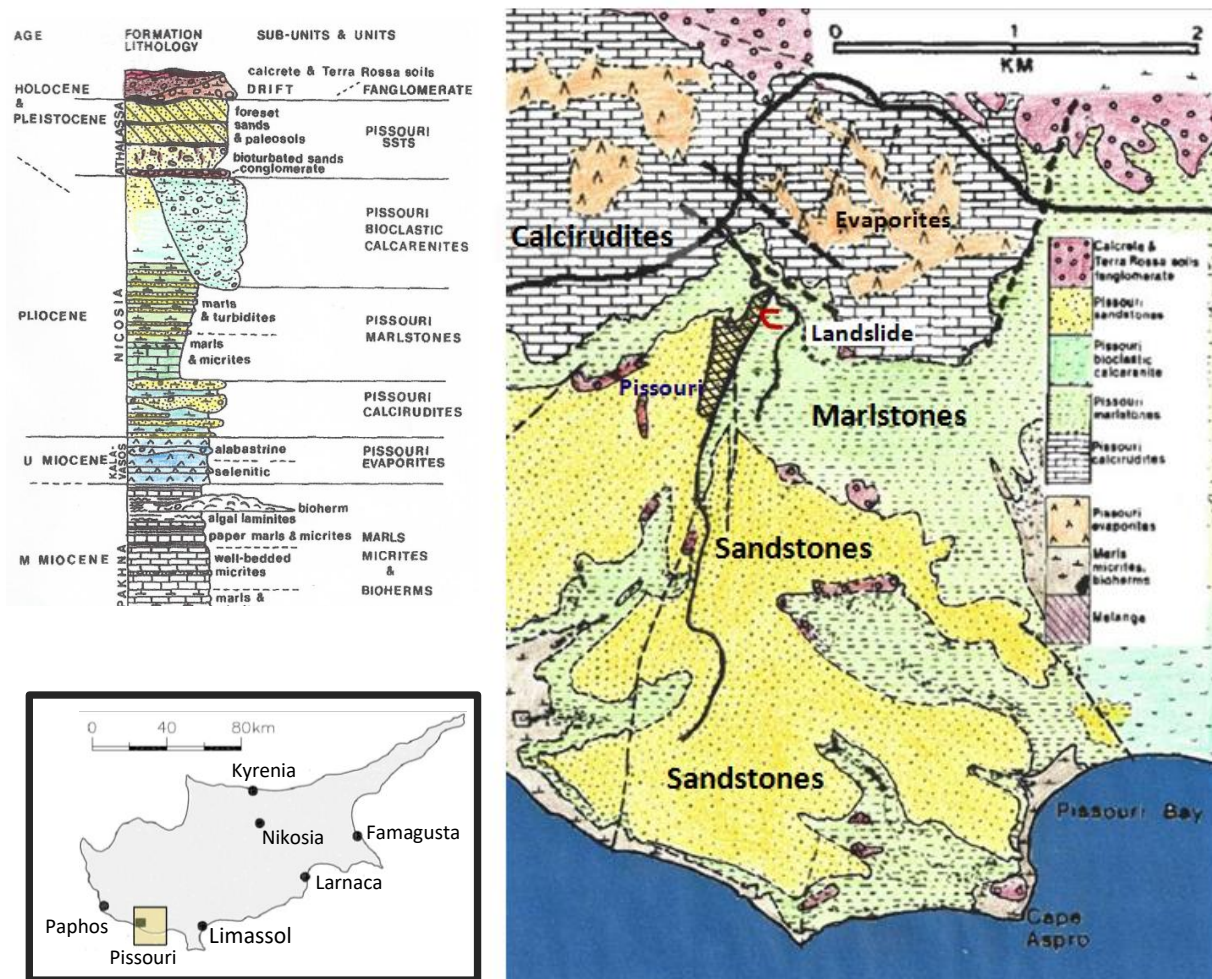
reddish - brown rock which in places disintegrates into a compound of marl blocks within a matrix of stiff fissured silty/clayey soil. The regional distribution of the aforementioned sedimentary units is depicted in Figure 3 (after Stow et al., 1995). The location of the landslide is also noted on the map.

Figure 3. Regional Geology of the Pissouri area. The village is developed on sandstones (yellow) underlain by the Pissouri marls (olive green). Geology after Stow et al., (1995)

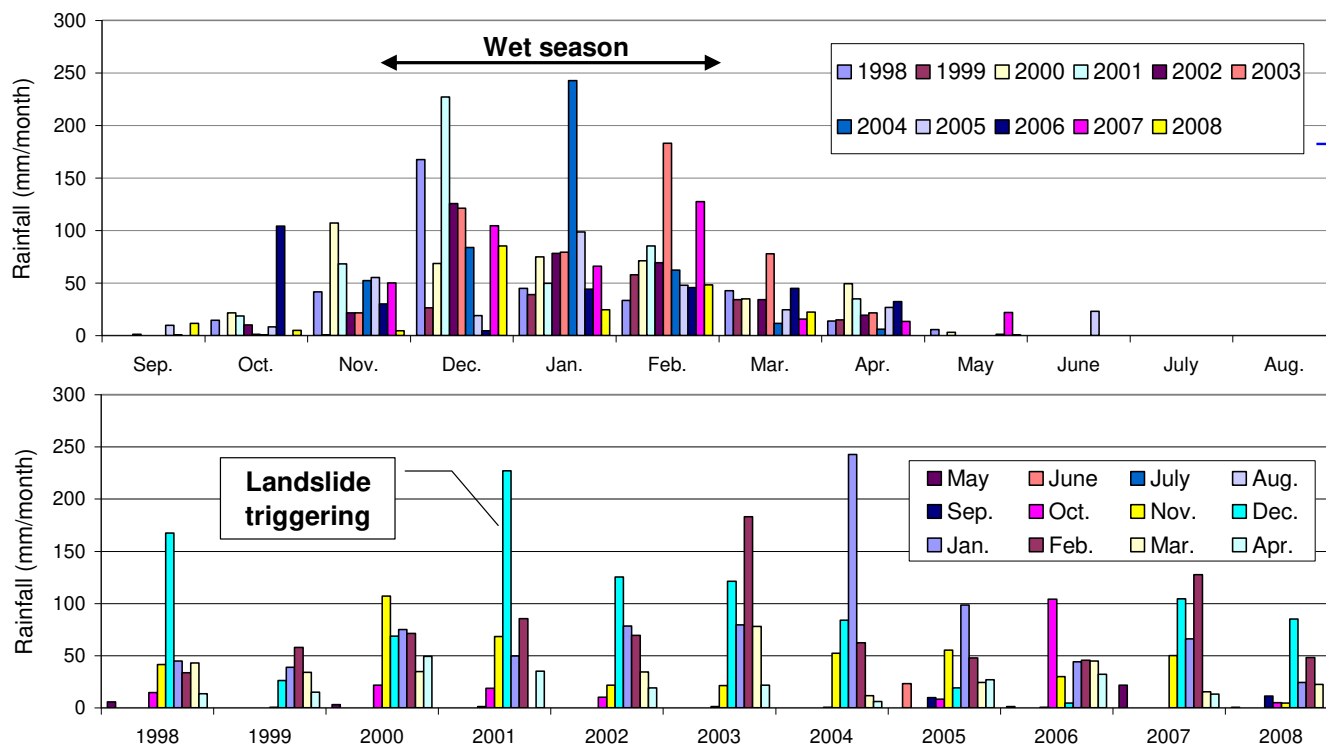
In the Limassol prefecture in particular, the annual precipitation is low, averaging 300-400 mm per year. The monthly rainfall time series retrieved by the Pissouri meteorological station during the 1998-2008 decade is presented in Figure 4. It is observed that during the December of 2001, when the Pissouri landslide was mobilized, precipitation was indeed high, exceeding 230 mm, but not a unique event in the decade. High precipitation undoubtedly triggered the landslide, but the contribution of other factors to slope instability should also be investigated. The high precipitation of December 2001 is associated with subsequent landslide events that took place in other parts of the island, as reported by Hadjigeorgiou et al., (2006) and Kyriakou & Hadjigeorgiou (2008).

Figure 4 Seasonal (upper figure) and annual (lower figure) distribution of monthly precipitation for the decade 1998 ~ 2008. Data from the "Pissouri" meteorological station.

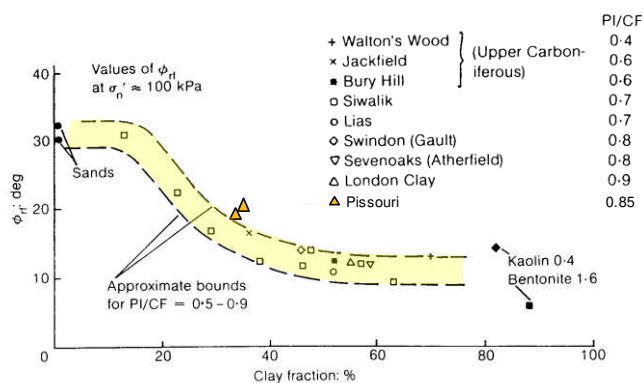
Figure 8. A comparison of the residual angle of shearing resistance of the weathered Pissouri marl with the dataset presented by Skempton (1985).
