A High Rock Cut Stabilization in Muscat City, Oman

Reference: Hayat, T.M., Bhatti, T.J. and Goldsmith, R. (2017). *A High Rock Cut Stabilization in Muscat City, Oman*.

International Journal of Geoengineering Case histories, <http://casehistories.geoengineer.org>, Vol.4, Issue 2, p.96-112.

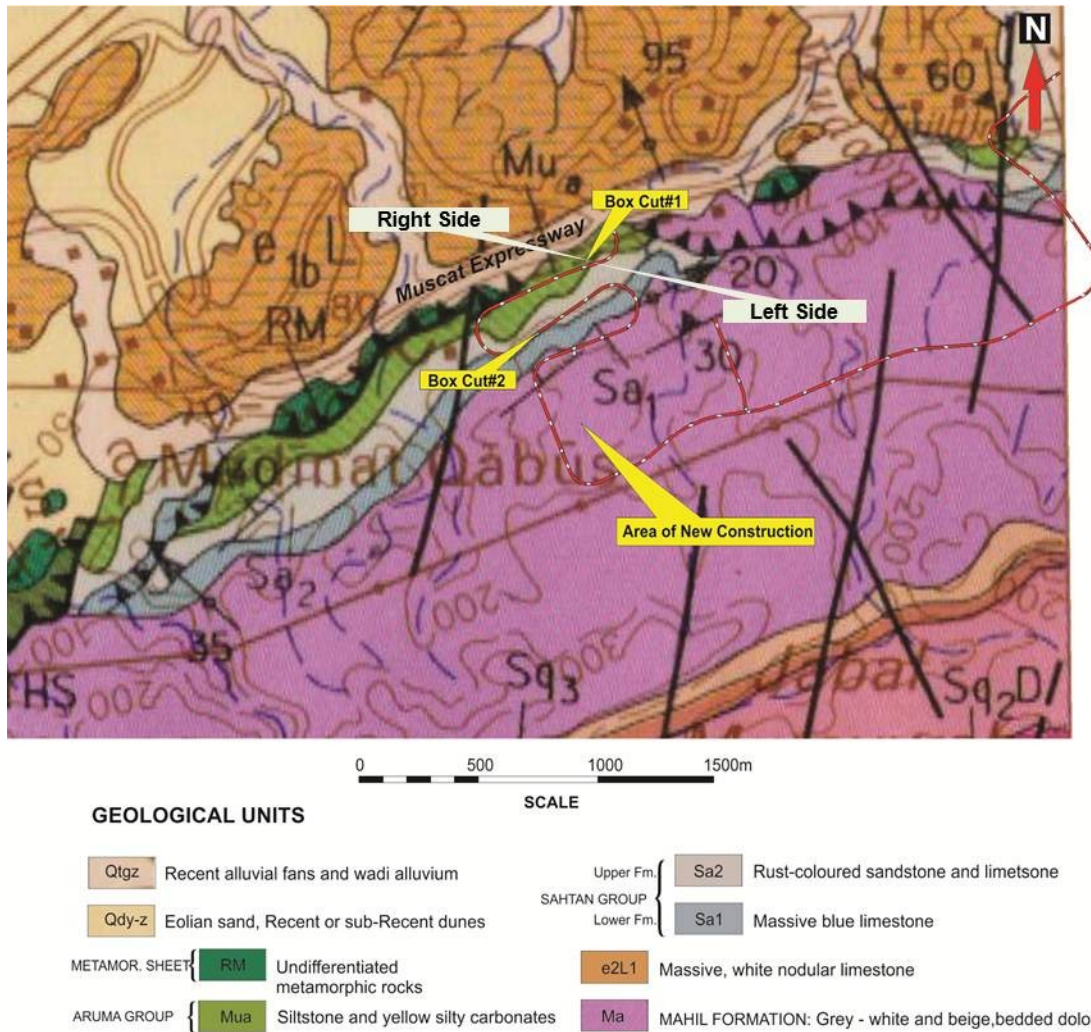
Figure 3. Geological map of the project area.

An extract of the Sib area geological sheet is shown in Figure 3. It illustrates the geology of Box Cut #1, which consists of ground making a contact between Aruma Group, and Sa2; the Upper Formation of the Sahtan Group. Box Cut #2 follows the contact between Units Sa2 and Sa1.

It is interpreted that the Lower Formation of the Sahtan Group is exposed in Box Cut #1 and the Upper Formation is exposed partly in box Cut #2. There was a discrepancy between the map and what was observed on the ground, i.e. when the built up landmarks were aligned, the geology did not match exactly and vice versa. This could be due to a shift in datum between the 1986 map and the project grid. What was observed and mapped on the ground was used in design.
