Geotechnical Damage Caused by the 2016 Kumamoto Earthquake, Japan

KEYWORDS: 2016 Kumamoto earthquake, damage survey, liquefaction, embankment, landslide, volcanic soil

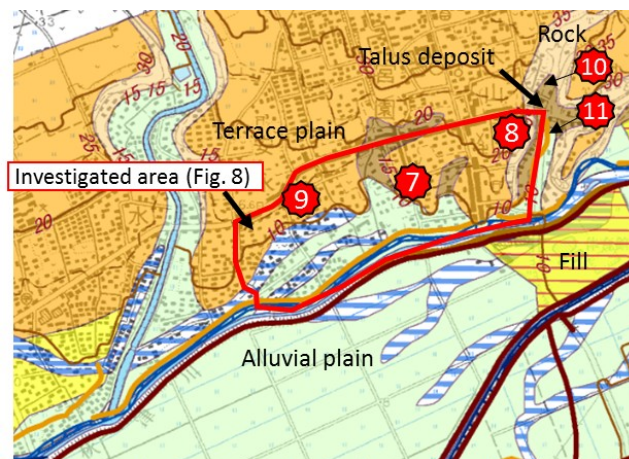
According to the landform classification map in Fig. 14, the significantly damaged area (yellow-colored in Fig. 12) consists of terrace plain (late Pleistocene), talus deposit and alluvial soil. The area is also gently sloping to the south, thus different site amplification effects due to the different soil conditions and residual deformation of sloped ground may be expected. There were some reported cases following recent earthquakes in Japan where residential houses in a developed area of sloping ground suffered from significant damage due to ground deformation associated with a large scale landslide (Mori et al., 2012). A walk-through survey was therefore conducted to understand the effects of ground deformation on the damage to houses in this area.

Figure 14. Landform classification map around the survey area in Mashiki Town (Modified from GSI's map, c.f. Fig. 12).
