Geotechnical Damage Caused by the 2016 Kumamoto Earthquake, Japan

ABSTRACT: On the 16th of April 2016, the Kumamoto earthquake (M_w 7.0) hit the Central Kyushu Region, Japan, following a M_w 6.2 shock on the 14th of April. The earthquake sequences caused severe damage in Kumamoto Prefecture. This paper presents quick reconnaissance results focusing on geotechnical damage features, which were observed during field investigations immediately after, one, and two weeks after the main shock. The damage surveys were carried out in southern Kumamoto City, Mashiki Town, Aso Caldera area and their suburbs. In southern Kumamoto City, evidence of liquefaction was found at many locations, and some buildings and river levees suffered from significant settlement and deformation; damage to an embankment of Kyushu Highway also seemed to be the result of liquefaction. The majority of the damaged residential houses were found in Mashiki Town and its suburbs, which may be linked to intense earthquake motions associated with the seismic fault location. In Aso Caldera area, a number of moderate to large scale landslides and their significant impact to structures were observed. The greater part of land

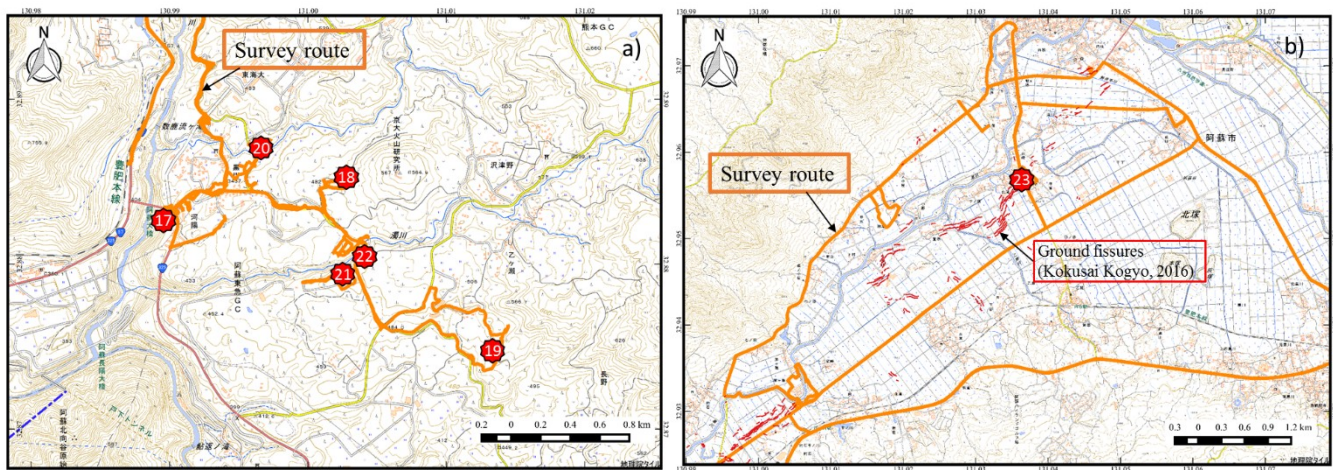
Figure 26. Survey route and locations of investigation sites in Aso Caldera area.

Natural slope failure and distortion of road embankment occurred at many locations in Aso Caldera area. Specifically, artificial earthfills for housing estate suffered from significant earthquake damage. In addition, a trough-like depression that extends fragmentally over several kilometers was observed in the basin of Aso Caldera. Fig. 26 is a map of Aso Caldera area showing locations of geotechnical damage that were investigated during the survey.
