Uplift of an Underground Tank in Northern Malabar Region, India

ABSTRACT: *An underground reinforced concrete tank was constructed for a project in the southwest region of India. The tank was 90 m x 35 m in plan and 7.3 m deep resting on partly filled-up and partly native soil. During the peak monsoon, a sudden uplifting of the base slab by about 300 mm and subsequent failure of the foundation raft and a partition wall was observed. Laboratory testing was executed and hydrogeological survey was carried out using ground penetrating radar, seismic refraction and infiltrometer testing, and an analytical study was carried out to identify the root cause of the tank uplifting. Based on this study, it was observed that the uplifting and structural failure was essentially due to the peculiar land terrain and soil properties and the development of excess hydraulic head below the bottom of the tank. After considering different options, the rectification measures were carried out by provision of dewatering wells along the tank periphery to release the excess hydrostatic pressure and stabilize the foundation raft. The structural repair of the top of the foundation raft and partition wall was

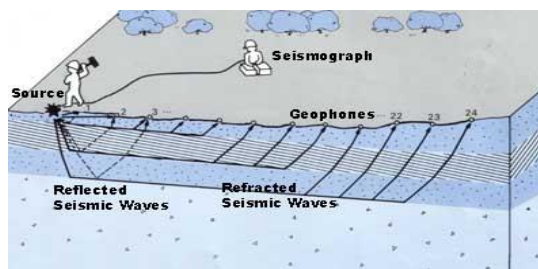
Figure 4. Typical set up for seismic refraction survey.
