Uplift of an Underground Tank in Northern Malabar Region, India

ABSTRACT: *An underground reinforced concrete tank was constructed for a project in the southwest region of India. The tank was 90 m x 35 m in plan and 7.3 m deep resting on partly filled-up and partly native soil. During the peak monsoon, a sudden uplifting of the base slab by about 300 mm and subsequent failure of the foundation raft and a partition wall was observed. Laboratory testing was executed and hydrogeological survey was carried out using ground penetrating radar, seismic refraction and infiltrometer testing, and an analytical study was carried out to identify the root cause of the tank uplifting. Based on this study, it was observed that the uplifting and structural failure was essentially due to the peculiar land terrain and soil properties and the development of excess hydraulic head below the bottom of the tank. After considering different options, the rectification measures were carried out by provision of dewatering wells along the tank periphery to release the excess hydrostatic pressure and stabilize the foundation raft. The structural repair of the top of the foundation raft and partition wall was

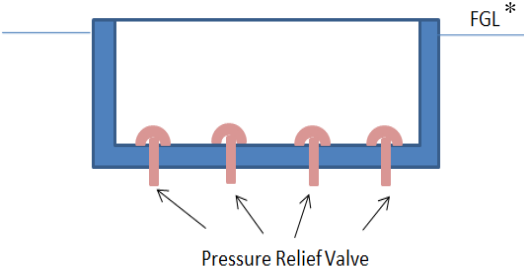
<p>Option 3</p>	<p>NON-RETURN PRESSURE RELIEF VALVES:</p> <p>Provision of non-return pressure relief valves on the bottom slab to release groundwater pressure, by allowing the groundwater to enter the tank through these valves.</p>

<p>There is a chance of groundwater contamination in case of malfunctioning of the non-return valve. This was not acceptable from an operation point of view.</p>
<p>Option 4</p>	<p>DEAD WEIGHT:</p> <p>Provision of dead weight in terms of 1.2 m thick layer of plain cement concrete (PCC) on top of the foundation raft inside the tank. This would increase the dead weight of the tank and would counterbalance the uplifting due to groundwater pressure.</p>

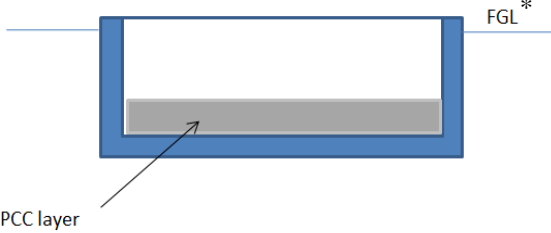
<p>Provision of PCC would also reduce the volume and ultimate capacity of the tank which was not acceptable from an operation point of view. Very high cost involved in this option.</p>
<p>Option 5</p>	<p>GROUND ANCHORS:</p> <p>Provision of ground anchors to hold the tank against uplifting.</p>

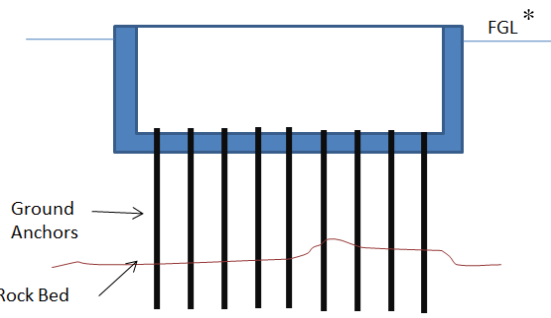
<p>During execution of ground anchors from inside the tank, dewatering of tank is required and has a risk of tank uplifting and cracking after dewatering. Else the groundwater level has to be temporarily lowered during anchoring by means of a well point system. Very high cost involved in this option.</p>
