Uplift of an Underground Tank in Northern Malabar Region, India

ABSTRACT: *An underground reinforced concrete tank was constructed for a project in the southwest region of India. The tank was 90 m x 35 m in plan and 7.3 m deep resting on partly filled-up and partly native soil. During the peak monsoon, a sudden uplifting of the base slab by about 300 mm and subsequent failure of the foundation raft and a partition wall was observed. Laboratory testing was executed and hydrogeological survey was carried out using ground penetrating radar, seismic refraction and infiltrometer testing, and an analytical study was carried out to identify the root cause of the tank uplifting. Based on this study, it was observed that the uplifting and structural failure was essentially due to the peculiar land terrain and soil properties and the development of excess hydraulic head below the bottom of the tank. After considering different options, the rectification measures were carried out by provision of dewatering wells along the tank periphery to release the excess hydrostatic pressure and stabilize the foundation raft. The structural repair of the top of the foundation raft and partition wall was

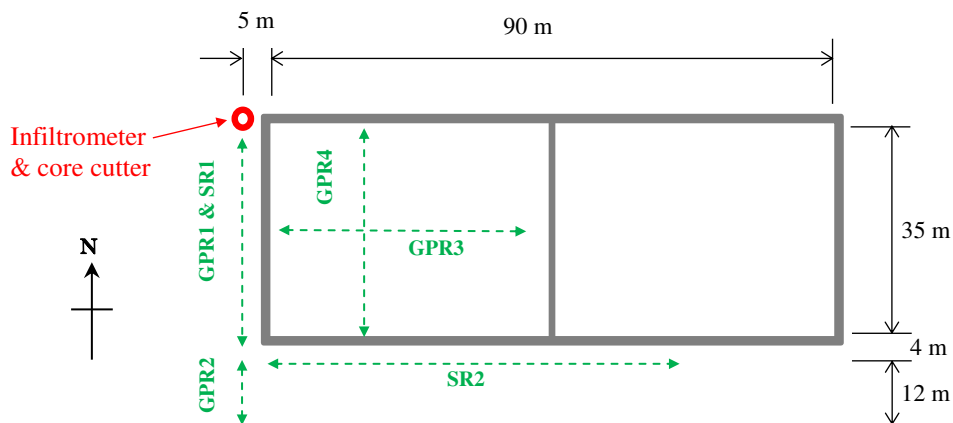
The numbers and tentative locations of GPR, SR tests and other field tests, with respect to the tank location, are indicated in Fig. 5 and Table 2.

Figure 5. The schematic plan illustrating the location of GPR profiles, seismic refraction (SR) survey profiles and soil samples (see also Table 2).

The investigation was focused on the west and south periphery of the tank, where the ground was submerged. It shall also be noted that historically there was a perennial water well near the southwest corner of the tank which was filled up with soil and boulders during construction. The water from this well was used for household purposes by the local villagers. The concrete slab was also cast on top of this well during construction. The area on north and east of the tank was observed to be relatively dry.
