Lessons Learned from Dike Failures in Recent Decades

ABSTRACT: *The paper describes five different dike failures that occurred in recent decades. The case histories were located on different rivers and involved different loading conditions. The observed failure mechanisms involved erosion and stability problems. The types of erosion observed were both internal erosion due to extreme groundwater flow and external erosion caused by the river flow and wave action. The case involving instability was caused by uplift, i.e., increased hydraulic head led to a sharp reduction in maximum shear strength between subsoil layers. Two cases demonstrate the importance of dike management and maintenance. Despite the variations in the loading conditions and failure mechanisms, all the cases show that the strength of a dike depends not only on the material used to build the dike but also on the strength of the subsoil.*

Reference: Zwanenburg, C., López-Acosta, N.P., Tourment, R., Tarantino, A., Pozzato, A. and Pinto, A. (2018).

Lessons Learned from Dike Failures in Recent Decades. International Journal of Geoenvironment Case histories, Vol.4, Issue 3, p.203-229. doi: 10.4417/IJGCH-04-03-04

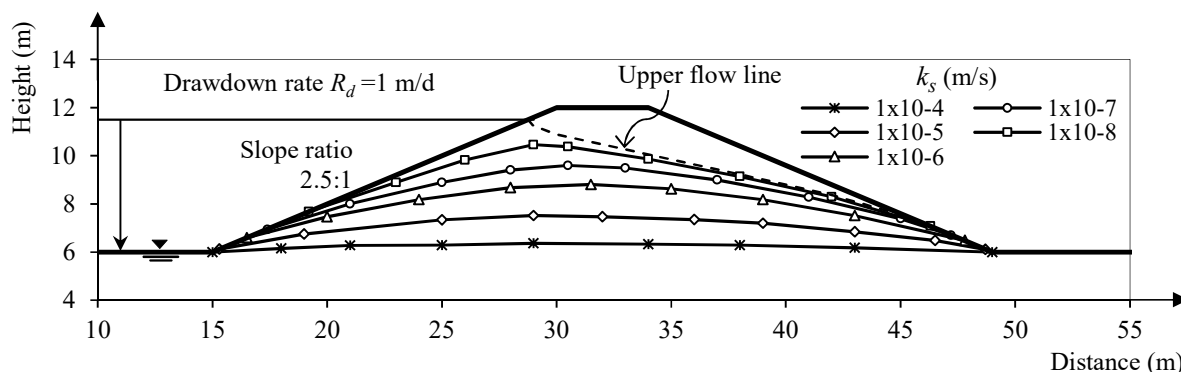
Figure 7. Phreatic surfaces (desaturation lines) at the end of the water drawdown stage in a dike with variable hydraulic conductivities k_s , (López-Acosta et al. 2015)

These analyses evaluated several homogeneous and isotropic dikes with a 2.5(H):1(V) slope and total dewatering head of 5.5 m for different hydraulic conductivities. Figure 7 shows the upper flow line for the initial steady-state condition and desaturation lines at the end of water drawdown in dikes with different hydraulic conductivities k_s for the transient-state condition and assuming a constant drawdown rate of $R_d = 1$ m/d. As can be seen from this figure, where $k_s = 1 \times 10^{-8}$ m/s, the desaturation line remains practically in the same position as the upper flow line, which is associated with the *fully rapid drawdown mode*. In this case, it can be assumed that the soil behaves undrained. For $k_s = 1 \times 10^{-4}$ m/s, the desaturation line inside the dike drops down almost in line with the reservoir water level, which is associated with the *fully slow drawdown mode*. In this case, it can be assumed that the soil behaves drained. It can also be assumed that the desaturation lines between these two extreme modes represent the *transient drawdown mode* in which a curvilinear water line is generated in the soil structure, the position of which depends on the drawdown rate and the constitutive material properties. The remaining pore pressure in the dike is therefore transient, it varies as a function of time, but also with the soil's ability to retain water. Several authors have recognised the three water drawdown modes described here (examples being Lane & Griffiths, 2000 and Berilgen, 2007).

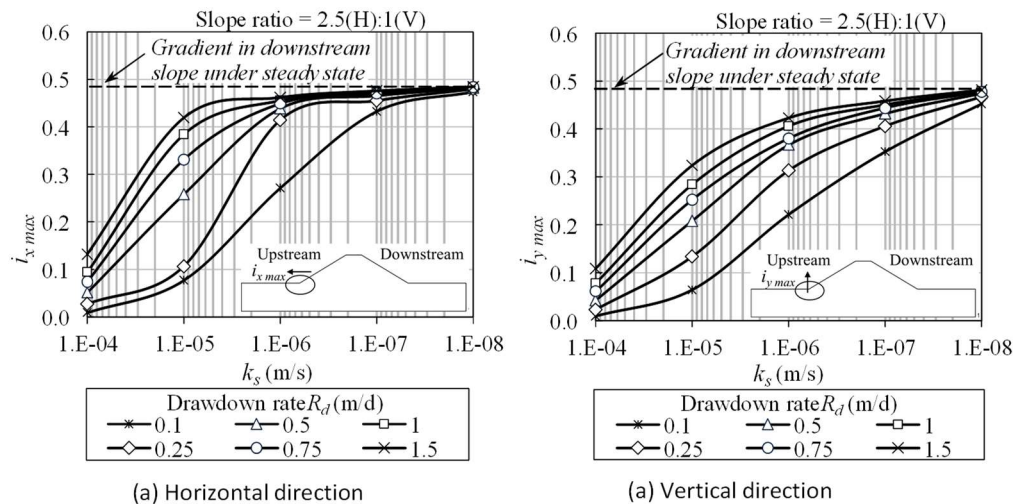
Figure 8. Effect of drawdown rate R_d on exit hydraulic gradients in dikes for variable hydraulic conductivities k_s , (López-Acosta et al. 2015)

Figure 8 shows the effect of the drawdown rate on exit hydraulic gradients in the horizontal and vertical directions, corresponding to the x and y axes respectively, in both the upstream and downstream slopes of the dikes with variable hydraulic conductivities k_s . In addition, Figure 9 summarizes the results obtained assuming variable permeabilities k_s and a constant drawdown rate ($R_d = 1$ m/d). The following conclusions can be drawn on the basis of the results of these parametric analyses:

- The more impermeable a material is, the larger the exit hydraulic gradients. In this sense, the maximum value of the exit gradient in the upstream slope tends to match the value of the computed gradient in the downstream slope under steady-state conditions.

- The exit hydraulic gradients were observed to increase when the drawdown rate increased.
- In general, given the admissible values suggested by several authors for local erosion and piping (for example, Den Adel et al., 1988; Wan & Fell, 2004; Ahlinhan & Achmus, 2010), the magnitude of the gradients computed here is significant. One suitable way of preventing internal erosion or piping is the installation of filters or drains placed strategically in the earth structure.

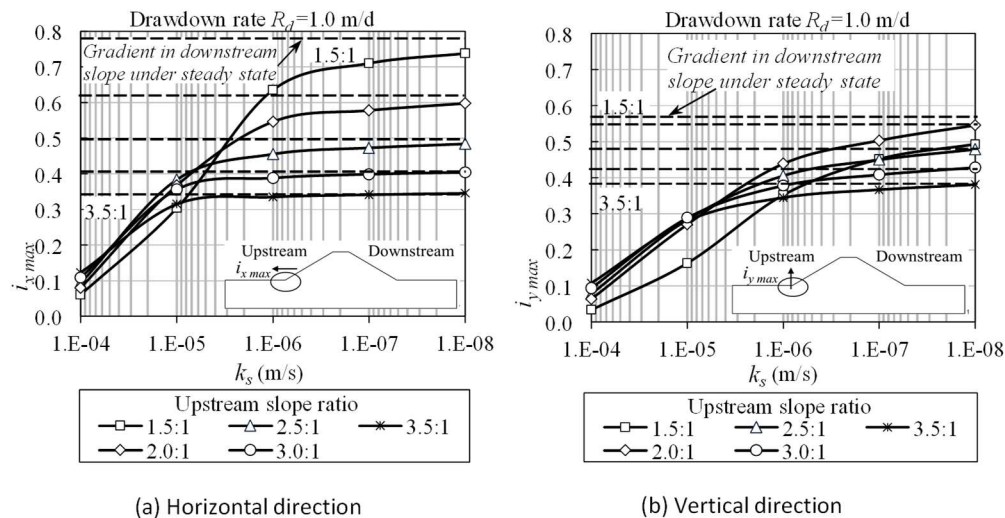
Figure 9. Effect of the slope ratio (H:V) on exit hydraulic gradients in dikes for different hydraulic conductivities k_s , (López-Acosta et al. 2015)

- Under a steady-state flow, the exit hydraulic gradients in the downstream slope remain constant for all k_s permeabilities studied.
- Changes in the slope ratio of dikes have a more significant effect on the magnitude of the exit hydraulic gradients than changes in the drawdown rate. It was observed that steeper slopes generate greater values for exit gradients.

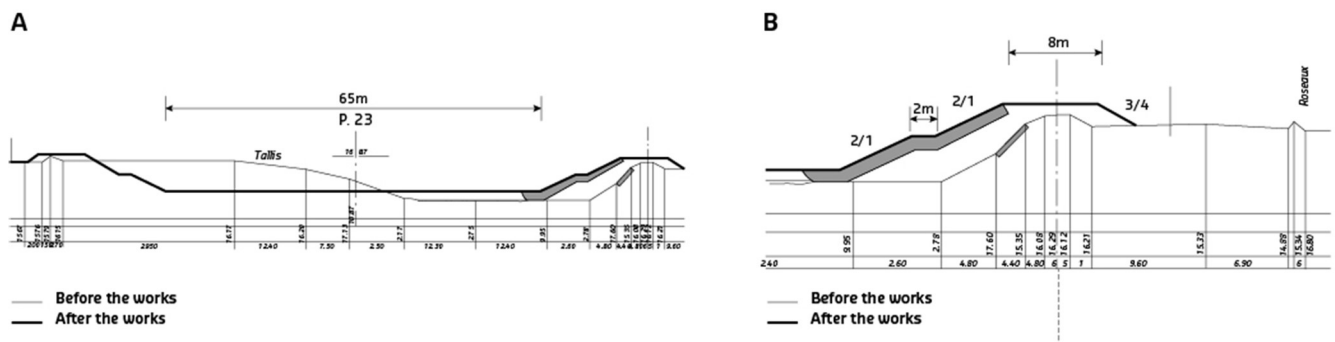
Figure 12. a) Re-profiling of the river and construction of the dikes, b) armouring of the river side of the dikes in concave sections

When the river was re-profiled in 1970, the bed was widened to 65-70 m. The dikes generally were constructed to an elevation of 2-3 m, 8 m wide at the crest, with 1V/2H slopes, see Figure 12 and were built using local material. Thus, the materials used vary along the dikes and may consist of loam and sandy loam or even gravel. There is riprap toe protection on the river side, and armour protection over the full height on the concave side of curved sections, as shown in Figure 12b.

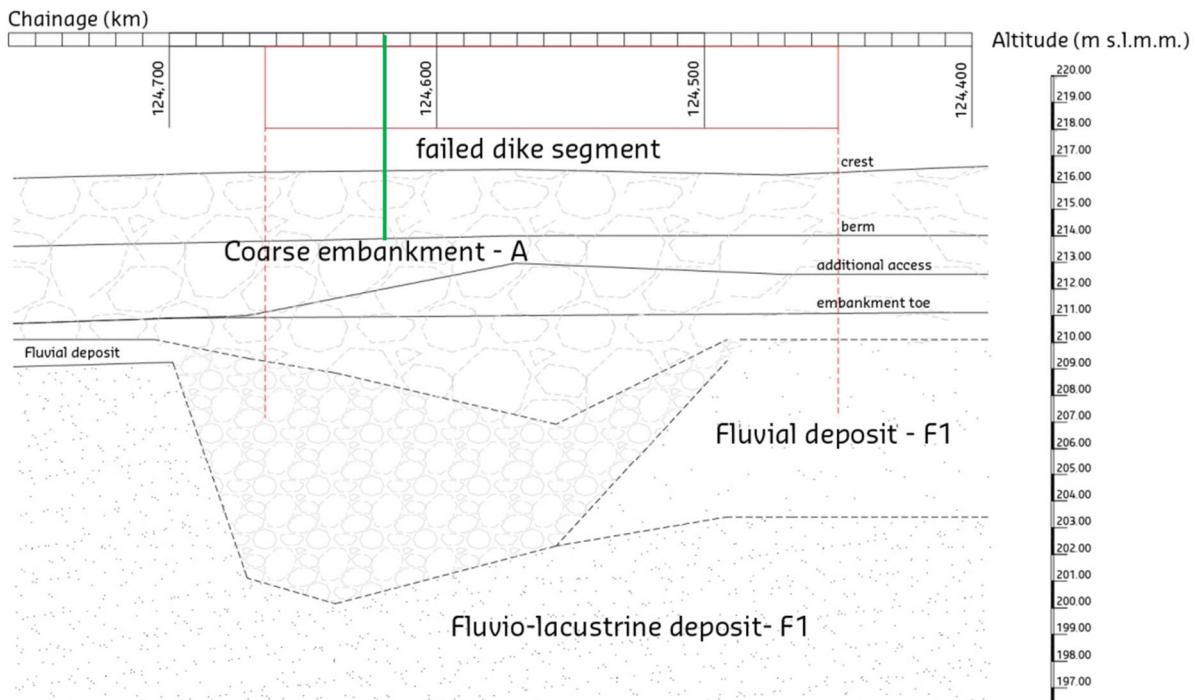
Figure 20. Longitudinal soil profile of the dike segment in Laag that includes the section breached in 1981. The location of the representative cross-section is indicated by the green line.

Figure 20 shows the longitudinal soil profile that includes the segment of the dike in Laag breached in 1981 and then reconstructed after 1981. The dip in the interface between the coarse-grained embankment and the ancient river bed is attributable to the excavation of the ancient river bed material after the dike was breached. During the flood, the embankment was patrolled frequently (a few times a day) and no evidence of sand boiling was detected. It is not possible to exclude that

sand boiling was occurring between one visual inspection and another. However, it would appear that failure was mainly caused by underseepage rather than erosion triggered by uplift pressures at the landside toe of the embankment.

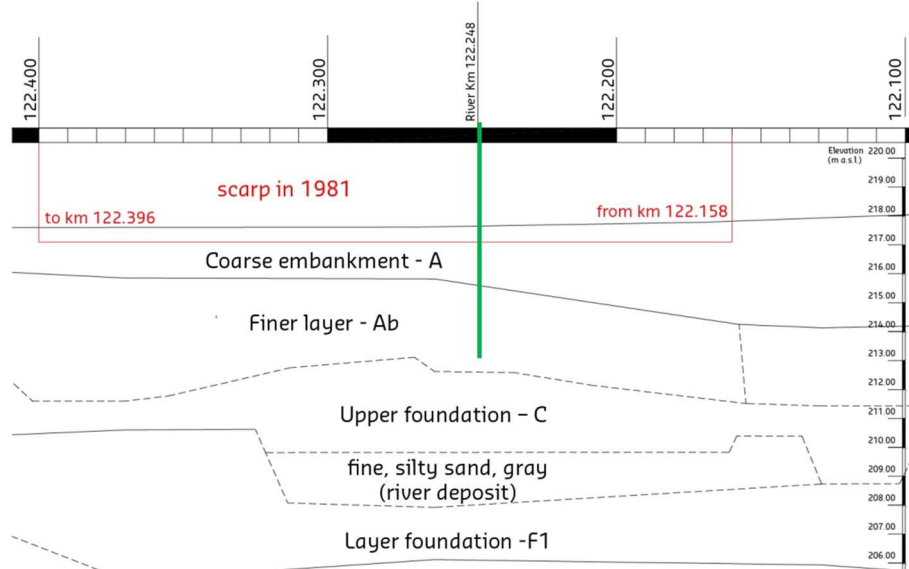
Figure 22. Longitudinal soil profile of the dike segment in St Florian that includes the portion affected by instability in 1981. The location of the representative cross-section is indicated by the green line.

The cross-section at chainage 124.620 km was selected to analyze the hydro-mechanical response of the embankment (Figure 21). Figure 22 shows the longitudinal soil profile that includes the segment of the dike in St Florian affected by instability in 1981 (scarp of about 50 cm). The cross-section at chainage 122.248 km was selected to analyze the hydro-mechanical response of the embankment (Figure 23).

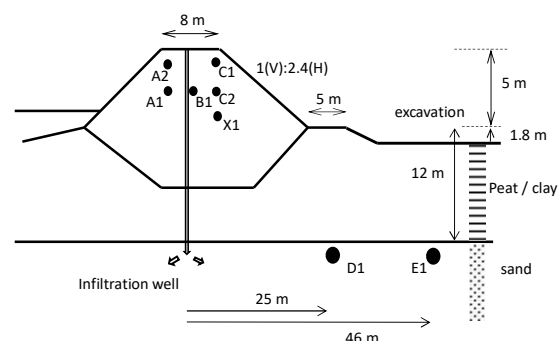
Figure 29. Test setup and dimensions, A1, A2, B1, C1, C2, X1, D1, E1 represent locations for hydraulic head measurements shown in Figures 35 and 36.

Figure 29 sketches a typical cross-section at the test site. The vertical dimensions are related to *Normaal Amsterdam Peil* NAP, which is approximately mean sea level. The crest height of the dike was NAP +5 m, while the ground level at the toe was NAP 0 m. To facilitate uplift the surface layer was dug away to a depth of 1.8 m over a distance of 70 m parallel to the dike. To prevent a shallow failure mechanism, the distance between the excavated area and the toe of the dike was maintained at 5 m and the excavated area began with a 1:3 slope. The clayey core of the dike body is of medieval origin. Over the years, the dike has been raised and widened and the total height is now 10 m, with a crest height of 5 m above surrounding ground level. The subsoil at the toe of the dike consists of approximately 12 m of peat and clay, followed by a thick Pleistocene sand deposit. Due to the weight of the dike body, the total thickness of the peat and clay layers is reduced to approximately 6 m. More details of the subsoil stratification are given by Figure 30 and Figure 31.

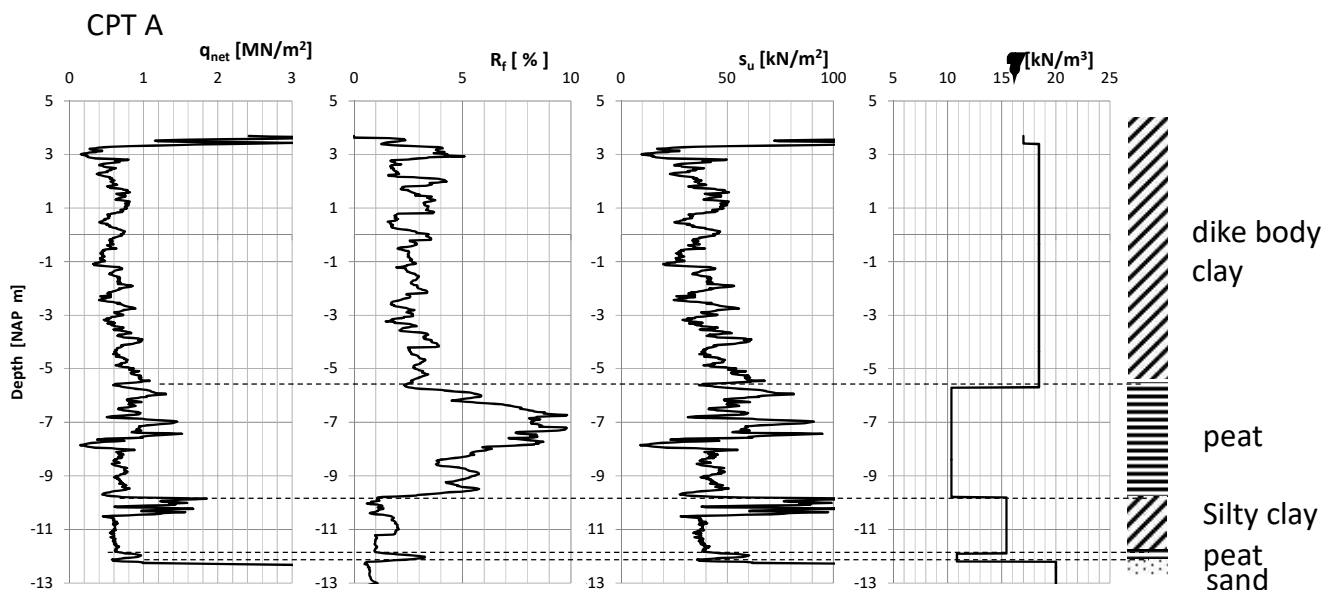
Figure 30. Depth profiles of corrected cone resistance, q_{net} , friction ratio, R_f , undrained shear strength S_u for CPT A, crest location (see Figure 28) and average unit weight γ .

The undrained shear strength profile found by CPTu B shows a dry crust at the top with a thickness of 1.5 m. Below the dry crust, the assessed undrained shear strength ranges mainly between 10 and 20 kN/m². A Pleistocene sand layer is found at NAP – 12 m. The top 9 m found by CPT A (Figure 30), represent the dike body. The peat and clay layers below the dike body show an undrained shear strength in the range of 40 to 50 kN/m². This range in s_u is clearly larger than found for the peat and organic clay layers by CPTu B. The difference in s_u found at CPT A and CPTu B can be explained by difference in stress level caused by the presence of the dike body at the location of CPT A.

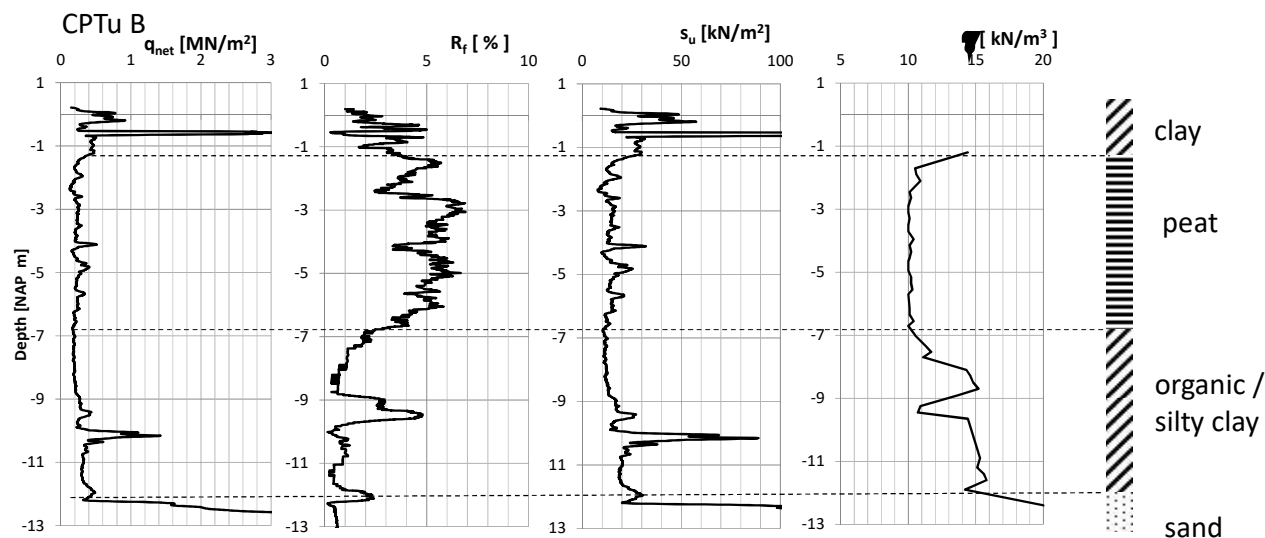
Figure 31. Depth profiles of corrected cone resistance, q_{net} , friction ratio, R_f , undrained shear strength s_u for CPTu B, polder side, location (see Figure 28) and unit weight γ from nearby borehole.

It should be noted that the subsoil, found at the location of CPTu B between NAP – 7 m and NAP – 12 m consists of a succession of organic and silty clay layers. For clarity reasons, Figure 31 does not identify these layers individually.

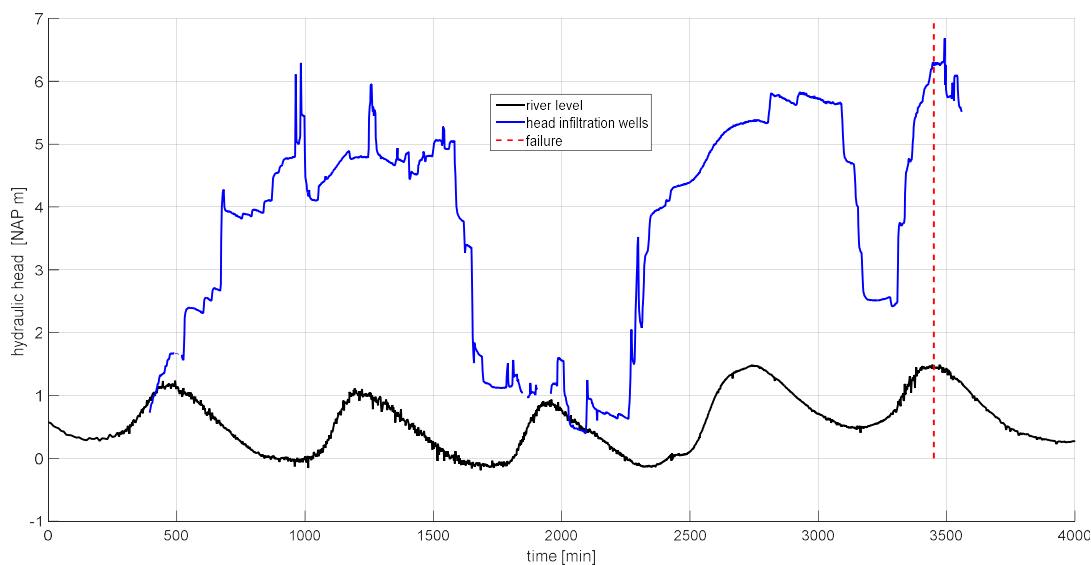
Figure 32. River level and hydraulic head in infiltration wells during the test

The test began at 06.00 on 26 November 2000, $t = 0$ in the graphs below. Figure 32 shows the river level and the average head in the nine infiltration wells. Infiltration started at $t = 370$ min, 6 hours after the start of the test. Initially, the hydraulic head in the wells followed the fluctuations in the river level. It should be noted that the test site is close to the sea and that the tidal wave has a pronounced influence on the water level in front of the dike. Although drinking water was used for infiltration, the infiltration wells clogged up after 26 hours, $t = 1580$ min, reducing well capacity. Due to maintenance, required to regain the full pumping capacity, the hydraulic head was seen to fall between $t = 1580$ and 2260 min, a period of 11.3 hours (Figure 32). Maintenance was also needed between $t = 3090$ and 3308 min, a period of 3.6 hours. Failure was observed at $t = 3450$ min, approximately 2.5 days after the start of the test, in the form of large longitudinal cracks in the dike body accompanied by major subsoil deformation (see Figures 33 and 34). The difference in height at the location of the cracks increased to more than 1.0 m (Figure 27b).

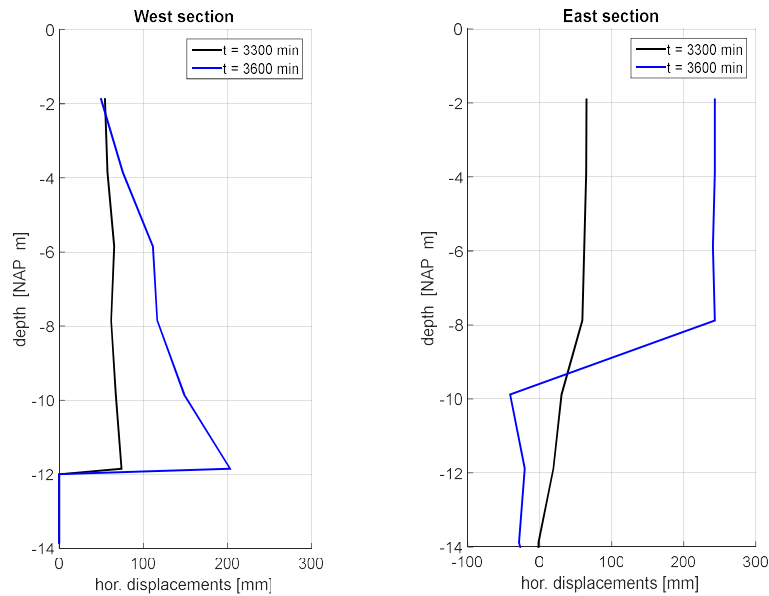
Figure 33. Horizontal displacement at the toe (both polder-side west respectively east of the central section as shown in Figure 27a)

Figure 33 shows the horizontal displacements measured at the toe in the eastern and western sections at $t = 3300$ min (55 h) and $t = 3600$ min (60 hours). Note that there was no inclinometer in the central section. The maximum displacement was found at the transition between the Pleistocene and Holocene layers, which was not at the same depth in both sections. Figure 34 shows the development of the maximum displacement for both sections. In the western section, horizontal displacements started to develop as soon as infiltration began. At approximately $t = 1500$ min, infiltration was suspended temporarily and no further deformation was observed until $t = 2500$ min, when infiltration resumed. Soon after, horizontal displacement developed in the eastern section as well. Infiltration was suspended for a second time, and horizontal displacement stopped again. Soon after infiltration resumed, displacement accelerated until the dike failed at $t = 3450$ min (57.5 hours) after the start of the test.

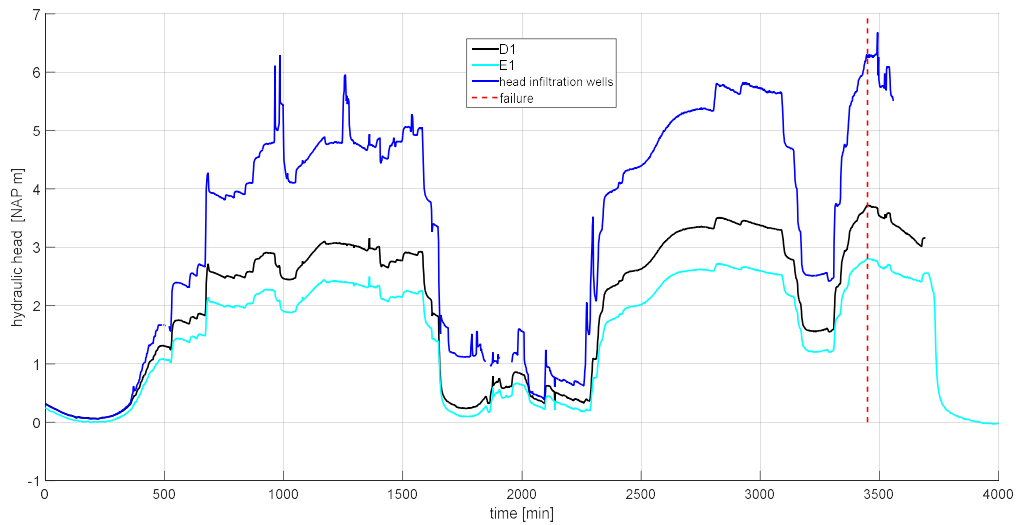
Figure 35. Hydraulic head in Pleistocene sand layer, locations D1 and E1 (see Figure 29)

Figure 35 shows the hydraulic head observed in the Pleistocene sand layer at distances of 21 and 42 m from the infiltration wells. The effect of infiltration declined with increasing distance from the well; the hydraulic head at D1 was lower than in the infiltration wells and a further reduction in maximum head was observed in E1.

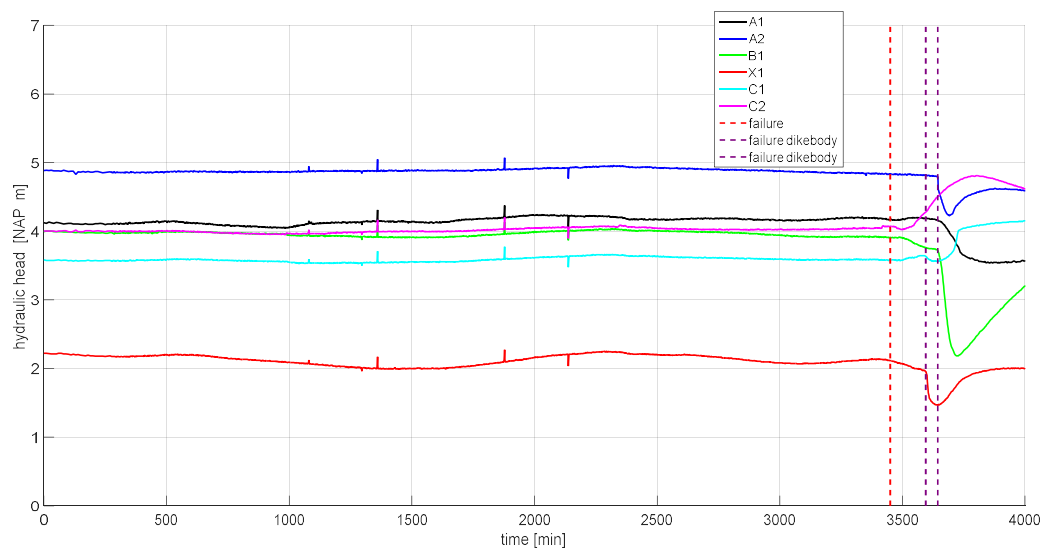
Figure 36. Hydraulic head in the dike body for locations A1 to C2 (see Figure 29)

Figure 36 shows how hydraulic head developed inside the dike body. Prior to failure there was no significant fluctuation in hydraulic head. The range in hydraulic heads measured by the different transducers can probably be explained by suction forces at the top of the dike. With the exception of C2, there was a sharp drop indicating failure. Close inspection shows that, inside the dike body, the response to failure was later than given by the observed horizontal displacement at the toe, $t = 3450$ min at which only the pore pressure at location C2 shows a response. There was a minor initial response at B1 and C1 shortly after $t = 3450$ min. The sharp drop in hydraulic head was observed later. The drop at X1 and C1 was observed at $t = 3595$ min, or 145 min (2.4 hours) later. At $t = 3644$ min (50 minutes later) the hydraulic head at B1 and A2 dropped significantly. The time differences for local failure found at different locations shows the propagation of the failure plane, starting deep in the subsoil and moving towards the crest. It should be noted that the development of the failure plane resulted in breakage of the infiltration wells. When infiltration ceased, the uplift conditions were no longer in place and sliding along the slip plane as indicated by Figure 28 stopped.

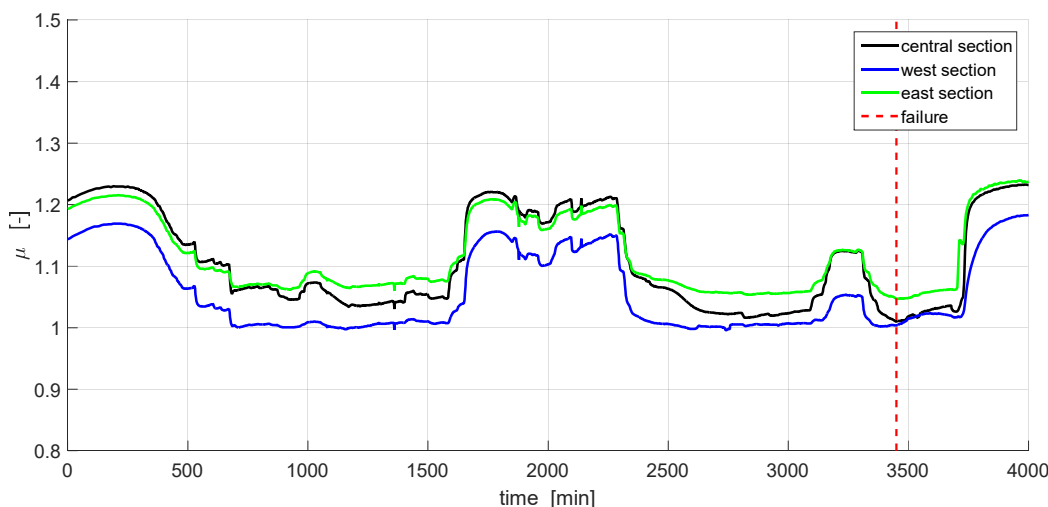
Figure 37. Ratio of total overburden pressure to pore pressure, μ , during the test

To check on the uplift conditions during the test, the ratio, μ , of the weight of the Holocene layer to pore pressure in the Pleistocene sand layer was determined for each of the transducers in the Pleistocene sand layer. Figure 37 shows the ratio, μ , during the test for the transducers placed at 46 m from the crest of the dike in the central, eastern and western sections. Initially, $\mu = 1.2$. When infiltration began, this value reduced, as expected. Due to differences in the subsoil layer, μ varied for the different sections, with the lowest value in the western section, where the value remained approximately 1. In the central and eastern sections, μ seemed to reduce slightly during the test. This corresponds to the slight increase in infiltration pressure during the test, as shown in Figure 35. The value did not drop significantly below 1.0. This could be explained by the pumping capacity, which does not allow for any further increase in pore pressure in the sand layer at the toe of the dike. It can also be hypothesized that when the pore pressure in the sand layer starts to exceed the weight of the clay and peat layers above it, a gap is created which is filled with pore water from the sand layer until a new equilibrium is attained. When pumping capacity is further increased, the gap may be widened, maintaining the equilibrium in vertical forces. In this hypothesis, $\mu = 1.0$ could be a physical boundary that will have prevented any further decline in the μ value in the western section during the test. It should be noted that, at larger distances from the dike, the Pleistocene hydraulic head decreased, causing an increase in μ . Close to the dike, μ is affected by the weight of the dike body.
