Lessons Learned from Dike Failures in Recent Decades

ABSTRACT: *The paper describes five different dike failures that occurred in recent decades. The case histories were located on different rivers and involved different loading conditions. The observed failure mechanisms involved erosion and stability problems. The types of erosion observed were both internal erosion due to extreme groundwater flow and external erosion caused by the river flow and wave action. The case involving instability was caused by uplift, i.e., increased hydraulic head led to a sharp reduction in maximum shear strength between subsoil layers. Two cases demonstrate the importance of dike management and maintenance. Despite the variations in the loading conditions and failure mechanisms, all the cases show that the strength of a dike depends not only on the material used to build the dike but also on the strength of the subsoil.*

Lessons Learned from Dike Failures in Recent Decades. International Journal of Geoenvironment Case histories, Vol.4, Issue 3, p.203-229. doi: 10.4417/IJGCH-04-03-04

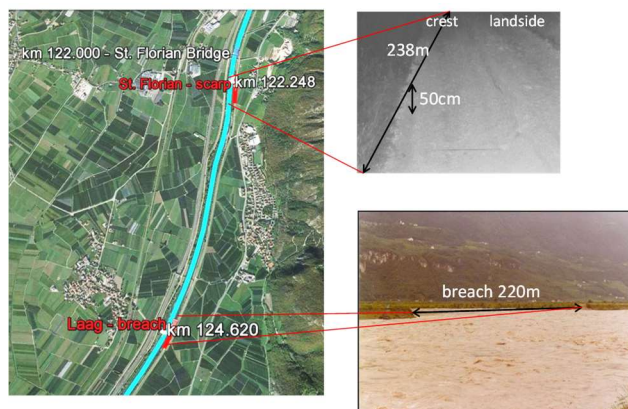
The flood event in 1981 led to the collapse of a 220-m-long section of the left flood embankment (chainage 124.450 km to 124.670 km) in Laag (Figure 16). At the same time, a scarp with a differential height of 50 cm was formed on a 238-m-long section in St Florian (chainage 122.150 km to 122.390 km), as shown in Figure 16.

Figure 16. Overview of the two considered segments of the Adige River at Laag and St Florian

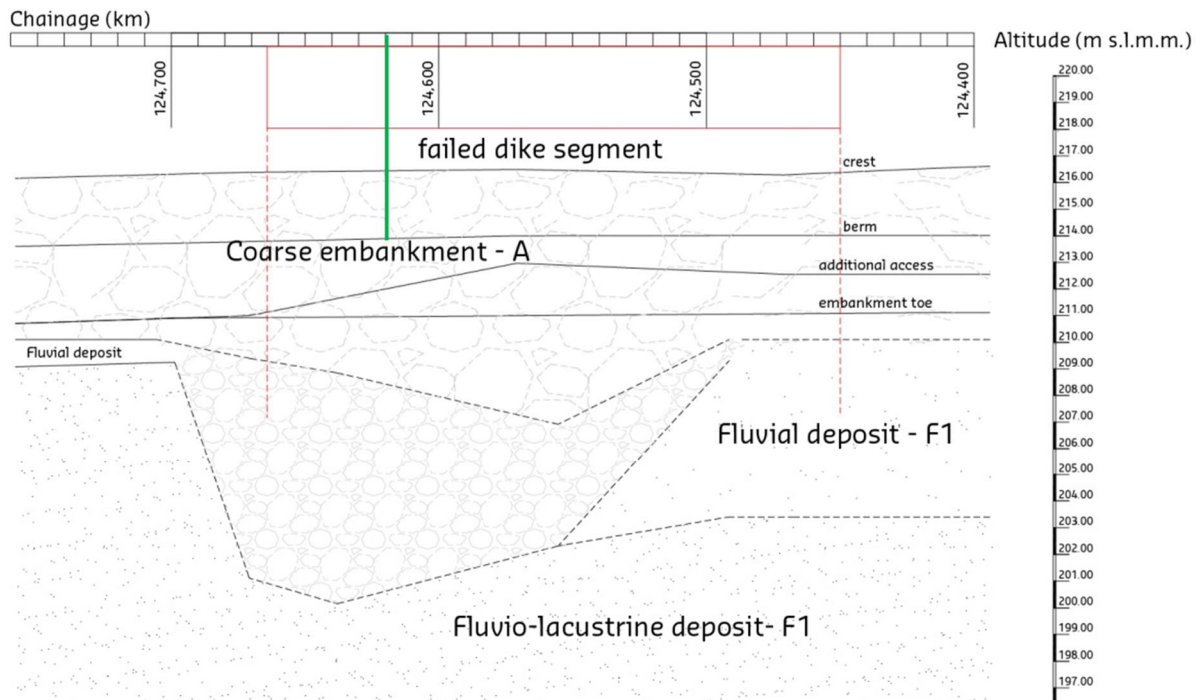
Figure 20. Longitudinal soil profile of the dike segment in Laag that includes the section breached in 1981. The location of the representative cross-section is indicated by the green line.

Figure 20 shows the longitudinal soil profile that includes the segment of the dike in Laag breached in 1981 and then reconstructed after 1981. The dip in the interface between the coarse-grained embankment and the ancient river bed is attributable to the excavation of the ancient river bed material after the dike was breached. During the flood, the embankment was patrolled frequently (a few times a day) and no evidence of sand boiling was detected. It is not possible to exclude that

sand boiling was occurring between one visual inspection and another. However, it would appear that failure was mainly caused by underseepage rather than erosion triggered by uplift pressures at the landside toe of the embankment.

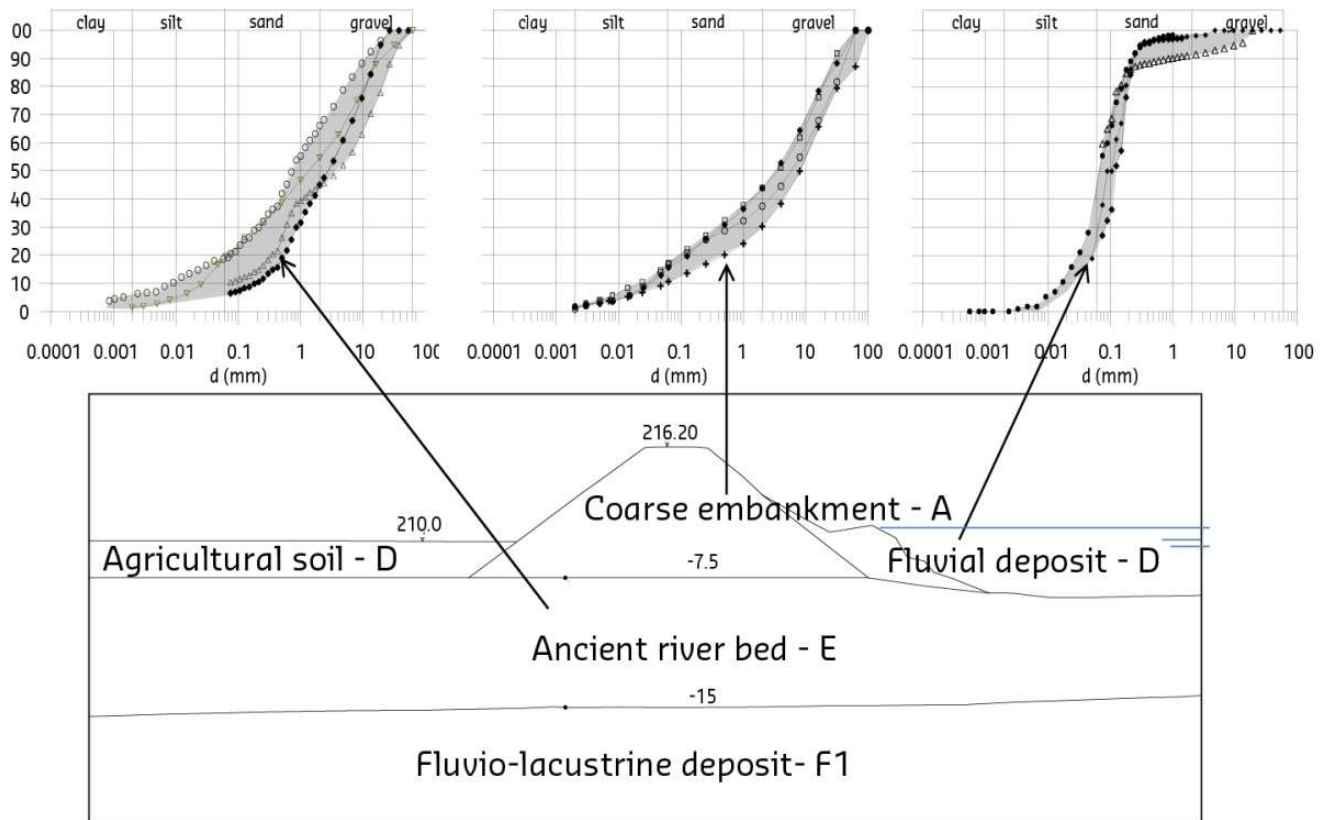
The cross-section at chainage 124.620 km was selected to analyze the hydro-mechanical response of the embankment (Figure 21). Figure 22 shows the longitudinal soil profile that includes the segment of the dike in St Florian affected by instability in 1981 (scarp of about 50 cm). The cross-section at chainage 122.248 km was selected to analyze the hydro-mechanical response of the embankment (Figure 23).

Figure 21. Soil profile for the cross-section representative of the dike segment in Laag breached in 1981 (chainage 124.620 km)

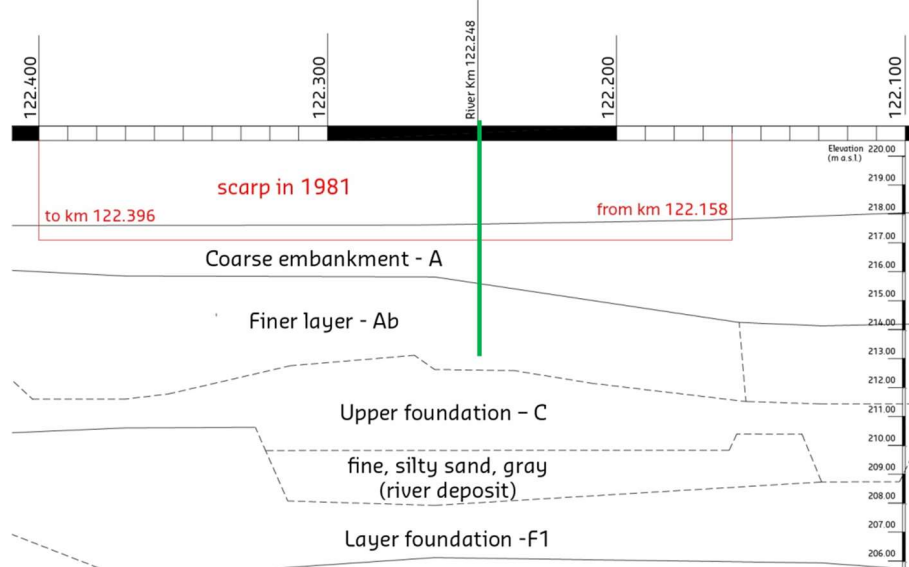
Figure 22. Longitudinal soil profile of the dike segment in St Florian that includes the portion affected by instability in 1981. The location of the representative cross-section is indicated by the green line.

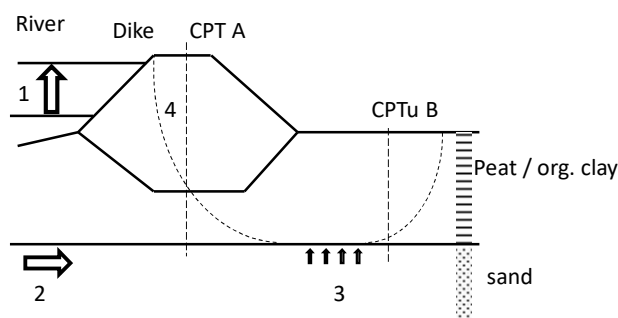
A typical failure mechanism for dikes in this area is loss of stability due to uplift of the soft soil layers at the toe. Figure 28 explains the failure mechanism. There is a hydraulic connection between the river and the Pleistocene sand layer. A rise in the river level (1) results in an increase in the hydraulic head in the Pleistocene sand layers (2) until the pore pressure equals the weight of the Holocene layers on top (3). The shear strength at the transition between the Holocene clay and peat layers on the one hand and the Pleistocene sand deposit on the other is drastically reduced, creating the conditions for a long, deep, slip plane (4). The uplift phenomenon is described in further detail by Cooling & Marsland (1953), Marsland (1961), Bauduin et al. (1989) and Van (2001). Observations of stability loss due to uplift are scarce and it was decided to study the uplift phenomenon at the Bergambacht test site.

Figure 28. Impression of the uplift failure mechanism, 1: river level rise, 2: hydraulic connection to sand layer, 3: pore pressure rise until uplift top layer, 4: failure plane.
