Lessons Learned from Dike Failures in Recent Decades

ABSTRACT: *The paper describes five different dike failures that occurred in recent decades. The case histories were located on different rivers and involved different loading conditions. The observed failure mechanisms involved erosion and stability problems. The types of erosion observed were both internal erosion due to extreme groundwater flow and external erosion caused by the river flow and wave action. The case involving instability was caused by uplift, i.e., increased hydraulic head led to a sharp reduction in maximum shear strength between subsoil layers. Two cases demonstrate the importance of dike management and maintenance. Despite the variations in the loading conditions and failure mechanisms, all the cases show that the strength of a dike depends not only on the material used to build the dike but also on the strength of the subsoil.*

Lessons Learned from Dike Failures in Recent Decades. International Journal of Geoenvironment Case histories, Vol.4, Issue 3, p.203-229. doi: 10.4417/IJGCH-04-03-04

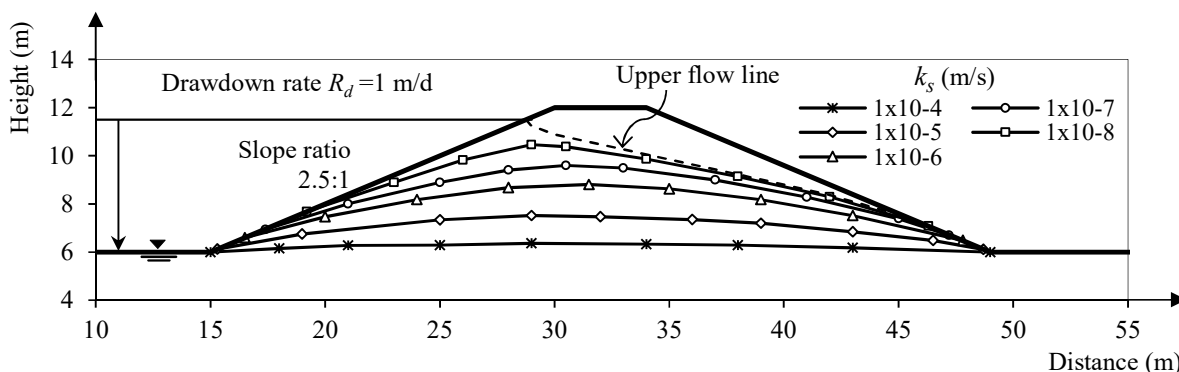
Figure 7. Phreatic surfaces (desaturation lines) at the end of the water drawdown stage in a dike with variable hydraulic conductivities k_s , (López-Acosta et al. 2015)

These analyses evaluated several homogeneous and isotropic dikes with a 2.5(H):1(V) slope and total dewatering head of 5.5 m for different hydraulic conductivities. Figure 7 shows the upper flow line for the initial steady-state condition and desaturation lines at the end of water drawdown in dikes with different hydraulic conductivities k_s for the transient-state condition and assuming a constant drawdown rate of $R_d = 1$ m/d. As can be seen from this figure, where $k_s = 1 \times 10^{-8}$ m/s, the desaturation line remains practically in the same position as the upper flow line, which is associated with the *fully rapid drawdown mode*. In this case, it can be assumed that the soil behaves undrained. For $k_s = 1 \times 10^{-4}$ m/s, the desaturation line inside the dike drops down almost in line with the reservoir water level, which is associated with the *fully slow drawdown mode*. In this case, it can be assumed that the soil behaves drained. It can also be assumed that the desaturation lines between these two extreme modes represent the *transient drawdown mode* in which a curvilinear water line is generated in the soil structure, the position of which depends on the drawdown rate and the constitutive material properties. The remaining pore pressure in the dike is therefore transient, it varies as a function of time, but also with the soil's ability to retain water. Several authors have recognised the three water drawdown modes described here (examples being Lane & Griffiths, 2000 and Berilgen, 2007).

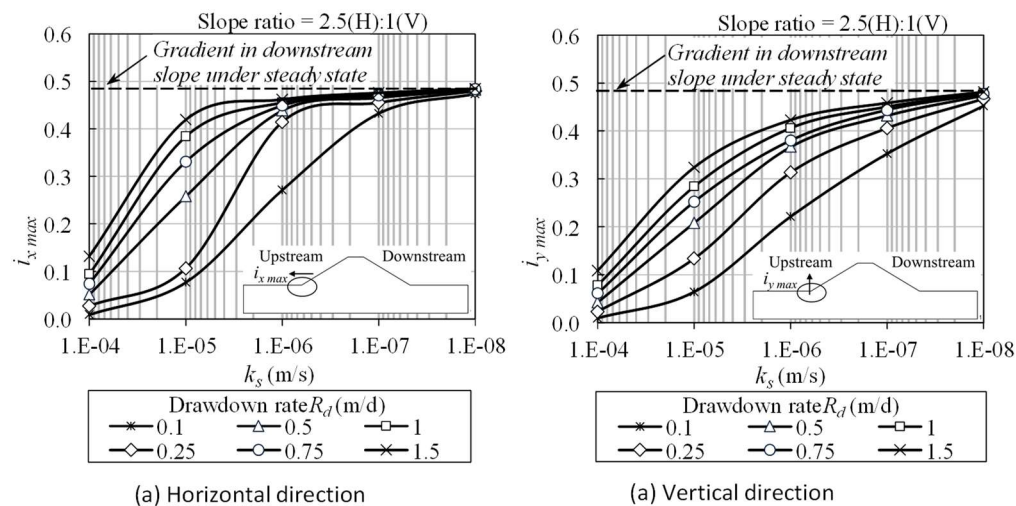
Figure 8 shows the effect of the drawdown rate on exit hydraulic gradients in the horizontal and vertical directions, corresponding to the x and y axes respectively, in both the upstream and downstream slopes of the dikes with variable hydraulic conductivities k_s . In addition, Figure 9 summarizes the results obtained assuming variable permeabilities k_s and a constant drawdown rate ($R_d = 1$ m/d). The following conclusions can be drawn on the basis of the results of these parametric analyses:

- The more impermeable a material is, the larger the exit hydraulic gradients. In this sense, the maximum value of the exit gradient in the upstream slope tends to match the value of the computed gradient in the downstream slope under steady-state conditions.

- The exit hydraulic gradients were observed to increase when the drawdown rate increased.
- In general, given the admissible values suggested by several authors for local erosion and piping (for example, Den Adel et al., 1988; Wan & Fell, 2004; Ahlinhan & Achmus, 2010), the magnitude of the gradients computed here is significant. One suitable way of preventing internal erosion or piping is the installation of filters or drains placed strategically in the earth structure.

Figure 8. Effect of drawdown rate R_d on exit hydraulic gradients in dikes for variable hydraulic conductivities k_s , (López-Acosta et al. 2015)

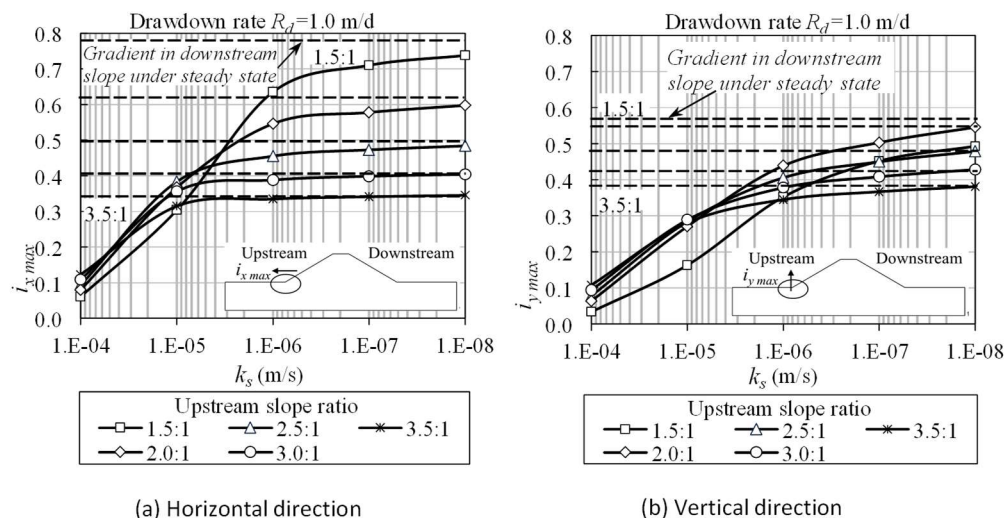
- Under a steady-state flow, the exit hydraulic gradients in the downstream slope remain constant for all k_s permeabilities studied.
- Changes in the slope ratio of dikes have a more significant effect on the magnitude of the exit hydraulic gradients than changes in the drawdown rate. It was observed that steeper slopes generate greater values for exit gradients.

Figure 9. Effect of the slope ratio (H:V) on exit hydraulic gradients in dikes for different hydraulic conductivities k_s , (López-Acosta et al. 2015)

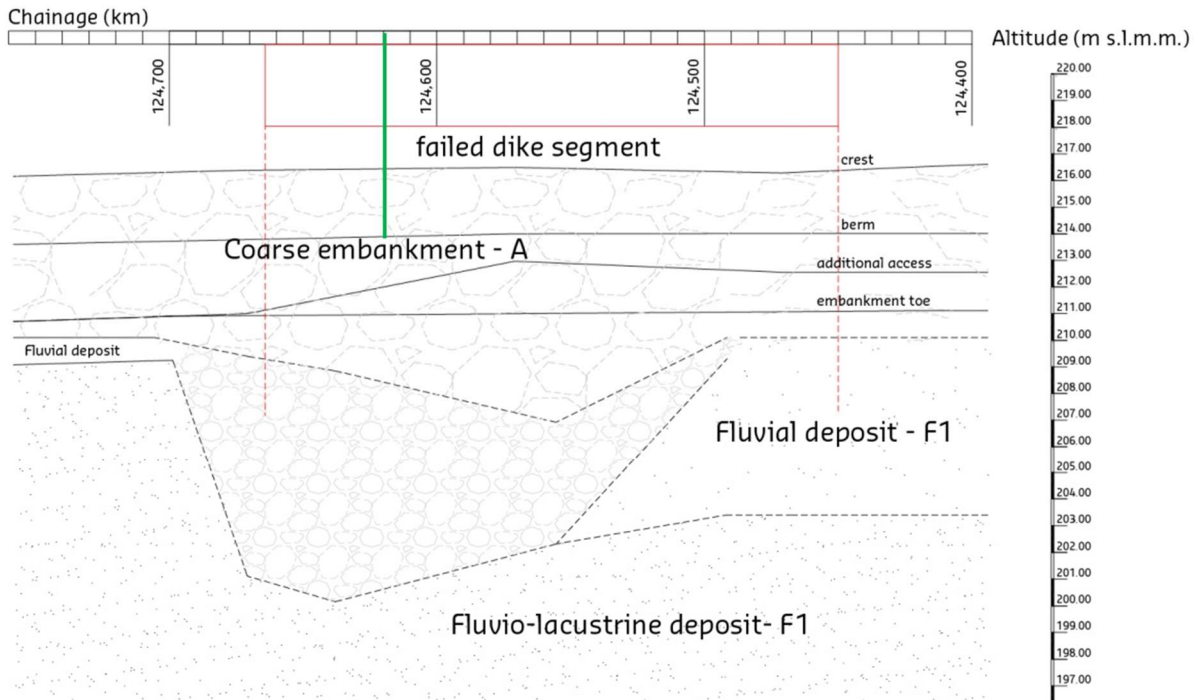
Figure 20. Longitudinal soil profile of the dike segment in Laag that includes the section breached in 1981. The location of the representative cross-section is indicated by the green line.

Figure 20 shows the longitudinal soil profile that includes the segment of the dike in Laag breached in 1981 and then reconstructed after 1981. The dip in the interface between the coarse-grained embankment and the ancient river bed is attributable to the excavation of the ancient river bed material after the dike was breached. During the flood, the embankment was patrolled frequently (a few times a day) and no evidence of sand boiling was detected. It is not possible to exclude that

sand boiling was occurring between one visual inspection and another. However, it would appear that failure was mainly caused by underseepage rather than erosion triggered by uplift pressures at the landside toe of the embankment.

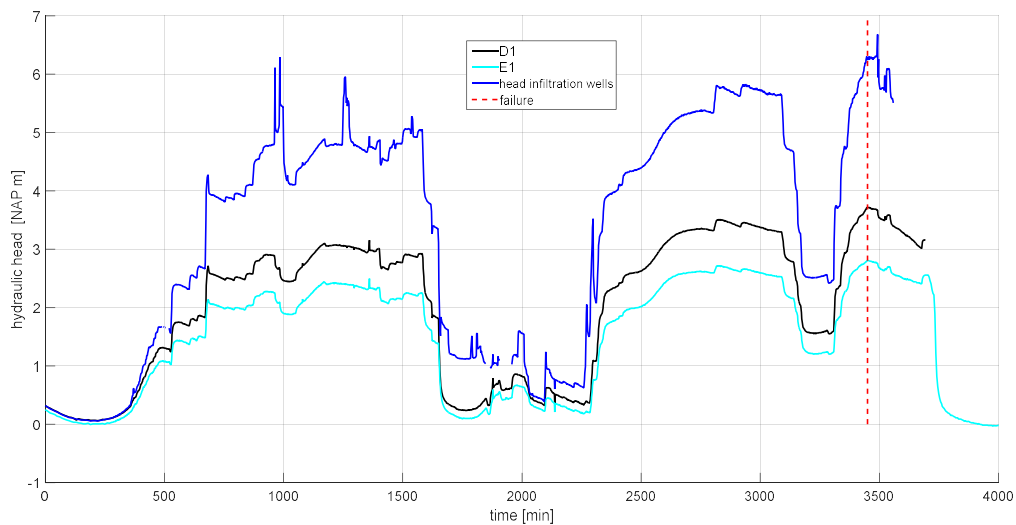
Figure 35. Hydraulic head in Pleistocene sand layer, locations D1 and E1 (see Figure 29)

Figure 35 shows the hydraulic head observed in the Pleistocene sand layer at distances of 21 and 42 m from the infiltration wells. The effect of infiltration declined with increasing distance from the well; the hydraulic head at D1 was lower than in the infiltration wells and a further reduction in maximum head was observed in E1.
