Lessons Learned from Dike Failures in Recent Decades

ABSTRACT: *The paper describes five different dike failures that occurred in recent decades. The case histories were located on different rivers and involved different loading conditions. The observed failure mechanisms involved erosion and stability problems. The types of erosion observed were both internal erosion due to extreme groundwater flow and external erosion caused by the river flow and wave action. The case involving instability was caused by uplift, i.e., increased hydraulic head led to a sharp reduction in maximum shear strength between subsoil layers. Two cases demonstrate the importance of dike management and maintenance. Despite the variations in the loading conditions and failure mechanisms, all the cases show that the strength of a dike depends not only on the material used to build the dike but also on the strength of the subsoil.*

Lessons Learned from Dike Failures in Recent Decades. International Journal of Geoengineering Case histories, Vol.4, Issue 3, p.203-229. doi: 10.4417/IJGCH-04-03-04

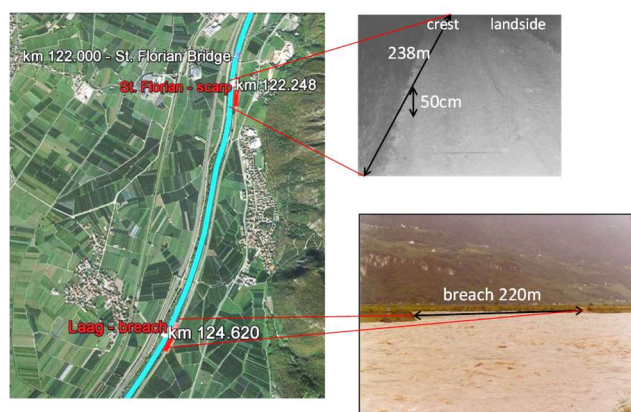
The flood event in 1981 led to the collapse of a 220-m-long section of the left flood embankment (chainage 124.450 km to 124.670 km) in Laag (Figure 16). At the same time, a scarp with a differential height of 50 cm was formed on a 238-m-long section in St Florian (chainage 122.150 km to 122.390 km), as shown in Figure 16.

Figure 16. Overview of the two considered segments of the Adige River at Laag and St Florian

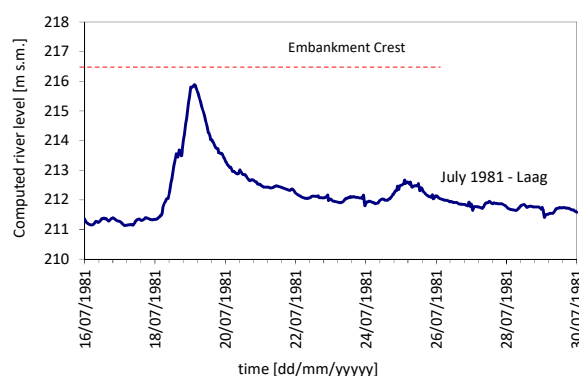
The river level at Laag and St Florian was derived from hydrometer measurements upstream (Branzoll hydrometer), assuming a uniform flow between the section where the hydrometer was installed and the sections where the embankment instabilities were located. The river level computed during the flood event is shown in Figure 17 and 19. At its peak, the river level in Laag and St Florian was still approximately 50 cm below the crest of the dike (Figure 17). Failure was therefore associated with water flow through the dike and/or its foundations and the collapse involved the instability of the landside bank.

Figure 17. River level computed at Laag (km 106.185) from 16 July to 30 July 1981. The elevation of the embankment crest is reported as a reference.

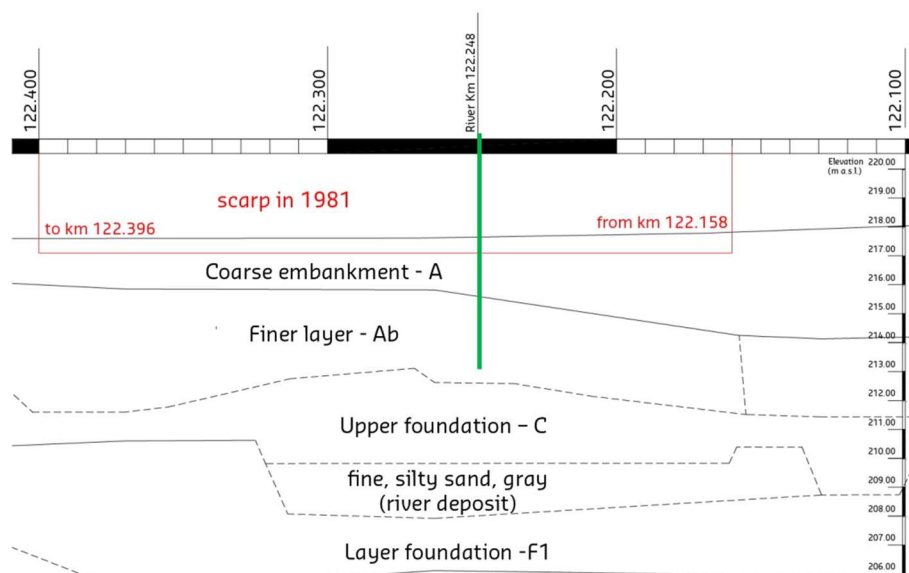
Figure 22. Longitudinal soil profile of the dike segment in St Florian that includes the portion affected by instability in 1981. The location of the representative cross-section is indicated by the green line.

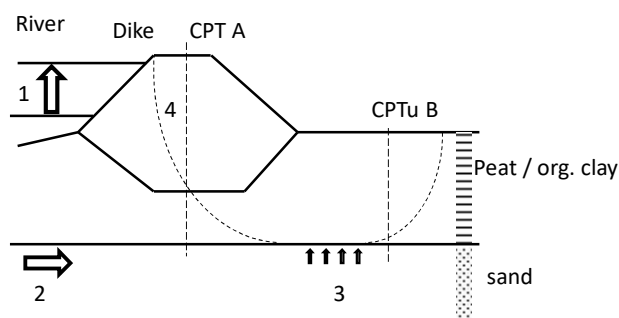
A typical failure mechanism for dikes in this area is loss of stability due to uplift of the soft soil layers at the toe. Figure 28 explains the failure mechanism. There is a hydraulic connection between the river and the Pleistocene sand layer. A rise in the river level (1) results in an increase in the hydraulic head in the Pleistocene sand layers (2) until the pore pressure equals the weight of the Holocene layers on top (3). The shear strength at the transition between the Holocene clay and peat layers on the one hand and the Pleistocene sand deposit on the other is drastically reduced, creating the conditions for a long, deep, slip plane (4). The uplift phenomenon is described in further detail by Cooling & Marsland (1953), Marsland (1961), Bauduin et al. (1989) and Van (2001). Observations of stability loss due to uplift are scarce and it was decided to study the uplift phenomenon at the Bergambacht test site.

Figure 28. Impression of the uplift failure mechanism, 1: river level rise, 2: hydraulic connection to sand layer, 3: pore pressure rise until uplift top layer, 4: failure plane.

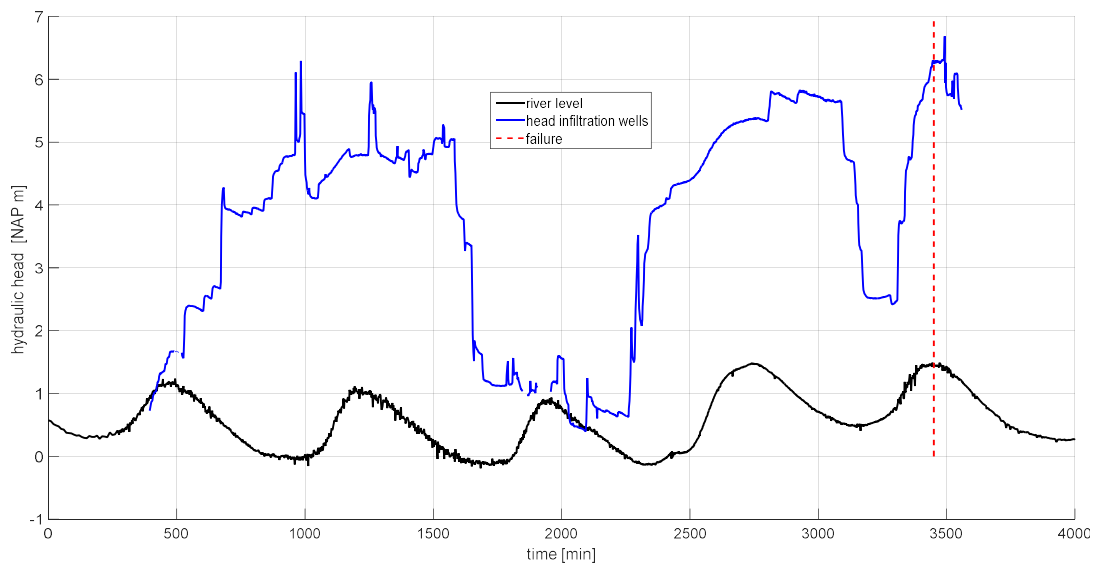
The test began at 06.00 on 26 November 2000, $t = 0$ in the graphs below. Figure 32 shows the river level and the average head in the nine infiltration wells. Infiltration started at $t = 370$ min, 6 hours after the start of the test. Initially, the hydraulic head in the wells followed the fluctuations in the river level. It should be noted that the test site is close to the sea and that the tidal wave has a pronounced influence on the water level in front of the dike. Although drinking water was used for infiltration, the infiltration wells clogged up after 26 hours, $t = 1580$ min, reducing well capacity. Due to maintenance, required to regain the full pumping capacity, the hydraulic head was seen to fall between $t = 1580$ and 2260 min, a period of 11.3 hours (Figure 32). Maintenance was also needed between $t = 3090$ and 3308 min, a period of 3.6 hours. Failure was observed at $t = 3450$ min, approximately 2.5 days after the start of the test, in the form of large longitudinal cracks in the dike body accompanied by major subsoil deformation (see Figures 33 and 34). The difference in height at the location of the cracks increased to more than 1.0 m (Figure 27b).

Figure 32. River level and hydraulic head in infiltration wells during the test
