Geotechnical Observations of Dams Failed During the 2015 Historic Flooding in South Carolina

ABSTRACT: *This paper presents a description of post-flood reconnaissance and geotechnical investigation of four earthen dams that were breached or damaged following an extreme flooding event in South Carolina in 2015. As a result of unprecedented rainfall and flooding that occurred during a five-day period at the beginning of October in 2015, a total of 51 earthen dams failed and nearly 200 were damaged. Many of these dams failed due to overtopping that led to a breach of the dam. Among the four dams investigated, full breach was observed at three dams; two of which were overtopped, and one was not. The fourth dam was not breached but was severely damaged. For each of these dams, the paper documents background information, pre-flood conditions, post-flood field observations and measurements, and laboratory testing results of collected soil samples. Impacts of vegetation on the dams and the effects of dam failure on critical infrastructure are also presented. The detailed descriptions and geotechnical investigations of the dam failures presented herein serve as case histories that can be u

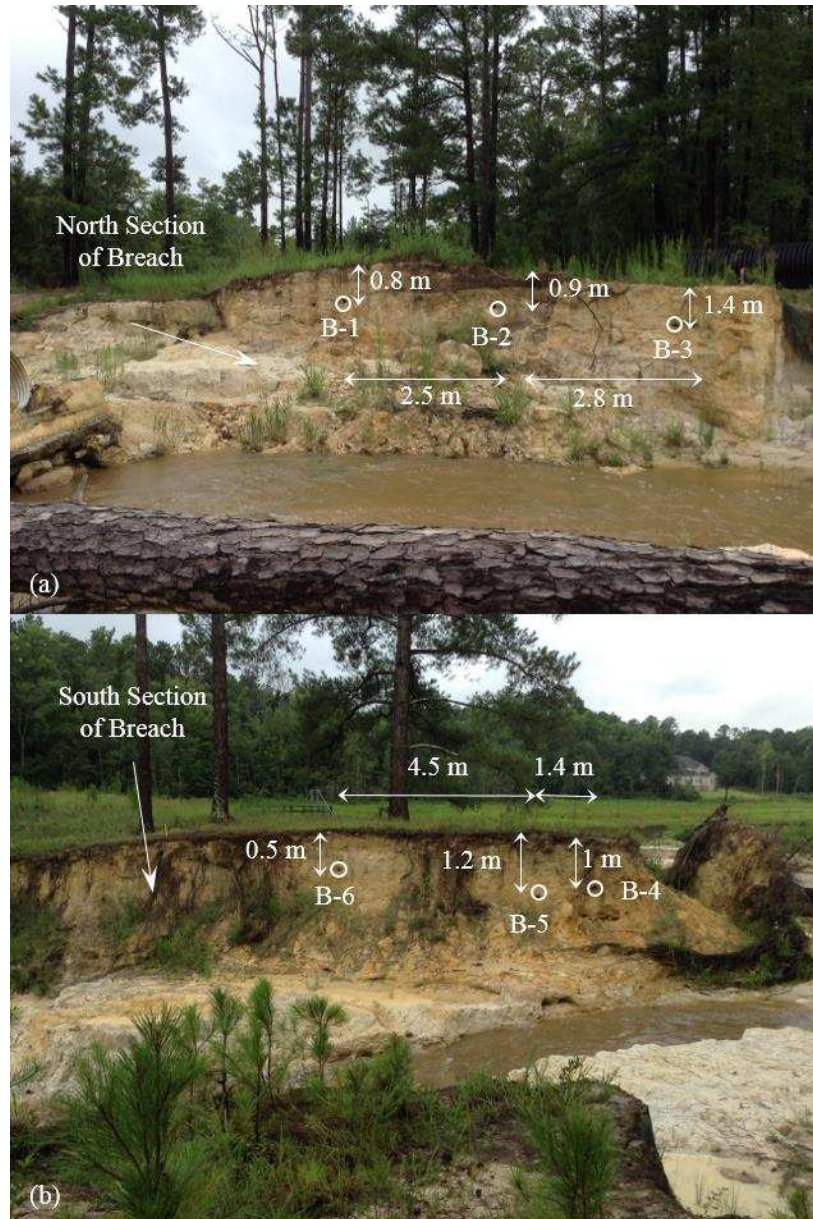
Laboratory testing results from soil samples collected at six locations from the breach section of Dam B are presented in Table 2. The sampling locations were selected to acquire soils representative of the full cross-section of the dam. Figure 17 shows the sampling locations viewed from the crest of the dam. The locations relative to the spillway, Congress Road, and the dam length, are also shown in Figure 12. Soils collected from the north and south sides of the breach are different. Samples B-1 and B-3 collected from the north side of the breach are classified as low to high plasticity clays and silts (MH and CH, and ML and CL, respectively), while the remaining soil samples were classified as silty or clayey sands (SM or SC). It is possible that because samples B-1 and B-3 were obtained from the north end of Dam B, there were natural materials scattered among the dam fill, or two different material types were used in the construction of the dam. In either case, there was no evidence of a dam core. Based on the results of samples taken closer to the middle section of the dam (B-4, B-5, and B-6), the dam material is mostly clayey sand with low plasticity fines. The fines content ranges from 15% to 49%. The erosion rate, based on the characteristics of the soils in this dam, is moderately rapid (Wan and Fell 2004). The presence of roots through the dam may result in significant increments of the erosion rate.

Figure 17. Sampling locations for Dam B, (a) north wall of breach section (north view from crest), and (b) south wall of breach section (south view from crest).

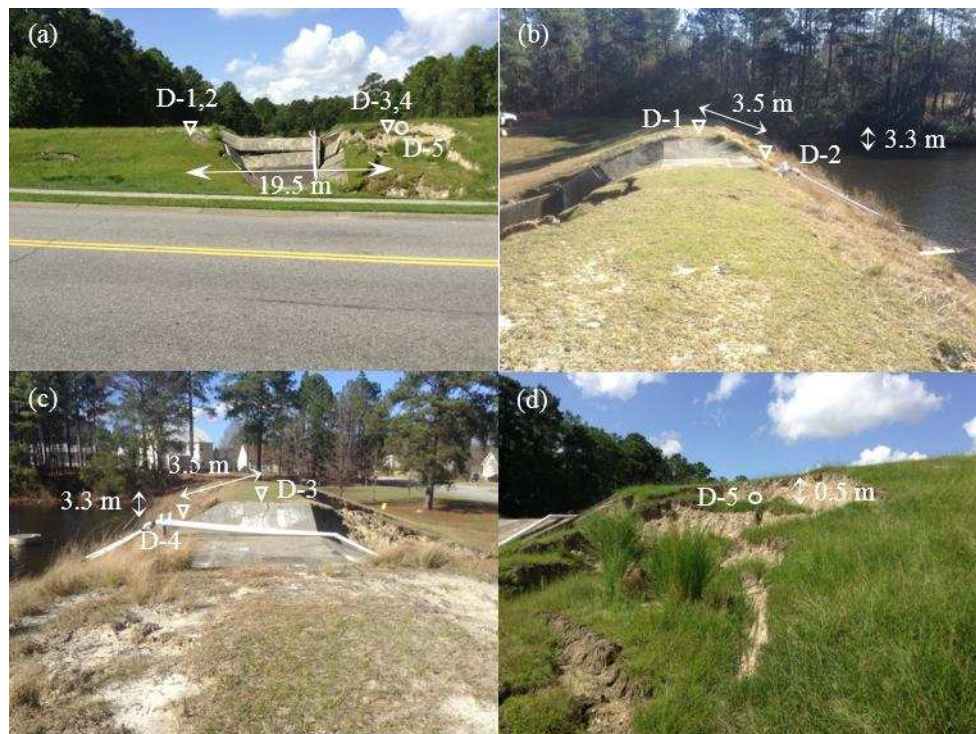
zone adjacent to the emergency spillway. Even though sample location D-5 is expected to be closer to the core of the dam (see Figure 31), pre-failure information provided by the dam owner indicates that Dam D does not have a definable core. In fact, the dam fill materials were consistent across all five sampling locations (primarily silty sands, SM, with little to no plasticity). Test results show that these soils have low to very low permeability (10^{-4} to 10^{-6} cm/s). The erosion rate, based on the characteristics of the soils in this dam, is extremely rapid (Wan and Fell 2004).

Figure 31. Sampling locations in Dam D: a) southwest view from Legion Drive, b) southeast view from the crest, c) northwest view from the crest, and d) southwest view from downstream side slope near the sliding zone (▽: vertical sample, ○: horizontal sample).
