Geotechnical Observations of Dams Failed During the 2015 Historic Flooding in South Carolina

ABSTRACT: *This paper presents a description of post-flood reconnaissance and geotechnical investigation of four earthen dams that were breached or damaged following an extreme flooding event in South Carolina in 2015. As a result of unprecedented rainfall and flooding that occurred during a five-day period at the beginning of October in 2015, a total of 51 earthen dams failed and nearly 200 were damaged. Many of these dams failed due to overtopping that led to a breach of the dam. Among the four dams investigated, full breach was observed at three dams; two of which were overtopped, and one was not. The fourth dam was not breached but was severely damaged. For each of these dams, the paper documents background information, pre-flood conditions, post-flood field observations and measurements, and laboratory testing results of collected soil samples. Impacts of vegetation on the dams and the effects of dam failure on critical infrastructure are also presented. The detailed descriptions and geotechnical investigations of the dam failures presented herein serve as case histories that can be u

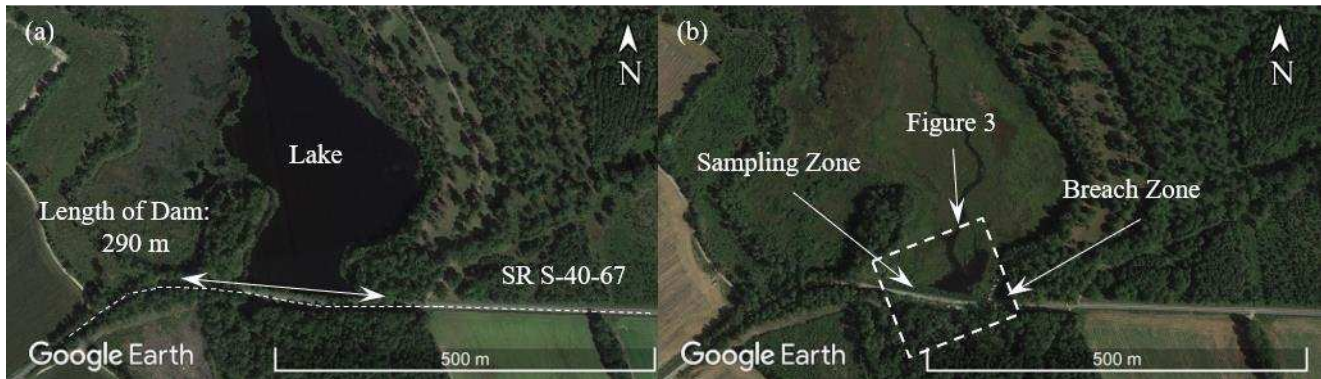
Dam A is located 28 km southeast from downtown Columbia, South Carolina. The dam was constructed around 1932 (USACE 2016). Satellite imagery of the dam before and after failure are shown in Figure 2. The crest width was measured to be 16 m, and the upstream side slope was measured to be 30° . The downstream side slope was completely washed out and could not be measured. According to USACE (2016), the height of the dam is 4 m, which is defined as the vertical distance from the lowest point on the crest to the lowest point in the original streambed. The original length of the dam is approximately 290 m. A two-lane roadway that is 16 m wide (including shoulders) runs along the crest of the dam. The dam impounds a lake with a surface area of about 0.06 km^2 under normal storage conditions (USACE 2016). The dam allows normal and maximum storage capacities of $178,000 \text{ m}^3$ and $400,000 \text{ m}^3$, respectively. SCDHEC (2016) considers this dam to be a low-

Figure 2. Dam A (a) before and (b) after failure (Google Earth, accessed on April 8, 2018).

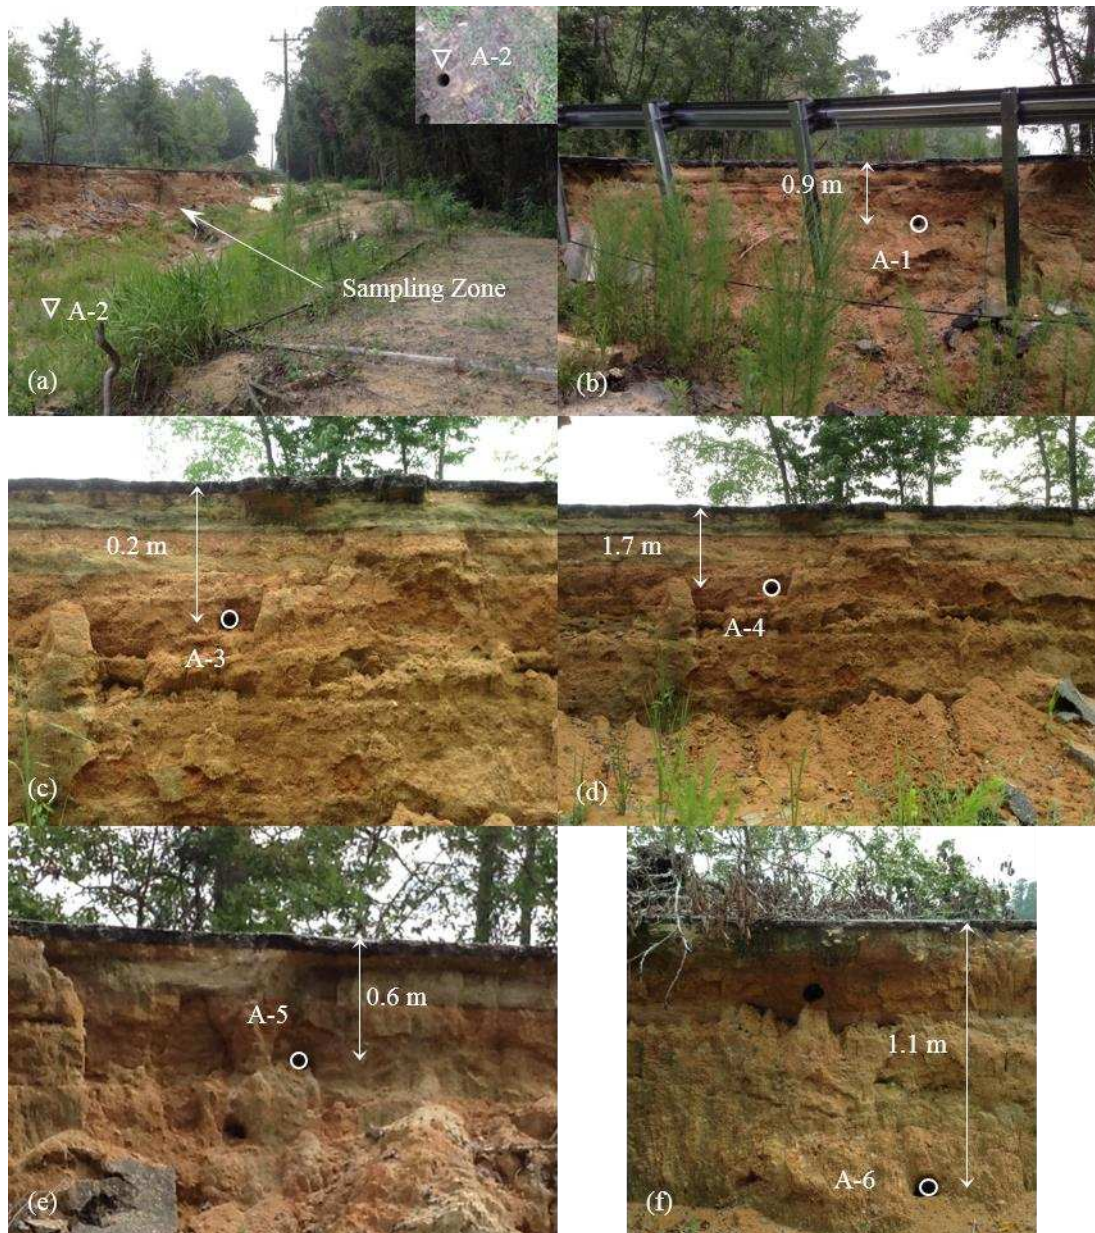
Laboratory testing results from soil samples collected at six locations from the downstream side slope of the dam are presented in Table 1. Approximately half of the road lane collapsed due to slope failure; therefore, the samples were collected relatively close to the center of the embankment. The samples were obtained in the area where surface erosion and slope failure occurred except for sample A-2, which was obtained from the foundation soil. The distance from the crest of the dam to the sample locations is presented in Figure 9, and the sampling depth for each hole is presented in Table 1. The distance of sampling locations relative to the breach zone are shown in Figure 3. The dam materials are mostly silty to clayey sands with 23% to 42% low plasticity fines. The foundation soil (A-2) at a depth of approximately 56-81 cm also appears to be silty sand. Based on these test results and the visual field observations of the soils along the length of the exposed embankment, the dam material appears to be relatively consistent (SM or SC) with no definable core. The coefficient of permeability is low to very low (10^{-4} to 10^{-6} cm/s). Based on the soil characteristics in Dam A, internal erosion would occur moderately to extremely rapidly in the presence of cracks or hydraulic fractures (Wan and Fell 2004).

Figure 9. Sampling locations in Dam A: a) east view from downstream side, and b), c), d), e) and f) north view from downstream side (∇ : vertical sample, \bigcirc : horizontal sample).

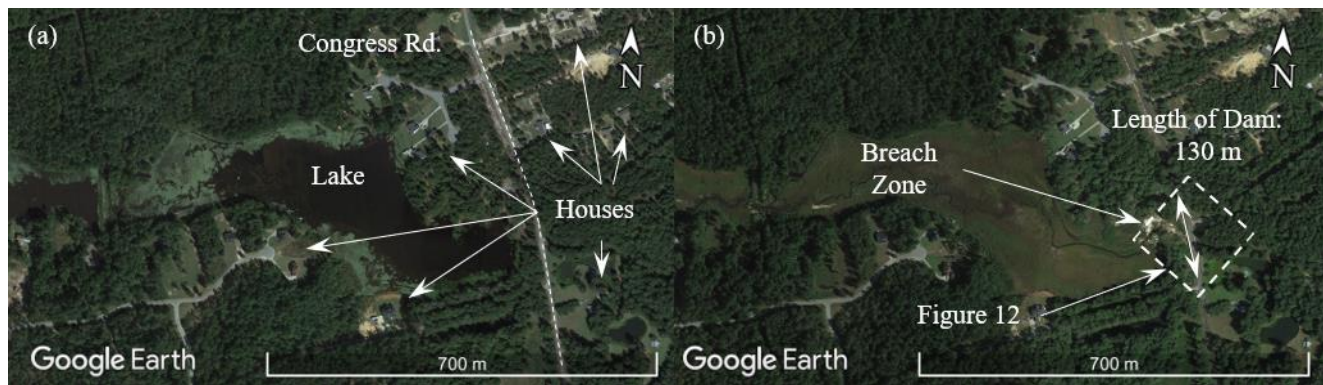
Dam B is located 27 km east of downtown Columbia, South Carolina. The dam was constructed in 1960 (USACE 2016). Satellite imagery of the dam before and after failure are shown in Figure 10. The crest width of the dam was measured to be 6 m and the upstream side slope was measured to be 23° . The downstream side-slope was not measured due to slope failure caused by surface erosion. According to USACE (2016), the height of the dam is 4.3 m, and the original length of the dam is approximately 130 m. The dam impounds a lake with surface area of 0.08 km^2 under normal storage conditions. The normal and maximum storage capacities are 89,000 and 166,000 m^3 , respectively. SCDHEC (2016) considers this dam to be a significant-hazard potential structure (C2). Several houses are located on the upstream and downstream sides of the dam (see Figure 10a). The dam is located west of Congress Road, a two-lane road located 40 m downstream of the dam. Pictures of the breached section of the dam, looking toward Congress Road are shown in Figure 11. The dam breach washed out both lanes of Congress Road and damaged the bridge supporting the road, as shown in Figures 12 and 13.

Figure 10. Dam B (a) before and (b) after failure (Google Earth, accessed on April 8, 2018).

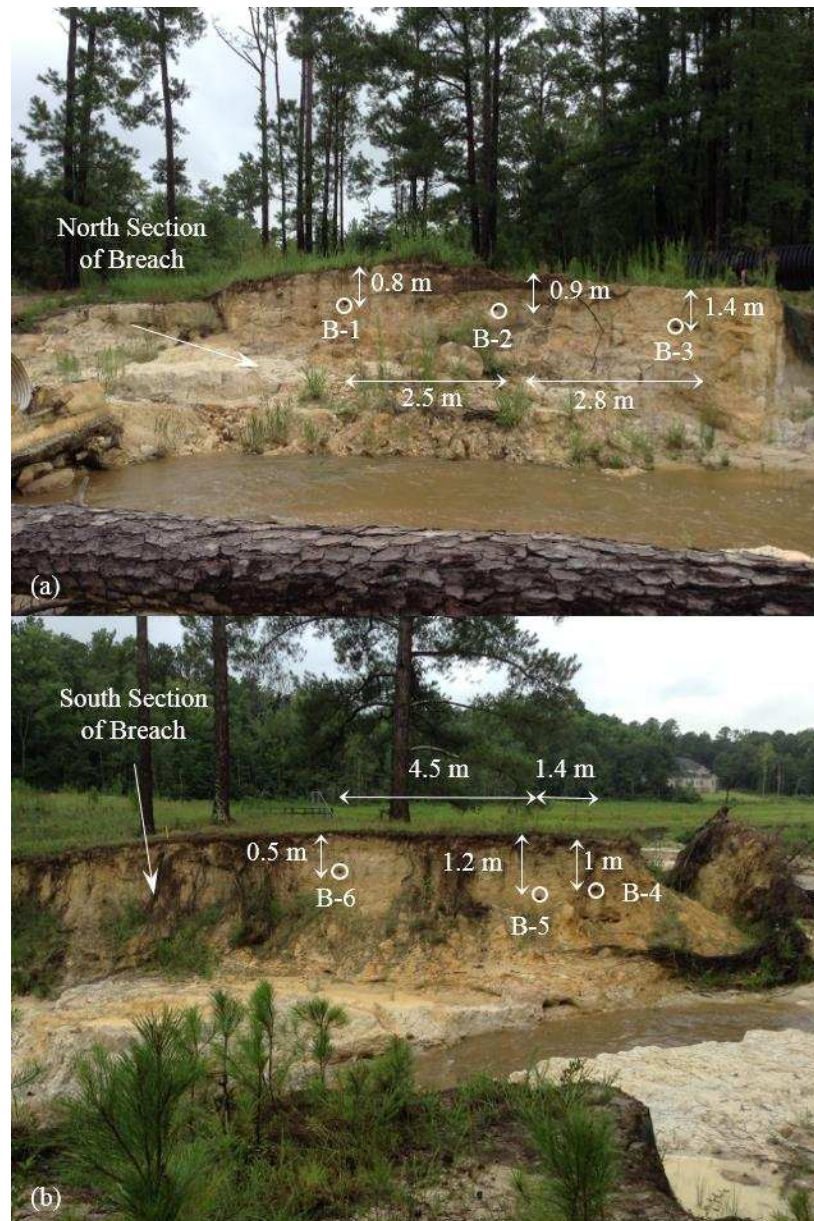
Laboratory testing results from soil samples collected at six locations from the breach section of Dam B are presented in Table 2. The sampling locations were selected to acquire soils representative of the full cross-section of the dam. Figure 17 shows the sampling locations viewed from the crest of the dam. The locations relative to the spillway, Congress Road, and the dam length, are also shown in Figure 12. Soils collected from the north and south sides of the breach are different. Samples B-1 and B-3 collected from the north side of the breach are classified as low to high plasticity clays and silts (MH and CH, and ML and CL, respectively), while the remaining soil samples were classified as silty or clayey sands (SM or SC). It is possible that because samples B-1 and B-3 were obtained from the north end of Dam B, there were natural materials scattered among the dam fill, or two different material types were used in the construction of the dam. In either case, there was no evidence of a dam core. Based on the results of samples taken closer to the middle section of the dam (B-4, B-5, and B-6), the dam material is mostly clayey sand with low plasticity fines. The fines content ranges from 15% to 49 %. The erosion rate, based on the characteristics of the soils in this dam, is moderately rapid (Wan and Fell 2004). The presence of roots through the dam may result in significant increments of the erosion rate.

Figure 17. Sampling locations for Dam B, (a) north wall of breach section (north view from crest), and (b) south wall of breach section (south view from crest).

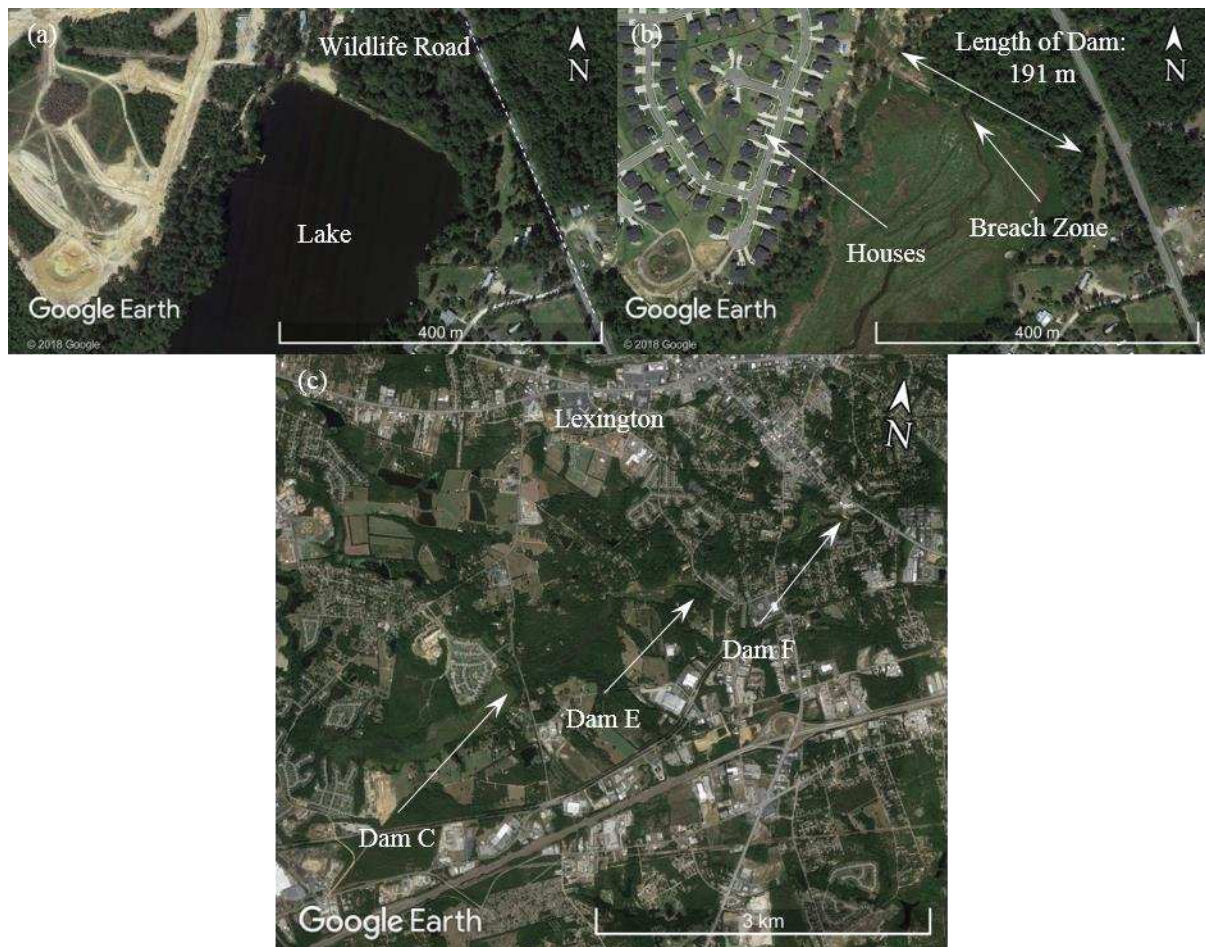
Dam C is located 21 km west from downtown Columbia, South Carolina. The dam was constructed in 1900 and is one of the oldest dams in South Carolina (USACE 2016). Satellite imagery of the dam, before and after the flood event, are shown in Figures 18a and 18b. The dam was built across a creek, nearly 4 km upstream of two pond dams (labeled Dam E and Dam F in Figure 18c). The crest width of the dam was measured to be 4 m and the upstream and downstream side slopes were measured to be 32° and 35° , respectively. According to USACE (2016), the height of the dam is 4 m, and the original length of the dam is approximately 191 m. The dam is located nearly 130 m southwest from a two-lane state road (labeled Wildlife Road in Figure 18), and close to a new subdivision located to the west of the dam. Dam C impounds a lake with an approximate surface area of 0.26 km^2 under normal storage conditions, allowing a storage of approximately $443,000 \text{ m}^3$. SCDHEC (2016) considers this dam to be a significant-hazard potential structure (C2). Fortunately, the breach did not cause significant damage to Wildlife Road or the houses nearby.

Figure 18. Dam C (a) before and (b) after failure, (c) locations of Dams E and F downstream of Dam C (Google Earth, accessed on April 8, 2018).

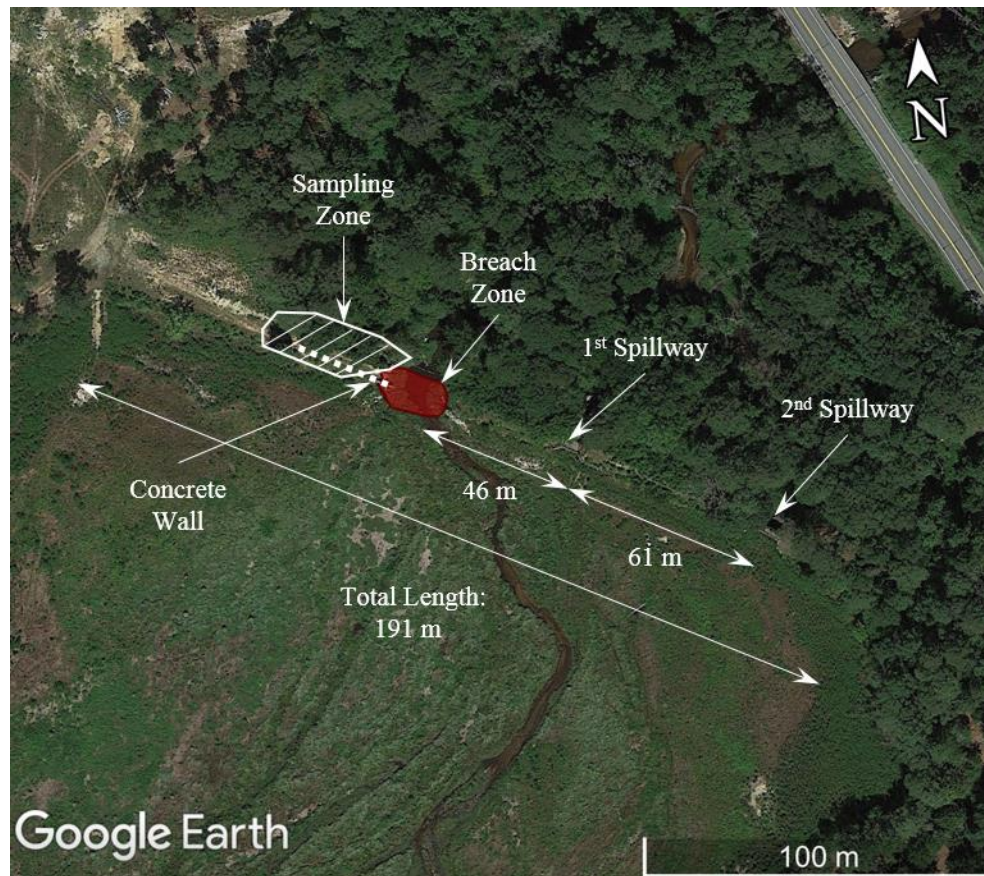
Figure 19. Locations of the breach and the two spillways in Dam C (Google Earth, accessed on April 8, 2018).

The dam was completely breached during the flood event as shown in Figure 22. The breach was located near the middle of the dam, 46 m northwest from the location of the first spillway gate (see Figure 19). The length of the breach was approximately 20 m of the total 191 m length of the dam, and nearly 900 m³ of soil were washed out. Eyewitnesses during the flood event indicated that overtopping did not occur. Subsequent field observations did not find evidence of surface erosion on the downstream side slope or near the spillways.

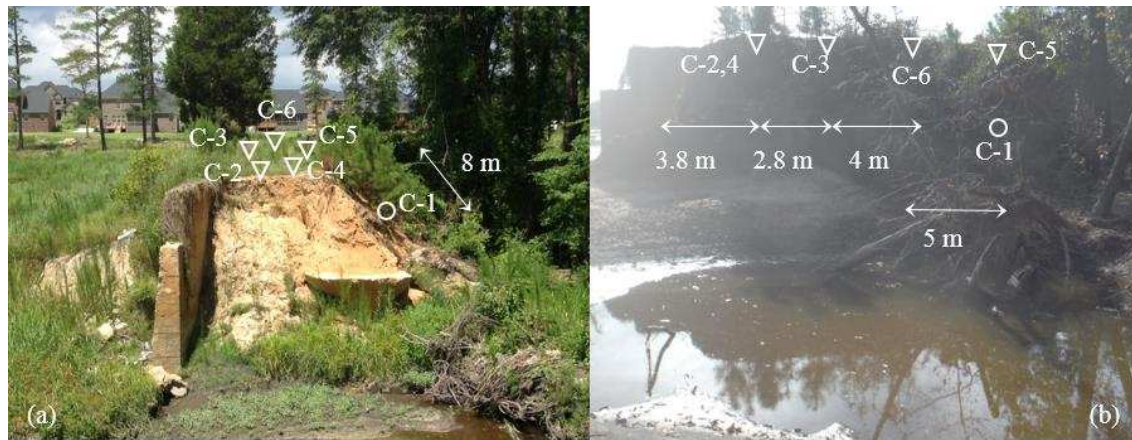
Laboratory testing results from soil samples collected at six locations from the crest and downstream side slope of Dam C are presented in Table 3. The sampling locations are presented in Figures 19 and 24. Dam fill materials are mainly clayey to silty sands with approximately 27% to 53% low plasticity fines. Based on the experimental results and field observations of the cross-section of the breach (see Figure 21), the dam fill materials are relatively consistent and a definable core was not observed. The erosion rate, based on the characteristics of the soils in this dam, is moderately to extremely rapid (Wan and Fell 2004).

Figure 24. Sampling locations for Dam C: a) northwest view from southeast section of breach, and b) southwest view from downstream (∇ : vertical sample, \bigcirc : horizontal sample).

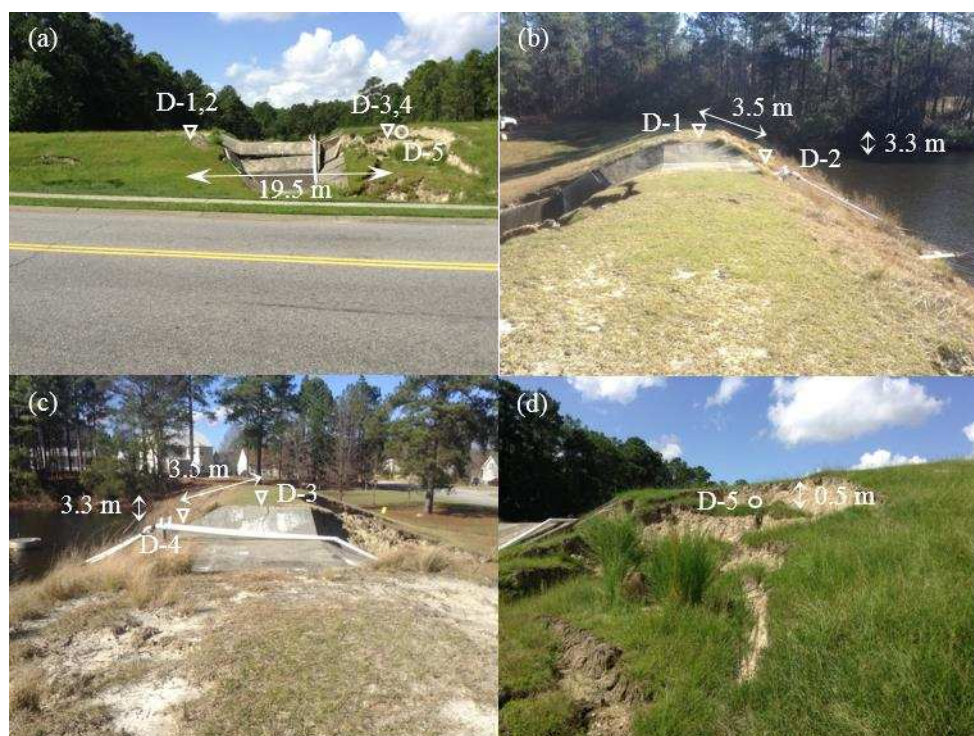
zone adjacent to the emergency spillway. Even though sample location D-5 is expected to be closer to the core of the dam (see Figure 31), pre-failure information provided by the dam owner indicates that Dam D does not have a definable core. In fact, the dam fill materials were consistent across all five sampling locations (primarily silty sands, SM, with little to no plasticity). Test results show that these soils have low to very low permeability (10^{-4} to 10^{-6} cm/s). The erosion rate, based on the characteristics of the soils in this dam, is extremely rapid (Wan and Fell 2004).

Figure 31. Sampling locations in Dam D: a) southwest view from Legion Drive, b) southeast view from the crest, c) northwest view from the crest, and d) southwest view from downstream side slope near the sliding zone (▽: vertical sample, ○: horizontal sample).
