Geotechnical Effects of Hurricane Harvey in the Houston, Beaumont, and Port Arthur Areas

ABSTRACT: *The Geotechnical Extreme Events Reconnaissance (GEER) Association deployed multiple teams of engineers from academia and practicing firms to the coast of Texas in late August and early September 2017 following Hurricane Harvey. This report summarizes the observations and data from the GEER team that focused primarily on the inland effects of Hurricane Harvey in the Houston area with some observations in the Port Arthur / Beaumont area east of Houston. Rain, not storm surge or wind, caused the observed damage in Houston, Beaumont, and Port Arthur by overwhelming stormwater management facilities and creating high flows and flooding in and near area waterways. The major Houston-area flood structures, Addicks and Barker Dams, performed well from a geotechnical perspective. Observed damages included shallow slides along levees, severe erosion along riverways, isolated road and culvert erosion and uplift, and area-wide flood effects in low and poorly drained neighborhoods.*

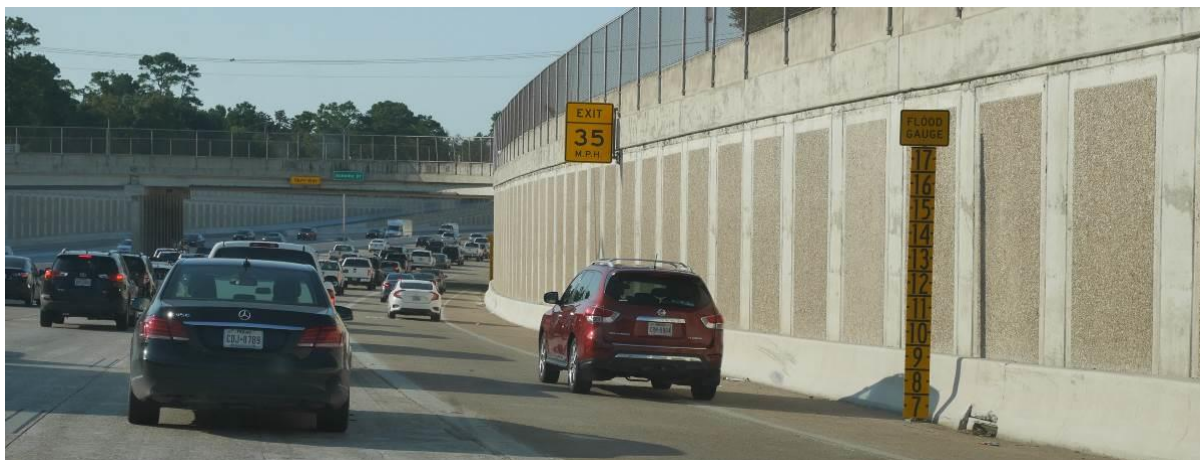
Flooding caused roadway damage to and closure of a major area artery at the underpass intersection of the Sam Houston Parkway / Beltway 8 and Boheme Drive (see Fig. 1 for location, 29.76736° N, 95.56210° W). The parkway is depressed at this intersection and floods often enough that flood depth sign gauges are posted along the road to warn motorists of the standing water depth (see Fig. 31).

Figure 31. Beltway 8 / Boheme Drive underpass and flood depth signs (September 11, 2017, 29.76694° N, 95.56139° W).
