Geotechnical Effects of Hurricane Harvey in the Houston, Beaumont, and Port Arthur Areas

ABSTRACT: *The Geotechnical Extreme Events Reconnaissance (GEER) Association deployed multiple teams of engineers from academia and practicing firms to the coast of Texas in late August and early September 2017 following Hurricane Harvey. This report summarizes the observations and data from the GEER team that focused primarily on the inland effects of Hurricane Harvey in the Houston area with some observations in the Port Arthur / Beaumont area east of Houston. Rain, not storm surge or wind, caused the observed damage in Houston, Beaumont, and Port Arthur by overwhelming stormwater management facilities and creating high flows and flooding in and near area waterways. The major Houston-area flood structures, Addicks and Barker Dams, performed well from a geotechnical perspective. Observed damages included shallow slides along levees, severe erosion along riverways, isolated road and culvert erosion and uplift, and area-wide flood effects in low and poorly drained neighborhoods.*

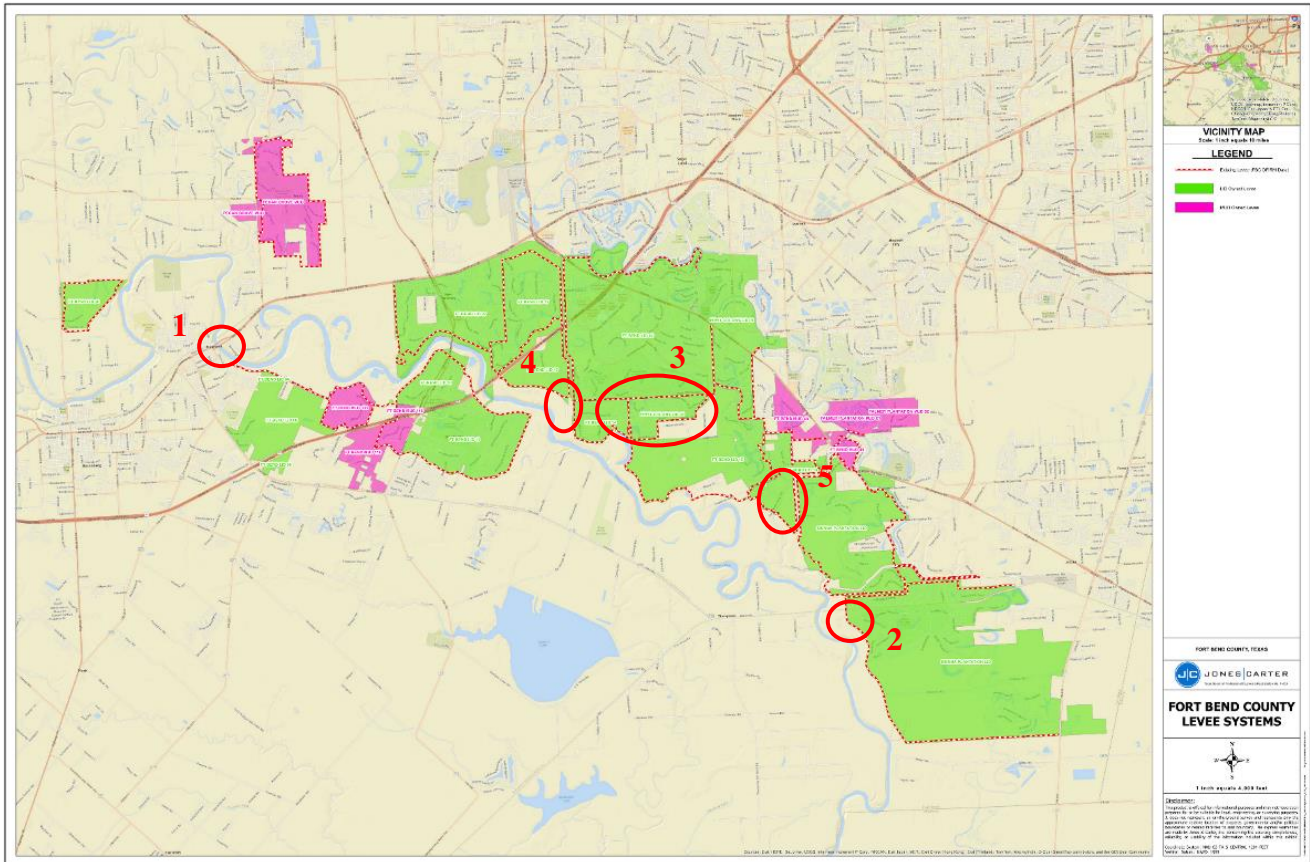
Figure 13. Fort Bend County Levee Systems. See following list for names of labelled systems. Existing levees are shown as red-dashed lines, LIDs in green, and MUDs in purple (from Jones|Carter), 1 – Richmond, Texas, USGS gauge on the Brazos River, 2 – Sienna Plantation Levee Improvement District levee surficial slough, 3 – First Colony LID 2, 4 – Ditch H, 5 – Flat Bank Diversion Channel

During the Hurricane Harvey flooding, the USGS stream gauge for the Brazos River at Richmond, Texas, (see Location 1 on Fig. 13) recorded a peak reading of 16.8 m (55.19 ft) corresponding to about 3,540 m³/s (125,000 cfs). The gauge also recorded a total of 64 cm (25 inches) of rain between August 25 and August 29, 2017. The previous high-water record at the gauge was 16.7 m (54.74 ft) on June 2, 2016 during the Memorial Day Flood.

Overall, we understand that the Brazos River LID levees performed well, with no major failures, breaches, or overtopping. One incident of a surficial slide on the protected slope of a Sienna Plantation LID levee was reported and photographed by others as shown in Fig. 14 (see Location 2 on Fig. 13). The GEER team visited the First Colony LID 2 (see Location 3 on Fig. 13) and two of the drainage ditches that serve the LIDs (see Locations 4 and 5 on Fig. 13). Despite the good levee performance, flooding occurred within several LIDs due to the issues with storm water removal from the protected side behind the levees to the river side. Some LIDs were even completely cut off due to water surrounding the entirety of the LID.
