Geotechnical Effects of Hurricane Harvey in the Houston, Beaumont, and Port Arthur Areas

ABSTRACT: *The Geotechnical Extreme Events Reconnaissance (GEER) Association deployed multiple teams of engineers from academia and practicing firms to the coast of Texas in late August and early September 2017 following Hurricane Harvey. This report summarizes the observations and data from the GEER team that focused primarily on the inland effects of Hurricane Harvey in the Houston area with some observations in the Port Arthur / Beaumont area east of Houston. Rain, not storm surge or wind, caused the observed damage in Houston, Beaumont, and Port Arthur by overwhelming stormwater management facilities and creating high flows and flooding in and near area waterways. The major Houston-area flood structures, Addicks and Barker Dams, performed well from a geotechnical perspective. Observed damages included shallow slides along levees, severe erosion along riverways, isolated road and culvert erosion and uplift, and area-wide flood effects in low and poorly drained neighborhoods.*

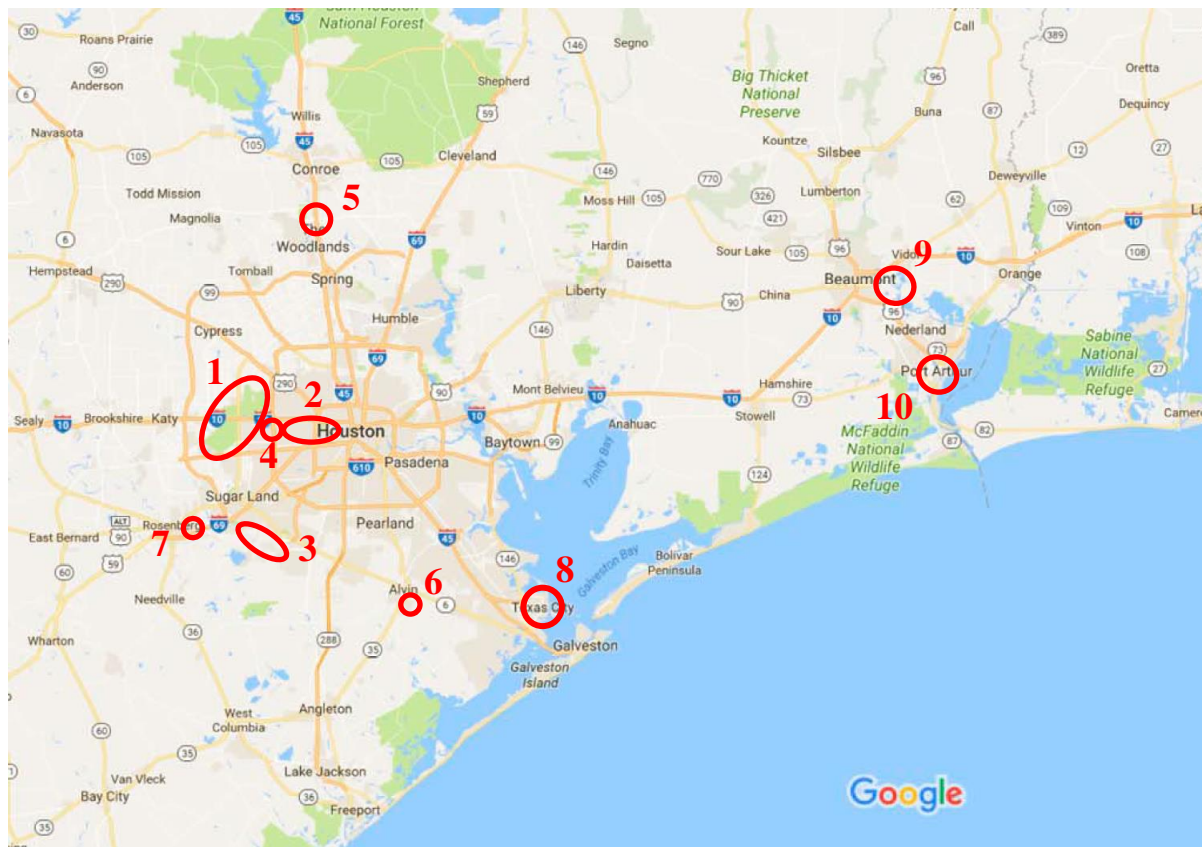
Figure 1. Observation Areas by GEER Hurricane Harvey Houston Team (see following list for site names). 1 – USACE Houston Flood Risk Management Dams – Barker and Addicks Dams, 2 – Buffalo Bayou, 3 – Brazos River Levees, 4 – Beltway 8 Underpass Slab, 5 – San Jacinto River Bridges, 6 – Mustang Bayou Bridge, 7 – FM 762 Road Culvert, 8 – Texas City Levees, 9 – Beaumont, 10 – Port Arthur
