Geotechnical Extreme Event Site Reconnaissance in Puerto Rico After The Passage of Hurricane Maria

ABSTRACT: *The National Weather Service classified Hurricane Maria as a strong Category 4 Hurricane on the Saffir-Simpson hurricane wind scale at the time of its landfall in Yabucoa, Puerto Rico, U.S.A., on September 20, 2017. The immediate aftermath of Hurricane Maria was a devastated island with at least 64 people killed, severe infrastructure loss, a devastated electric power grid, and numerous geotechnical failures related to the intense rainfall and strong winds associated to this extreme event. This paper will summarize the event timeline and the geotechnical consequences of Maria's path across Puerto Rico. The impacts of Hurricane Maria on infrastructure and geomorphology are documented through the data and observations of the engineers and geologists that comprised the Geotechnical Extreme Events Reconnaissance (GEER) team. The main reconnaissance mission took place between October 25 and November 6, 2017, followed by a second field component involving terrestrial LiDAR surveys and UAV photogrammetry performed January 8 to 11, 2018.*

Reference: Silva-Tulla F., and Pando M. A

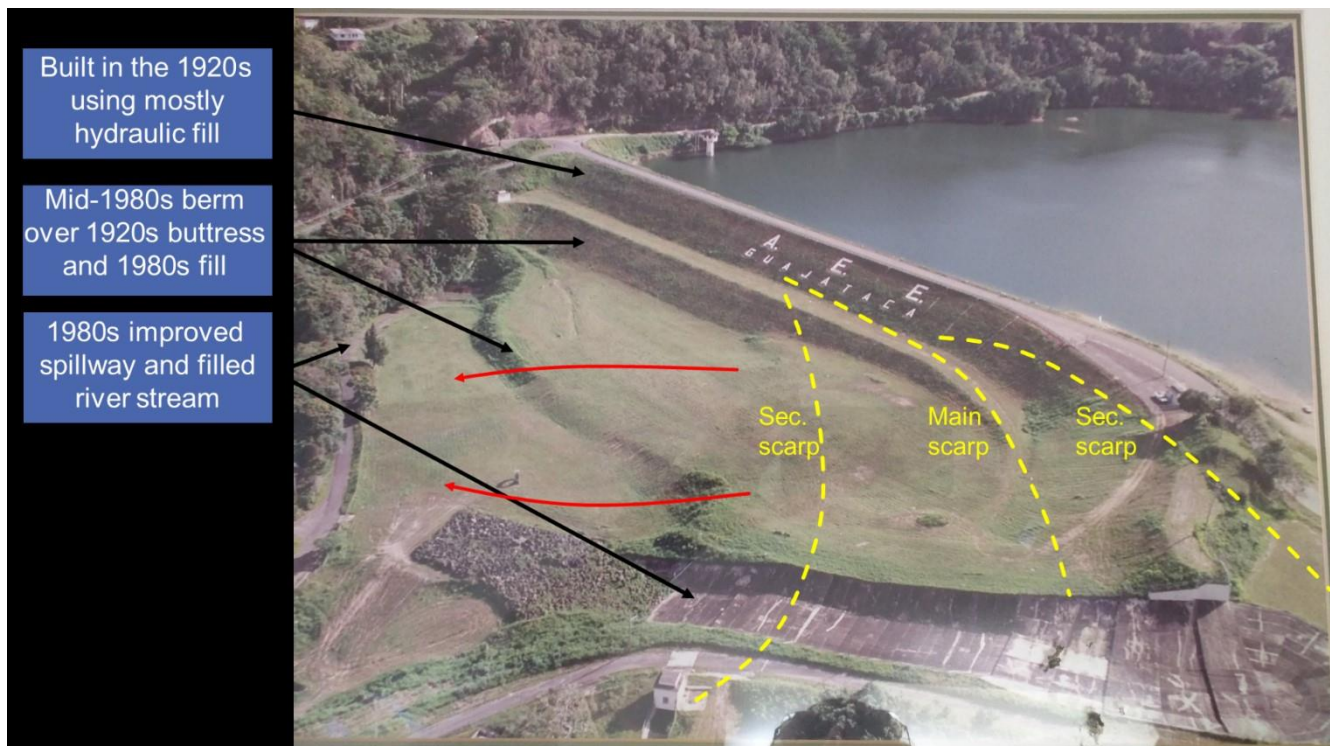
Figure 8. Photo of Guajataca Dam (Lat. +18.397895, Lon. -66.923725), taken a few decades before Hurricane Maria – exact date of photo unknown (adapted from Silva-Tulla et al., 2018).

The GEER mission visited Guajataca Dam, where severe damage to the spillway and dam safety concerns prompted the evacuation of about 70,000 downstream residents. Figure 8 shows Guajataca Dam, an earthfill dam built in the 1920s, mostly by hydraulic fill methods, and modified in the 1980s. The dam has a maximum height of about 37 m (121 ft) and a crest 316 m (1,037 ft) long and 9.5 m (31.2 ft) wide, with a “puddle clay” core sloping at about 0.5 to 1 (horizontal to vertical [H:V]). Its upstream and downstream faces slope at ratios of 2:1 H:V or flatter. According to the National Inventory of Dams (USACE, 2016), Guajataca Dam was designed for and owned by the Puerto Rico Electric Power Authority. A detailed description of the history and construction of the dam can be found in USBR (2002).

Note: Figure shows historical and landslide features remediated in the 1980s.

The river is no longer visible in Figure 8, indicating that the photo was taken after completion of the 1980s improvements. Between 1992 and 1993, instrumentation consisting of seven inclinometers was installed (three along the crest, one over the buttress, and three downstream of the toe). Three of the four inclinometers installed on the buttress and downstream of the dam became inoperable within ten years of their installation due to excessive horizontal movements. Although these inclinometers were not completely sheared by 2002, we understand that they currently are. Movement was reported to our GEER team to have occurred at a depth of about 19 m (elevation 170 m), where a layer of green clay that slopes at an angle of about 4° exists. The appearance of piezometers in the field suggests they are contemporaneous with the slope indicators (i.e., installed in the early 1990s) (Silva-Tulla et al., 2018).

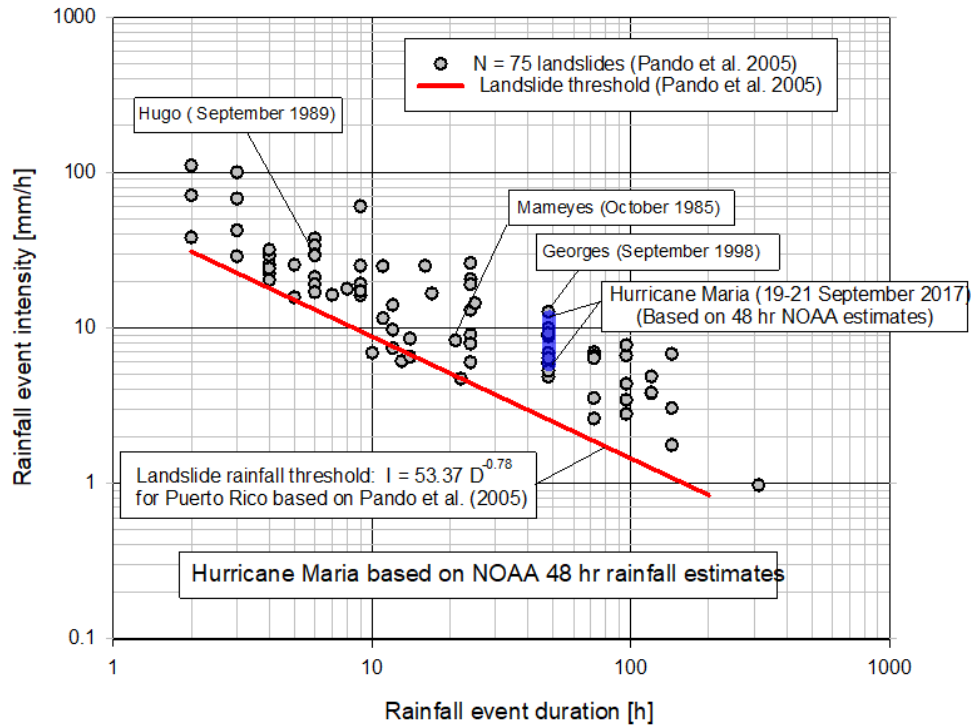
Figure 15. Estimated Hurricane Maria rainfall (blue line) and the Pando et al. (2005) rainfall-induced landslide threshold.

The passing of Hurricane Maria destroyed most rainfall gauges. However, rainfall estimates by NOAA and the National Weather Service for the period of 8:00 AM on September 19 to 8:00 AM on September 21 indicate rainfall ranging between 279 to 559 mm (11 to 22 in) for the municipalities most affected by landslides. For this 48-hour period, the average rainfall intensity would range approximately from about 5.8 to 11.6 mm/hr. Figure 15 shows this estimated range of rainfall intensity for Hurricane Maria, considering a 48-hour duration, together with a preliminary regional landslide rainfall threshold for Puerto Rico by Pando et al. (2005). The estimated rainfall intensity and duration for Hurricane Maria falls above this generalized regional landslide rainfall threshold, consistent with the many documented landslides recorded.
