# Geotechnical Extreme Event Site Reconnaissance in Puerto Rico After The Passage of Hurricane Maria

**Francisco Silva-Tulla**, Consulting Civil Engineer, GeoEngineering and Environment, Lexington, Massachusetts, U.S.A.; email: [silva@alum.mit.edu](mailto:silva@alum.mit.edu)

**Miguel A. Pando**, Associate Professor, Department of Civil, Architectural, and Environmental Engineering, Drexel University, Philadelphia, PA, 19104, U.S.A.; email: [miguel.a.pando@drexel.edu](mailto:miguel.a.pando@drexel.edu)

Submitted: 7 November 2018; Published: 2 July 2020

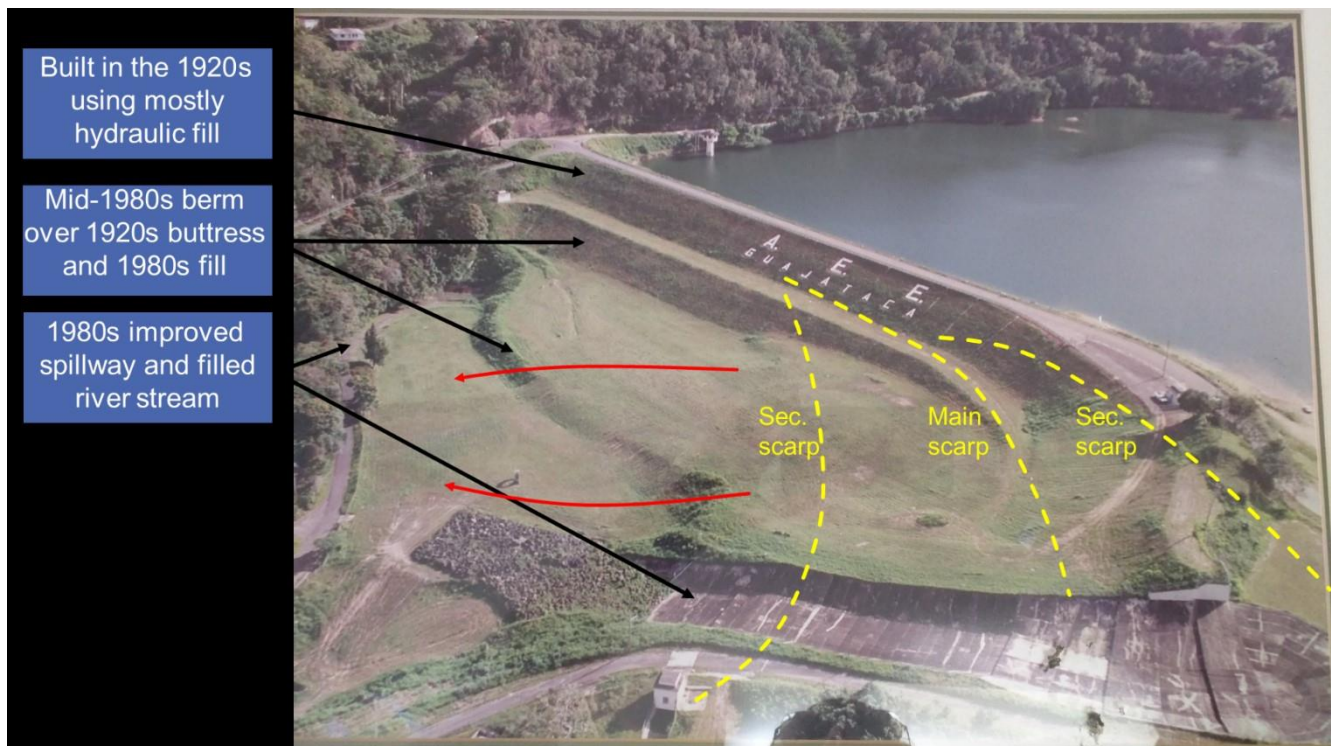
The GEER mission visited Guajataca Dam, where severe damage to the spillway and dam safety concerns prompted the evacuation of about 70,000 downstream residents. Figure 8 shows Guajataca Dam, an earthfill dam built in the 1920s, mostly by hydraulic fill methods, and modified in the 1980s. The dam has a maximum height of about 37 m (121 ft) and a crest 316 m (1,037 ft) long and 9.5 m (31.2 ft) wide, with a “puddle clay” core sloping at about 0.5 to 1 (horizontal to vertical [H:V]). Its upstream and downstream faces slope at ratios of 2:1 H:V or flatter. According to the National Inventory of Dams (USACE, 2016), Guajataca Dam was designed for and owned by the Puerto Rico Electric Power Authority. A detailed description of the history and construction of the dam can be found in USBR (2002).

Note: Figure shows historical and landslide features remediated in the 1980s.

Figure 8. Photo of Guajataca Dam (Lat. +18.397895, Lon. -66.923725), taken a few decades before Hurricane Maria – exact date of photo unknown (adapted from Silva-Tulla et al., 2018).

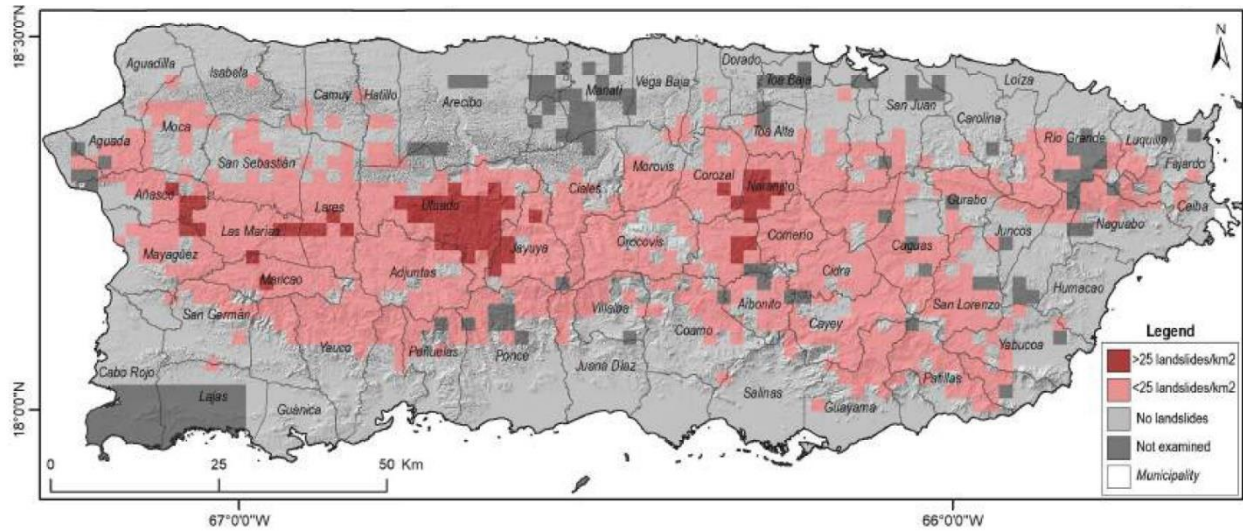
A rapid identification of landslide density across the island was performed by the USGS (Bessette-Kirton et al., 2017 and 2019) by examining post-hurricane satellite and aerial images (Figure 13). The map was generated analyzing FEMA and DigitalGlobe images collected between September 26 and October 8 in order to estimate the number of landslides inside 2 km x 2 km square cells. The authors warn of limitations of the study related to poor visibility associated with clouds, vegetation, and/or shadows. Further, the authors assumed that the majority of landslides detected were triggered by rainfall from Hurricane Maria, but the effects of antecedent rainfall from Hurricane Irma (September 6, 2017) and heavy rainfall reported in the days after Hurricane Maria may have also triggered landslides.

Figure 13. USGS map showing concentration of landslides attributed to Hurricane Maria (Bessette-Kirton et al., 2019).

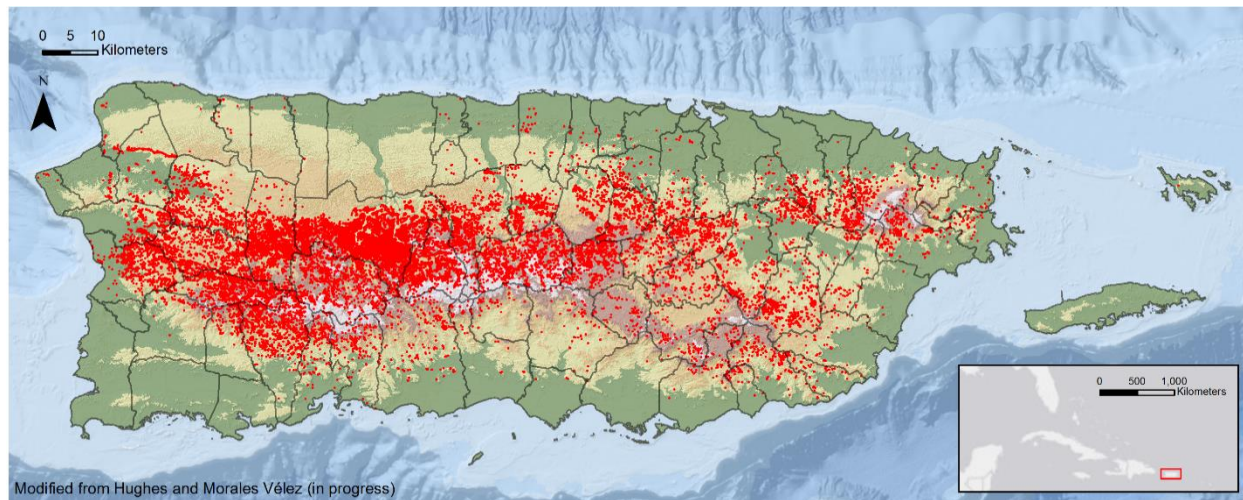
Despite these constraints, this map is useful in helping to identify the most critical areas of the island affected by landslides, and in aiding response and recovery efforts. The map in Figure 14 shows results of an ongoing investigation at UPRM by Hughes and Morales-Vélez (2017), in which more than 40,000 debris flow landslide sites have been identified across PR. Based on results from these two studies, the municipalities most severely impacted by landslides were Añasco, Mayagüez, Las Marías, Maricao, Lares, Utuado, Adjuntas, Jayuya, Ciales, and Orocovis. Three deaths were attributed directly to one of the landslides in the town of Utuado.

Figure 14. More than 40,000 debris flow sites (shown as red dots) identified across PR by Hughes & Morales-Vélez (2017).

The majority of the slides shown in Figure 14 consisted of shallow debris flows. Figure 16 shows a site, visited by the GEER team, which was affected by some debris flows; this site is located along Puerto Rico State Road 4131 (PR-4131) near the Rio Blanco River in the municipality of Lares. The largest debris flow shown destroyed three homes along the lower road alignment (Silva-Tulla et al., 2018). Luckily, the inhabitants of those homes were not present at the time of the landslide. The debris flow initiated just above the highest road cut on a switchback along PR-4131. The upper area is the primary zone of volume loss, while the lower portion of the road was only covered by debris. The hillslope material slid directly into the river below, which carried much of the small- to medium-sized sediment downstream. Figure 17 shows aerial imagery of the landslide before and after Hurricane Maria.

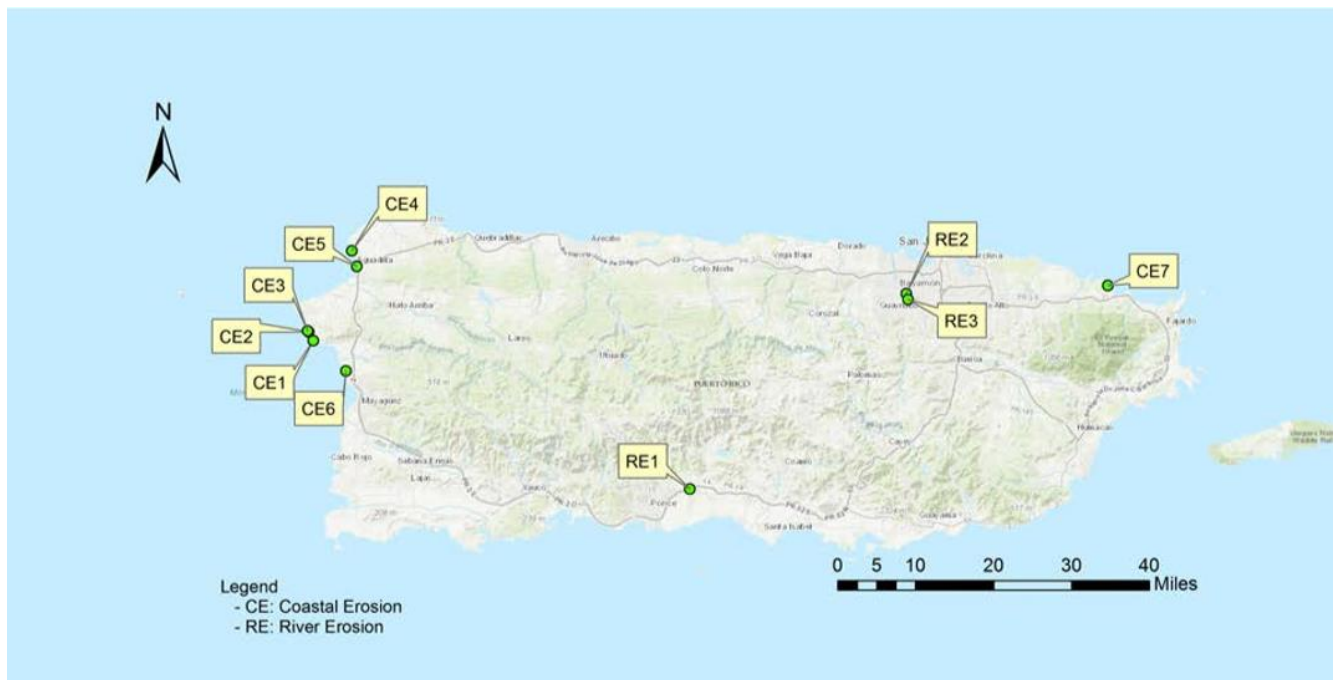
resulting thrust from the debris pushing on their upstream sides. Figure 18 shows the coastal and river scour sites visited by the GEER team. For the sake of brevity, only a couple of these sites are presented herein. A detailed description of all sites shown in this figure appear in the GEER report (Silva-Tulla et al., 2018).

Figure 18. Location of coastal and river scour sites visited by GEER team (Silva-Tulla et al., 2018).
