# Hurricane Irma: Consequences of Intense Rainfall and Storm Surge from a Tropical Storm in North and Central Florida

**ABSTRACT:** Hurricane Irma affected the Florida peninsula from September 9-11, 2017, with high winds, rainfall, and storm surge. Although the storm made landfall on the west coast of Florida, impacts of the rainfall and storm surge affected central and northeast Florida. A GEER team mobilized on September 23, 2017, spent three days documenting sinkhole damage in central Florida, coastal scour and erosion along the northeast coast of Florida, and infrastructure damage in northeast Florida. Numerous sites with geotechnical damage were documented but this case history focuses specifically on sinkhole damage in The Villages, erosion and scour at Vilano Beach, failure of a concrete cover earth dam at Hampton Lake, and bridge embankment damage on US-17 over the Trout River. The most notable challenges to reconnaissance were the widespread and varied nature of the damages from Hurricane Irma and the rapid repair of damaged infrastructure that required the team to work closely with local, state, and federal officials to obtain documentation of the damage prior to repair.

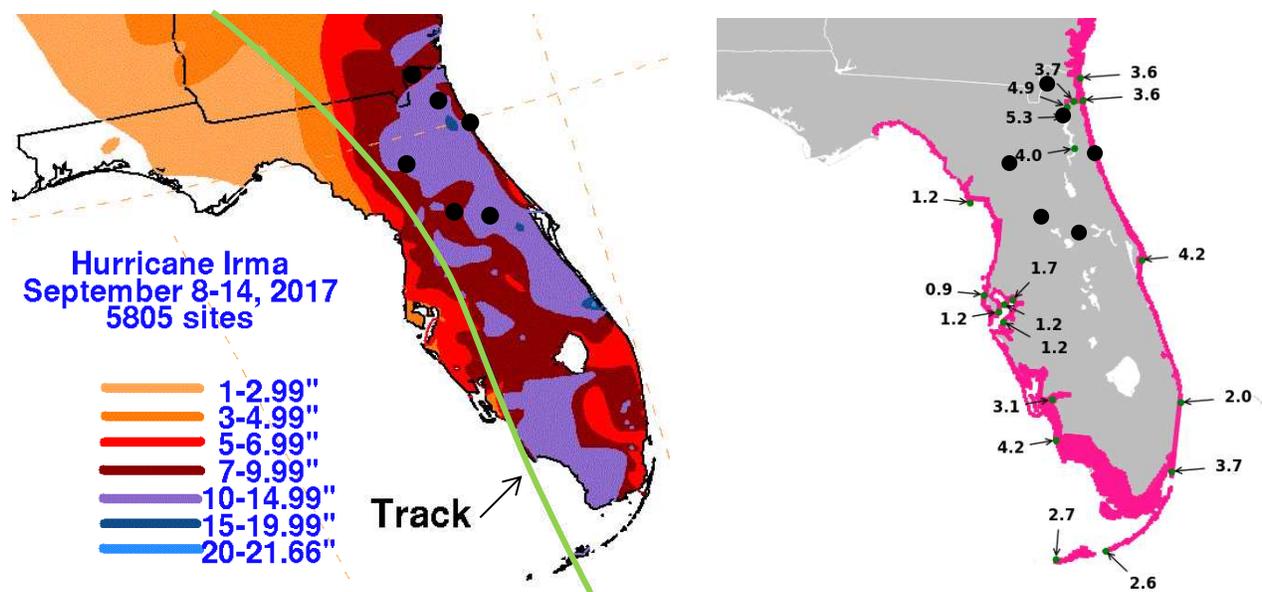
Water levels along the coast of Florida and in major estuaries and rivers are shown in Figure 2 (right). The data presented are tidal gage measured elevations in feet above mean higher high water (MHHW). MHHW is the Cangialosi et al. (2018) proxy for estimating the normal high-water mark, where water levels above these values indicate flooding from storm surge. Inundation is defined as the height of water over areas of normally dry ground due to the combination of both storm surge and astronomical tide. An estimated 0.9 m to 1.5 m (2.9 ft to 4.9 ft) of inundation above ground level occurred from Cape Canaveral, FL, in the south northward to the Florida-Georgia state line (Cangialosi et al., 2018). Tidal sensors reporting wave-corrected water levels above MHHW recorded values of 1.5 m (4.8 ft) in the Matanzas River just south of Vilano Beach and St. Augustine, and 1.25 m (4.1 ft) at Jacksonville Beach (Cangialosi et al., 2018), both of these being areas where GEER activities were focused. The United States Geological Survey (USGS) surveyed high water marks were reported to be 0.6 m to 1.2 m (2 ft to 4 ft) above MHHW in St. Augustine and 1 m (3.3 ft) above MHHW at Vilano Beach (Cangialosi et al., 2018). Cangialosi et al. (2018) also report that flooding in the St. Johns River in Jacksonville and the surrounding areas was significant due to both rainfall runoff and storm surge, where measured water levels were between 1.2 m and 1.6 m (4.0 ft to 5.3 ft) above MHHW.

The spatial distribution of rainfall from Irma is illustrated in Figure 2 (left). Between 0.18 m to 0.38 m (7 in to 15 in) of rainfall was recorded in north and central Florida. This heavy rainfall contributed significant amounts of water to overland flow and into natural and constructed water conveyance and storage systems (e.g., streams, culverts, retention ponds, and storm drains) and underground (e.g., through leaky underground piping and sinkhole conduits). The influx of water increased the potential for sinkhole activity. Rainfall and runoff along the coastal areas of Florida contributed to significant flooding. Many rivers in northeast Florida experienced major or record flooding. Record flooding occurred in Metropolitan Jacksonville

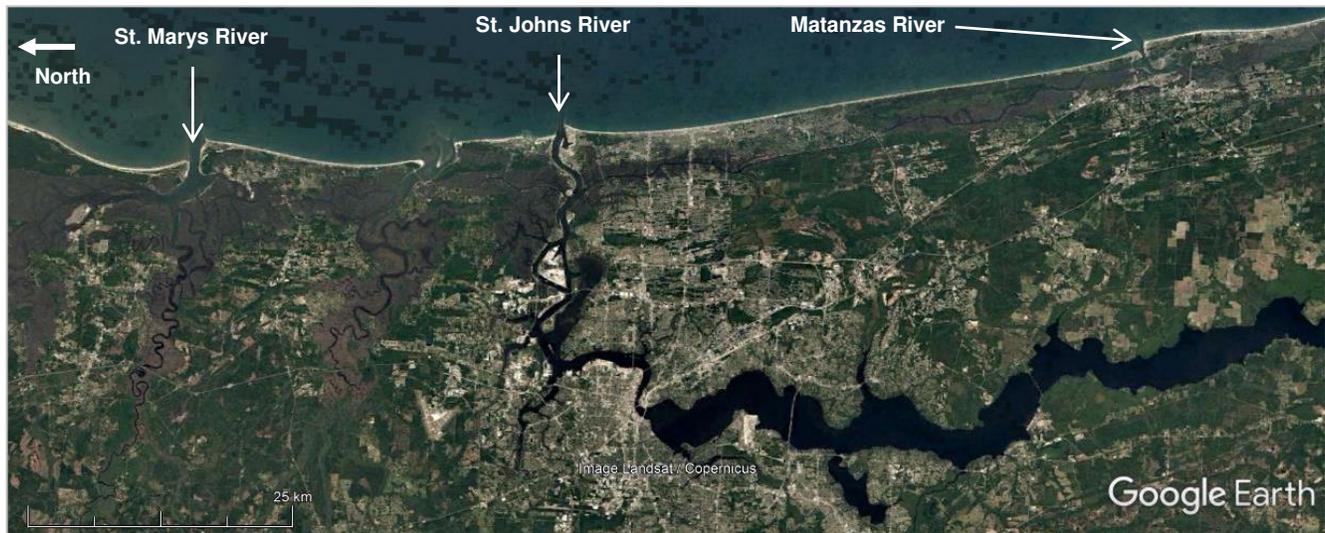
Figure 3. Northeastern rivers influenced by runoff and storm surge, including St. Marys River leading to Lake Hampton, St. Johns River leading to Jacksonville, and Matanzas River near Vilano Beach and St. Augustine (Google Earth, 2018).

and Hampton Lake, which were the focus of this GEER reconnaissance. The St. Johns River in Jacksonville and St. Marys River downstream of Hampton Lake (Figure 3) were likely influenced by wind-induced storm surge that retarded the flow of rainfall out of the system and led to damage at the Lake Hampton Dam in Hilliard and the US-17 bridge embankment in Jacksonville.

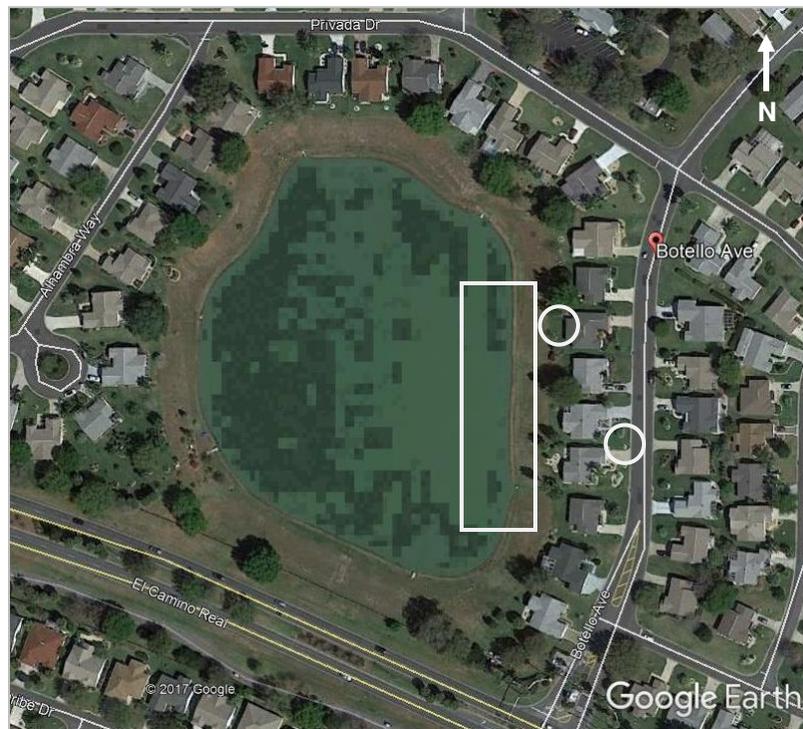
Figure 4. Location of sinkholes formed in the retention pond in The Villages Alhambra, FL, at 28°57'10.68"N latitude and 81°59'33.65"W longitude (Google Earth, 2017).

Several sinkholes were identified at a stormwater retention pond (Figure 4) in The Villages Alhambra, a body of water that is approximately 2 hectares (4.9 acres) in size, has six inlets, and is bounded by Privada Drive to the north and Botello Avenue to the east. The sinkholes associated with Hurricane Irma formed along the bottom, on the bank slope, and at the crest of the eastern side of the pond. Two additional sinkholes also affected residences.

Residents graciously provided the GEER team with an account of the sinkhole events and photographs taken prior to the GEER team's arrival. On September 11, the water level in the pond was above the inlet pipes. On September 12, the water level decreased to approximately the midpoint of the inlet pipes. By the morning of September 13, the pond was empty. Digital photographs from residents show five sinkholes in the retention pond basin and two sinkholes on the bank behind the house at 2536 Botello Avenue (Figure 5). During the site visit 14 days following Hurricane Irma on September 25, repair of

the sinkholes within the basin and along the bank was being completed. Repair was performed using a Caterpillar D4 bulldozer to end dump granular fill near the holes, infill them, and then compact the fill with the machine's weight. The dimensions of the sinkholes themselves could not be estimated from either the pre-repair photos or the repairs.

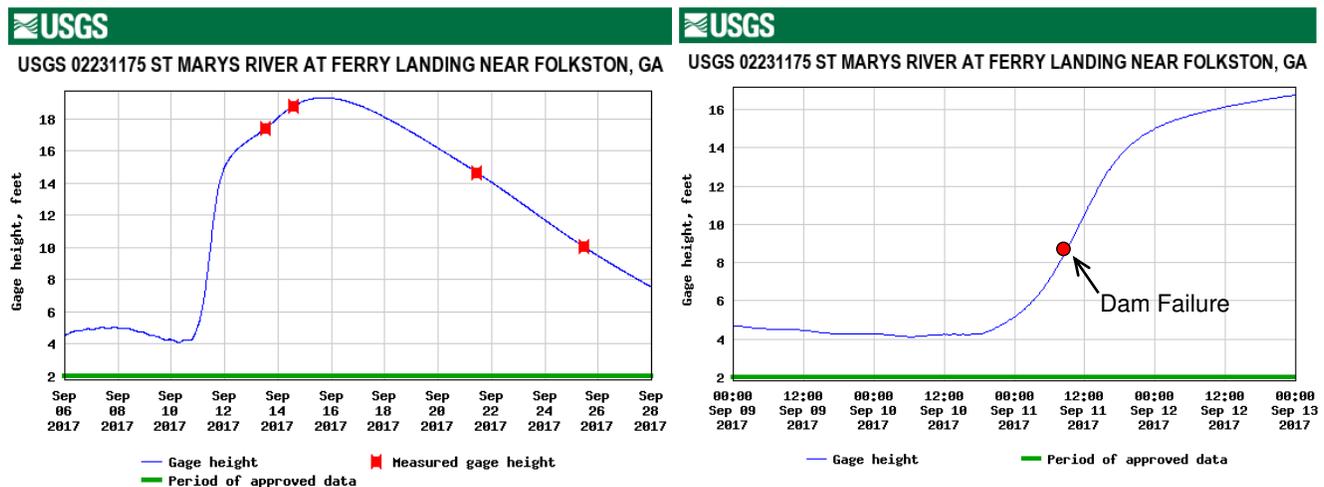
Figure 19: St. Marys River hydrograph elevations in NAVD 88 at the USGS 02231175 St. Marys River gage at Ferry Landing near Folkston, Georgia, prior to and after Hurricane Irma (USGS 2018).

The GEER team interviewed two witnesses present at the time of the dam failure who provided mobile phone video and anecdotal evidence of the timeline and sequence of events. Eyewitnesses and video indicate the dam spillway failed at approximately 7:44 AM on September 11, 2017, when the USGS gage measured tail water elevation was approximately 2.44 m (8 ft) (Figure 19b). Video showed three critical conditions that led to, and/or resulted from, the dam failure: (1) water undermined the spillway slab, causing the concrete cover to collapse and expose the underlying soil to further erosion; (2) water overflowed the spillway crest, indicating the height of the reservoir pool elevation was greater than 5.2 m (17 ft), and; (3) the east side of the embankment was heavily eroded (Hudyma et al., 2017).

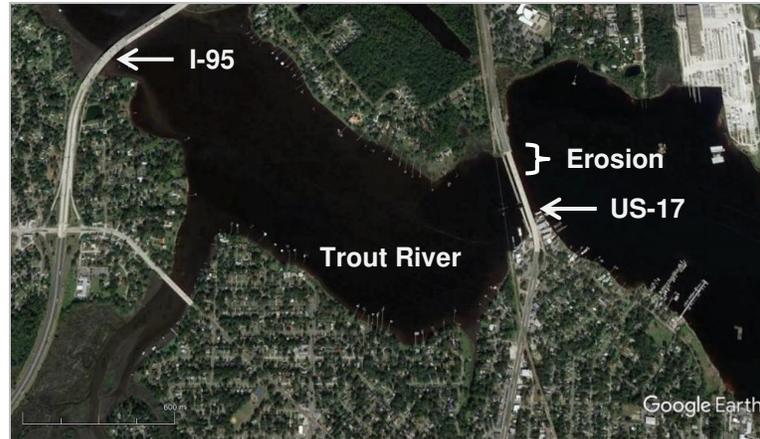
Figure 20: Location of the US 17 bridge over the Trout River in Jacksonville, Florida (Google Earth 2018).

The US-17 bridge (structure number 720011, Figure 20) over the Trout River in Jacksonville, Duval County, Florida, was built in 1958 and has four lanes that convey approximately 12,000 vehicles per day (City-Data, 2018). The Trout River is a tributary of the St. Johns River and thus tidally influenced. The soil embankment supporting the roadway sits atop a concrete support wall that is approximately 1 m to 2 m (3.2 to 6.6 ft) above the Trout River water level, depending on the tide. The soil embankment is stabilized along the front and sides by a concrete facing and supported at the furthest extent of the concrete where it meets the grassy embankment by a stacked concrete-sack wall. Utilities are installed in the embankment 1.5 m (4.9 ft) below the finished grade, and include sewer pipes, access structures, and electrical conduit.
