Hurricane Irma: Consequences of Intense Rainfall and Storm Surge from a Tropical Storm in North and Central Florida

ABSTRACT: Hurricane Irma affected the Florida peninsula from September 9-11, 2017, with high winds, rainfall, and storm surge. Although the storm made landfall on the west coast of Florida, impacts of the rainfall and storm surge affected central and northeast Florida. A GEER team mobilized on September 23, 2017, spent three days documenting sinkhole damage in central Florida, coastal scour and erosion along the northeast coast of Florida, and infrastructure damage in northeast Florida. Numerous sites with geotechnical damage were documented but this case history focuses specifically on sinkhole damage in The Villages, erosion and scour at Vilano Beach, failure of a concrete cover earth dam at Hampton Lake, and bridge embankment damage on US-17 over the Trout River. The most notable challenges to reconnaissance were the widespread and varied nature of the damages from Hurricane Irma and the rapid repair of damaged infrastructure that required the team to work closely with local, state, and federal officials to obtain documentation of the damage prior to repair.

Refe

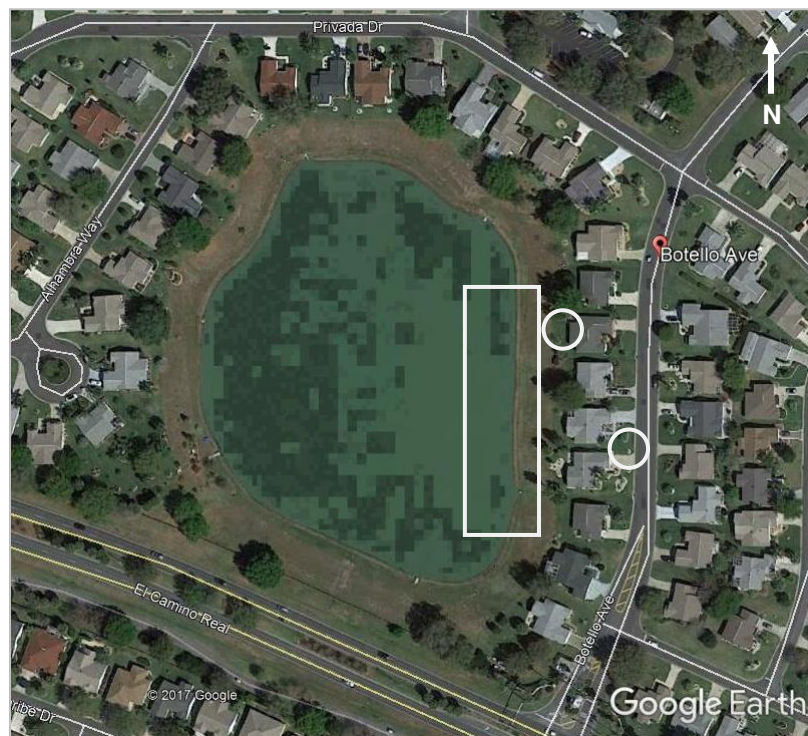
Several sinkholes were identified at a stormwater retention pond (Figure 4) in The Villages Alhambra, a body of water that is approximately 2 hectares (4.9 acres) in size, has six inlets, and is bounded by Privada Drive to the north and Botello Avenue to the east. The sinkholes associated with Hurricane Irma formed along the bottom, on the bank slope, and at the crest of the eastern side of the pond. Two additional sinkholes also affected residences.

Figure 4. Location of sinkholes formed in the retention pond in The Villages Alhambra, FL, at 28°57'10.68"N latitude and 81°59'33.65"W longitude (Google Earth, 2017).

the sinkholes within the basin and along the bank was being completed. Repair was performed using a Caterpillar D4 bulldozer to end dump granular fill near the holes, infill them, and then compact the fill with the machine's weight. The dimensions of the sinkholes themselves could not be estimated from either the pre-repair photos or the repairs.

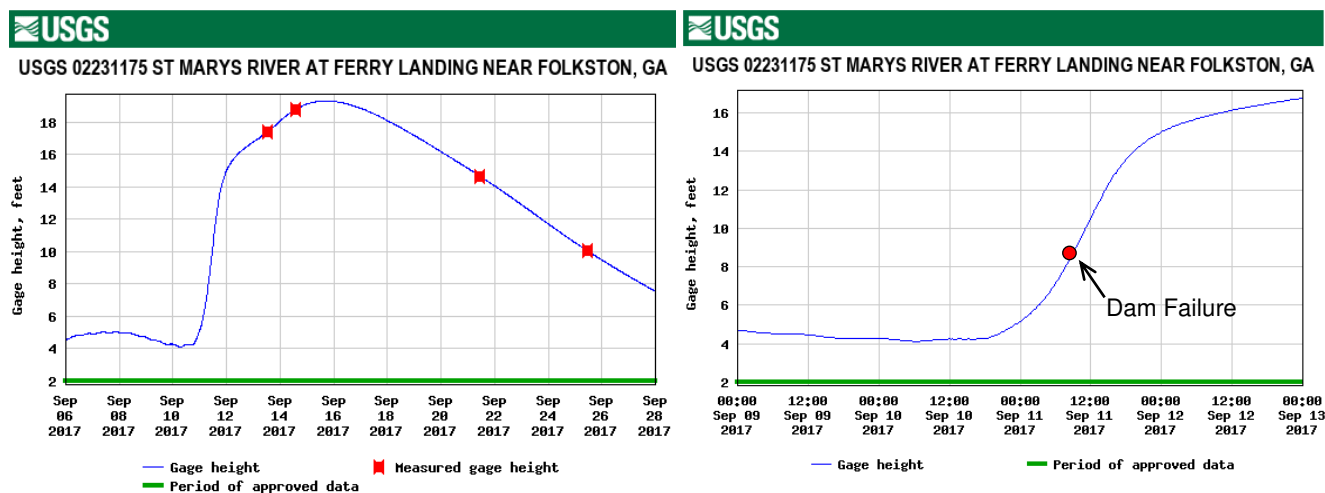
Figure 19: St. Marys River hydrograph elevations in NAVD 88 at the USGS 02231175 St. Marys River gage at Ferry Landing near Folkston, Georgia, prior to and after Hurricane Irma (USGS 2018).
