Hurricane Irma: Consequences of Intense Rainfall and Storm Surge from a Tropical Storm in North and Central Florida

Reference: Landon M. E., Hudyma N. W., and Sharma R. S. (2020). Hurricane Irma: Consequences of Intense Rainfall and Storm Surge from a Tropical Storm in North and Central Florida. *International Journal of Geoengineering Case Histories*, Volume 5, Issue 4, pp. 26-46, doi: 10.4417/IJGCH-05-04-02

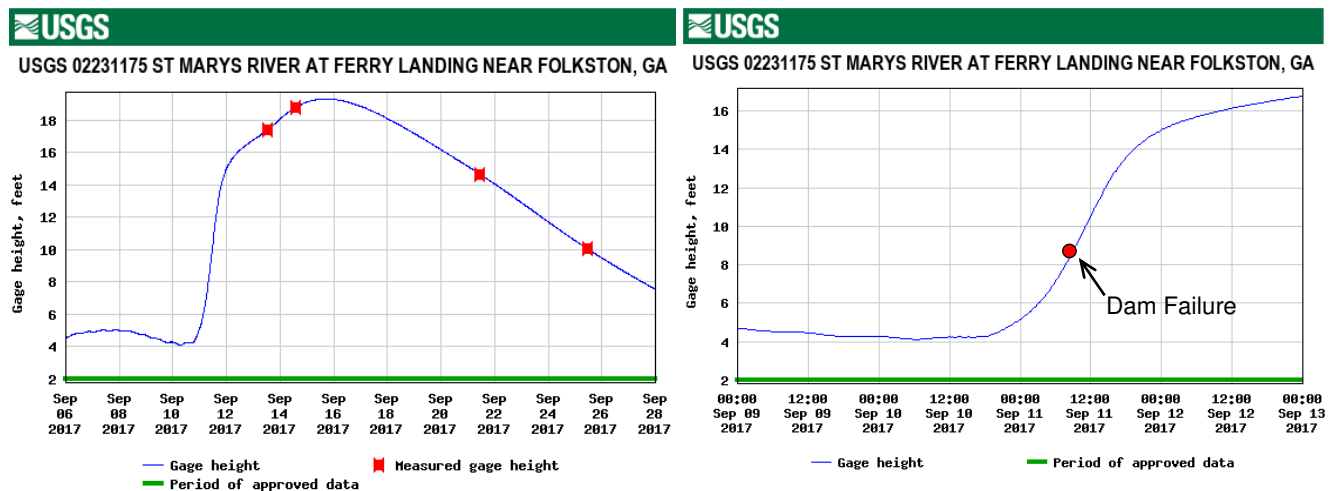
Cangialosi et al. (2018) report that record flooding occurred at Lake Hampton, with rainfall between 0.18 m to 0.25 m (0.6 to 0.8 ft) (Figure 2) and storm surge water levels between 1.2 m to 1.6 m (3.9 ft to 5.2 ft) above MHHW in the St. Johns River. The St. Marys River outlet to the Atlantic Ocean is approximately 35 km (21.7 mi) north of the St. Johns River outlet (Figure 3); thus, storm surge likely propagated similarly upstream in the St. Marys River. Figure 19 illustrates water level height in the St. Marys River approximately 9 km (5.6 mi) upstream from the Pigeon Creek outlet. Water level initially increased significantly from approximately 1.3 m (4 ft) to 4.5 m (15 ft) during Hurricane Irma and continued to increase for several days thereafter. The initial rapid initial water level increase is likely from a combination of overland flow in the watershed, back up of water into the tributaries of the St. Johns River due to the flooding, and storm surge water level increases described in Cangialosi et al. (2018). The subsequent slower increase is from water entering the St. Marys River from overland flow and groundwater following infiltration.

Figure 19: St. Marys River hydrograph elevations in NAVD 88 at the USGS 02231175 St. Marys River gage at Ferry Landing near Folkston, Georgia, prior to and after Hurricane Irma (USGS 2018).

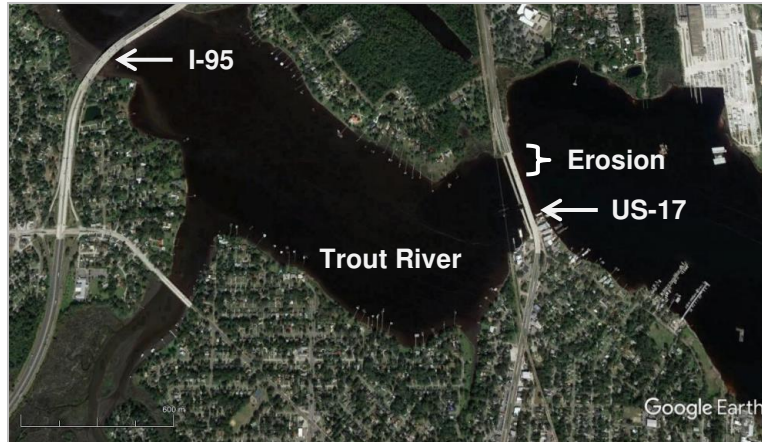
Figure 20: Location of the US 17 bridge over the Trout River in Jacksonville, Florida (Google Earth 2018).

The US-17 bridge (structure number 720011, Figure 20) over the Trout River in Jacksonville, Duval County, Florida, was built in 1958 and has four lanes that convey approximately 12,000 vehicles per day (City-Data, 2018). The Trout River is a tributary of the St. Johns River and thus tidally influenced. The soil embankment supporting the roadway sits atop a concrete support wall that is approximately 1 m to 2 m (3.2 to 6.6 ft) above the Trout River water level, depending on the tide. The soil embankment is stabilized along the front and sides by a concrete facing and supported at the furthest extent of the concrete where it meets the grassy embankment by a stacked concrete-sack wall. Utilities are installed in the embankment 1.5 m (4.9 ft) below the finished grade, and include sewer pipes, access structures, and electrical conduit.
